## Profile/Photo Observation Report

Street:	<b>ALLEY BEWTWEEN MAPLE ST &amp; ALA</b>	Flow Control:	<b>Not Controlled</b>
City:	<b>Hobart, IN</b>	Year Renewed:	
Location:	<b>Other</b>	Tape/Media #:	
Purpose:	<b>Not Known</b>	Dia/Height:	<b>8"</b>
Use:	<b>Sanitary</b>	Material:	<b>PVC</b>
Drain Area:	<b>NA</b>	Lining:	
Category:	<b>NA</b>		
Comment:

Location Details:		Direction of Survey:	<b>Downstream</b>
US MH:	<b>M-103-122</b>	DS MH:	<b>M-103-126</b>
		Total Length Surveyed (ft):	<b>240.3</b>

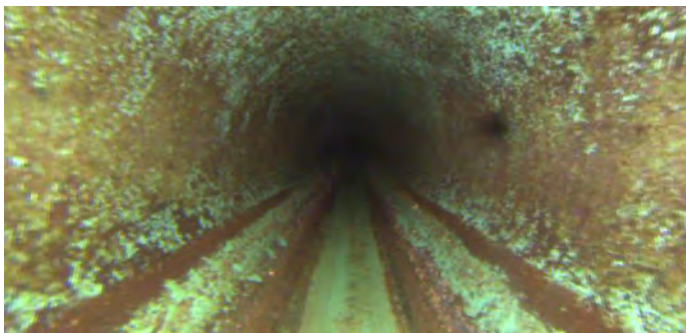
Code: **AMH**  
Description: **Manhole**

Distance (ft): **.0**  
Structural Grade: **0**  
O&M Grade: **0**  
Clock Start/From:  
Clock To:  
1st Value:  
2nd Value:  
Value Percent:  
Continuous Index:  
Within 8" of Joint: **NO**  
Remarks: **M-103-122**

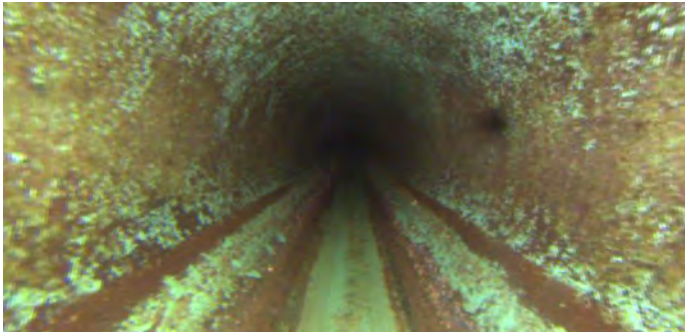
Code:	<b>MWL</b>
Description:	<b>Water Level</b>

Distance (ft):	<b>.0</b>
Structural Grade:	<b>0</b>
O&M Grade:	<b>0</b>
Clock Start/From:	
Clock To:	
1st Value:	
2nd Value:	
Value Percent:	<b>5.000</b>
Continuous Index:	
Within 8" of Joint:	<b>NO</b>
Remarks:

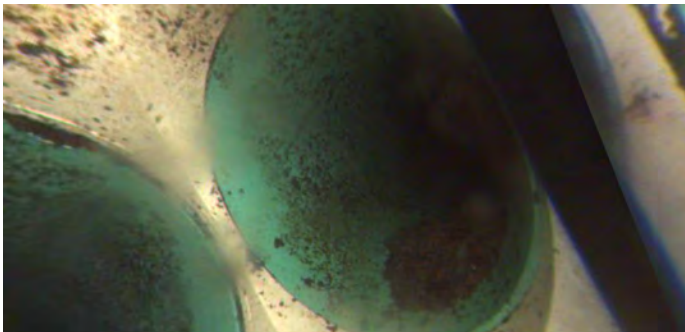
Code:	<b>TF</b>
Description:	<b>Tap Factory</b>

Distance (ft):	<b>56.4</b>
Structural Grade:	<b>0</b>
O&M Grade:	<b>0</b>
Clock Start/From:	<b>10</b>
Clock To:	
1st Value:	<b>4.000</b>
2nd Value:	
Value Percent:	
Continuous Index:	
Within 8" of Joint:	
Remarks:

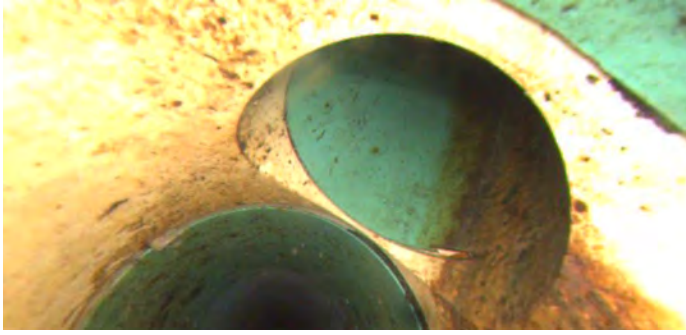
Code: **TF**  
Description: **Tap Factory**

Distance (ft): **57.9**  
Structural Grade: **0**  
O&M Grade: **0**  
Clock Start/From: **1**  
Clock To:  
1st Value: **4.000**  
2nd Value:  
Value Percent:  
Continuous Index:  
Within 8" of Joint:  
Remarks:

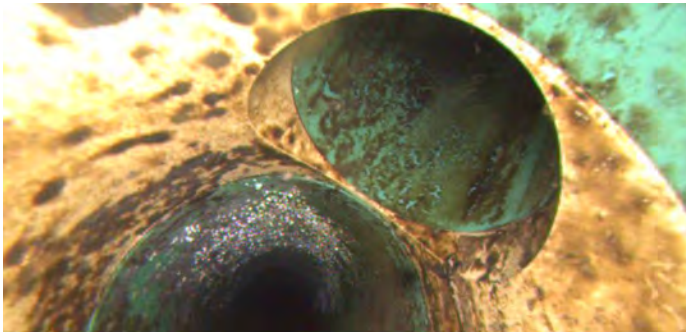
Code: **TF**  
Description: **Tap Factory**

Distance (ft): **75.7**  
Structural Grade: **0**  
O&M Grade: **0**  
Clock Start/From: **1**  
Clock To:  
1st Value: **4.000**  
2nd Value:  
Value Percent:  
Continuous Index:  
Within 8" of Joint:  
Remarks:

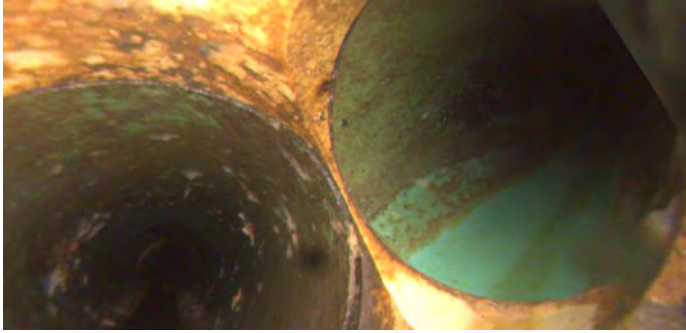
Code: **TF**  
Description: **Tap Factory**

Distance (ft): **115.2**  
Structural Grade: **0**  
O&M Grade: **0**  
Clock Start/From: **2**  
Clock To:  
1st Value: **4.000**  
2nd Value:  
Value Percent:  
Continuous Index:  
Within 8" of Joint:  
Remarks:

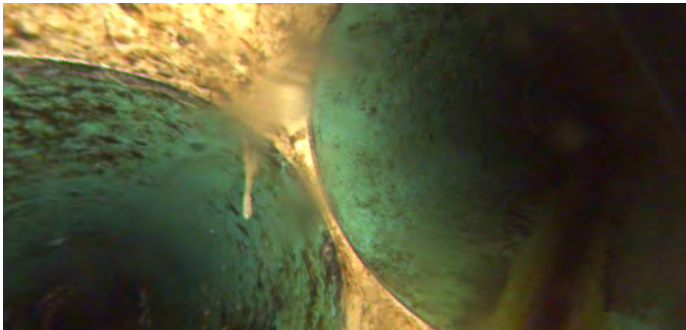
Code: **TF**  
Description: **Tap Factory**

Distance (ft): **119.8**  
Structural Grade: **0**  
O&M Grade: **0**  
Clock Start/From: **10**  
Clock To:  
1st Value: **4.000**  
2nd Value:  
Value Percent:  
Continuous Index:  
Within 8" of Joint:  
Remarks:

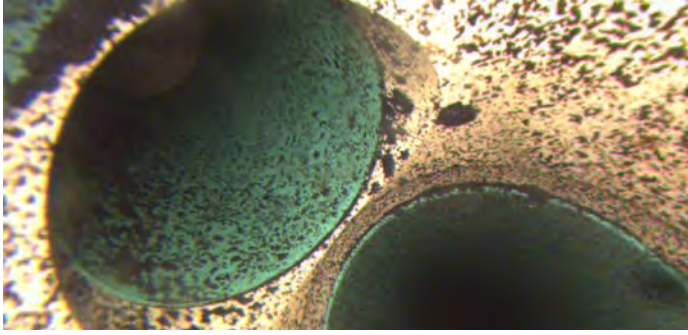
Code: **TF**  
Description: **Tap Factory**

Distance (ft): **198.5**  
Structural Grade: **0**  
O&M Grade: **0**  
Clock Start/From: **10**  
Clock To:  
1st Value: **4.000**  
2nd Value:  
Value Percent:  
Continuous Index:  
Within 8" of Joint:  
Remarks:

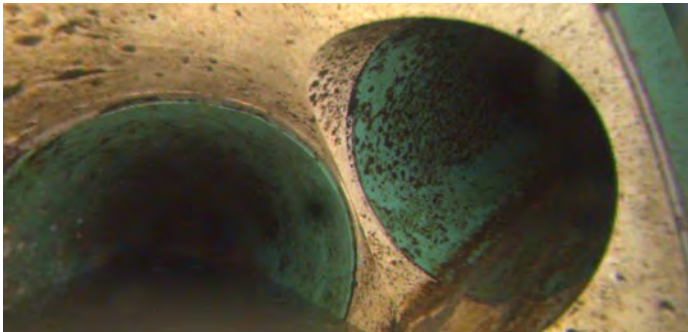
Code: **TFA**  
Description: **Tap Factory Active**

Distance (ft): **236.9**  
Structural Grade: **0**  
O&M Grade: **0**  
Clock Start/From: **3**  
Clock To:  
1st Value: **4.000**  
2nd Value:  
Value Percent:  
Continuous Index:  
Within 8" of Joint:  
Remarks:

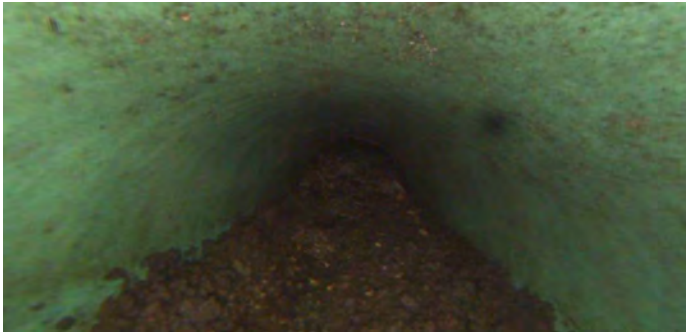
Code: **MSA**  
Description: **Abandoned Survey**

Distance (ft): **240.3**  
Structural Grade: **0**  
O&M Grade: **0**  
Clock Start/From:  
Clock To:  
1st Value:  
2nd Value:  
Value Percent:  
Continuous Index:  
Within 8" of Joint: **NO**  
Remarks: **DSGV**

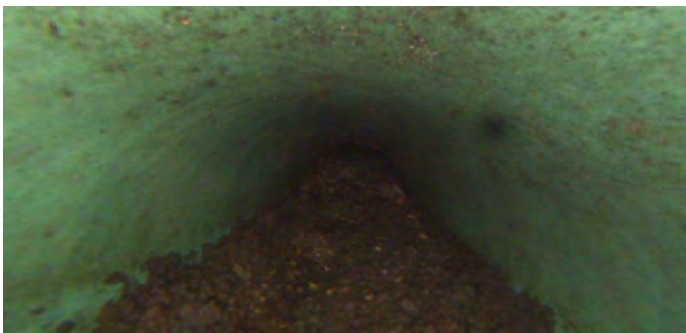
Code: **DSGV**  
Description: **Deposits Settled Gravel**

Distance (ft): **240.3**  
Structural Grade: **0**  
O&M Grade: **5**  
Clock Start/From: **12**  
Clock To: **12**  
1st Value:  
2nd Value:  
Value Percent: **45.000**  
Continuous Index:  
Within 8" of Joint: **NO**  
Remarks:
