Profile/Photo Observation Report

Date:	03/22/2018	Weather:		Coding:	PACP 6.0
Pipe Length (ft):	206.6	Owner:	NA	Pre Clean:	Not Known
P.O.#:		Surveyor:	Selasie Honu	PSR:	P-103-125-124
Customer:		Clean Date:	01/01/1900	Shape:	C

Street:	MAPLE ST	Flow Control:	Not Controlled
City:	Hobart, IN	Year Renewed:	
Location:	Other	Tape/Media #:	
Purpose:	Not Known	Dia/Height:	8"
Use:	Sanitary	Material:	PVC
Drain Area:	NA	Lining:	
Category:	NA		
Comment:	Pipe filled with dry debris

Location Details:		Direction of Survey:	Downstream
US MH:	M-103-124	DS MH:	M-103-125
		Total Length Surveyed (ft):	200.5

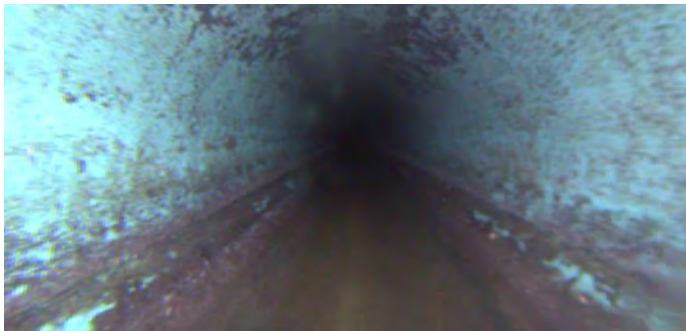
Code: **AMH**
Description: **Manhole**

Distance (ft): **.0**
Structural Grade: **0**
O&M Grade: **0**
Clock Start/From:
Clock To:
1st Value:
2nd Value:
Value Percent:
Continuous Index:
Within 8" of Joint: **NO**
Remarks: **M-103-124**

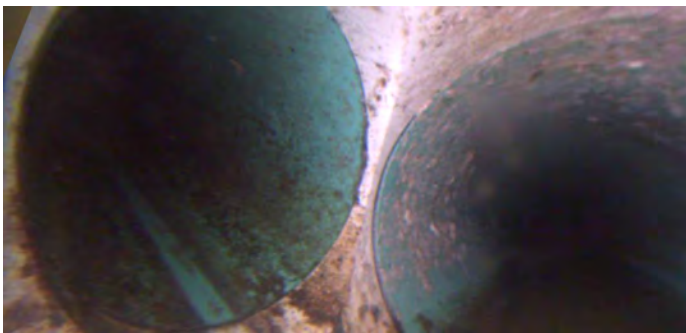
Code: **TF**
Description: **Tap Factory**

Distance (ft): **148.3**
Structural Grade: **0**
O&M Grade: **0**
Clock Start/From: **9**
Clock To:
1st Value: **4.000**
2nd Value:
Value Percent:
Continuous Index:
Within 8" of Joint:
Remarks:

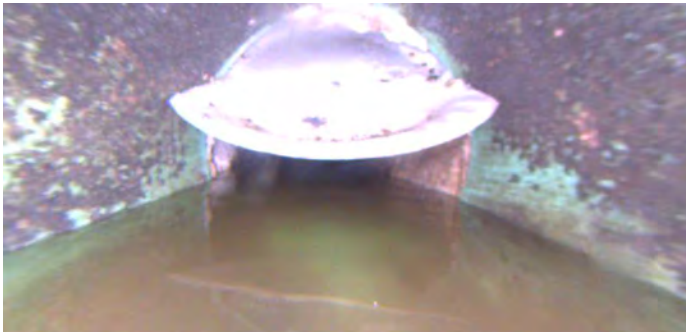
Code: **OBZ**
Description: **Obstacle Other**

Distance (ft): **198.4**
Structural Grade: **0**
O&M Grade: **5**
Clock Start/From: **3**
Clock To: **9**
1st Value:
2nd Value:
Value Percent: **40.000**
Continuous Index:
Within 8" of Joint: **NO**
Remarks: **PLATE BLOCKING MH**
