Profile/Photo Observation Report

Date:	12/21/2024	Weather:		Coding:	PACP 7.0
Pipe Length (ft):	214.7	Owner:	City of Hobart	Pre Clean:	Heavy Cleaning
P.O.#:	YES502259	Surveyor:	S. Bucklin	PSR:	P-103-128-127
Customer:	City of Hobart	Clean Date:	12/19/2024	Shape:	C

Street:	West 38th Avenue	Flow Control:	Not Controlled
City:	Hobart, IN	Year Renewed:	
Location:	Alley	Tape/Media #:	
Purpose:	Sewer System Evaluation Survey (SS	Dia/Height:	8"
Use:	Sanitary Sewage Pipe	Material:	PVC
Drain Area:		Lining:	None
Category:	NA		
Comment:			
Location Details:		Direction of Survey:	Downstream
US MH:	M-103-128	DS MH:	M-103-127
		Total Length Surveyed (ft):	206.8

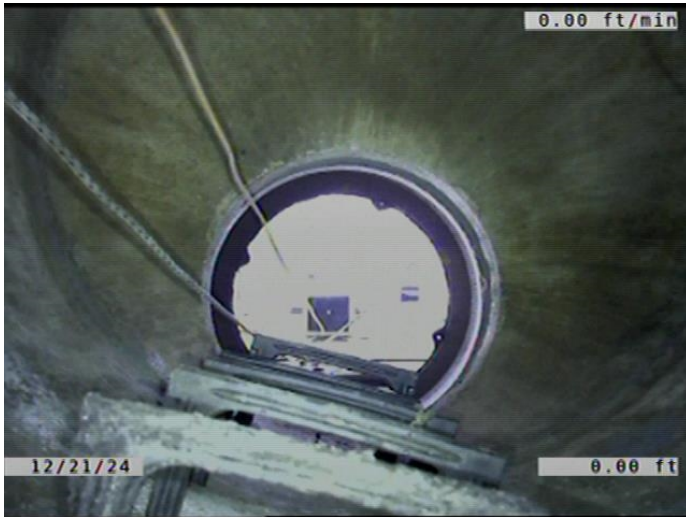
Code: **AMH**
Description: **Manhole**

Distance (ft): **.0**
Structural Grade: **0**
O&M Grade: **0**
Clock Start/From:
Clock To:
1st Value:
2nd Value:
Value Percent:
Continuous Index:
Within 8" of Joint: **NO**
Remarks: **M-103-128**

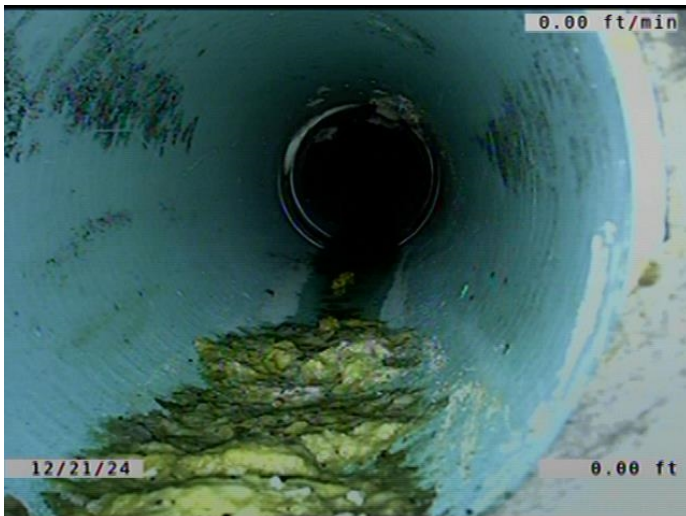
Code: **MWL**
Description: **Miscellaneous Water Level**

Distance (ft): **.0**
Structural Grade: **0**
O&M Grade: **0**
Clock Start/From:
Clock To:
1st Value:
2nd Value:
Value Percent: **5.000**
Continuous Index:
Within 8" of Joint: **NO**
Remarks:

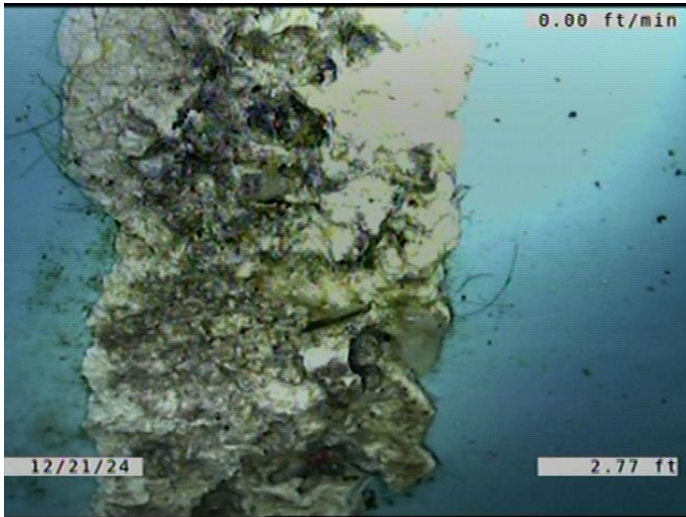
Code: **DAGS**
Description: **Deposits Attached Grease**

Distance (ft): **2.8**
Structural Grade: **0**
O&M Grade: **2**
Clock Start/From: **11**
Clock To: **2**
1st Value:
2nd Value:
Value Percent: **5.000**
Continuous Index: **S01**
Within 8" of Joint: **YES**
Remarks:

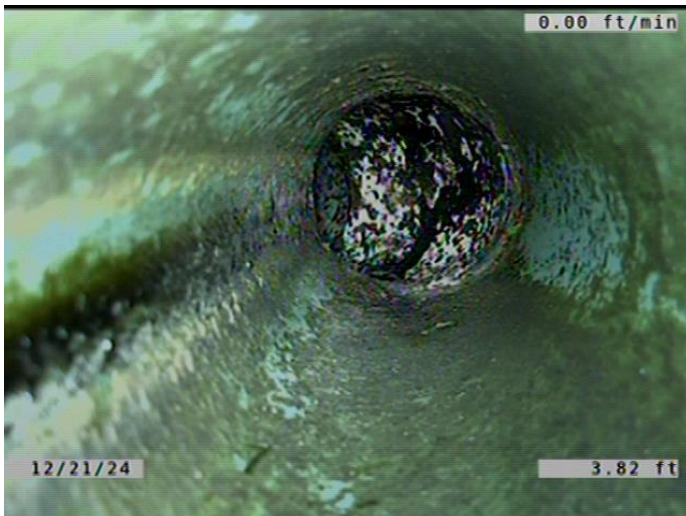
Code: **TF**
Description: **Tap Factory**

Distance (ft): **3.8**
Structural Grade: **0**
O&M Grade: **0**
Clock Start/From: **11**
Clock To:
1st Value: **6.000**
2nd Value:
Value Percent:
Continuous Index:
Within 8" of Joint: **NO**
Remarks: **CONSTANTLY RUNNING WATER.**

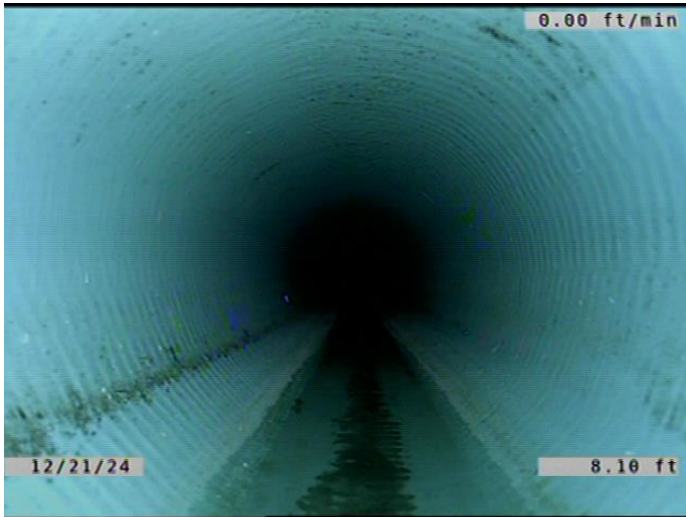
Code: **DAGS**
 Description: **Deposits Attached Grease**

Distance (ft): **8.1**
 Structural Grade: **0**
 O&M Grade: **2**
 Clock Start/From: **11**
 Clock To: **2**
 1st Value:
 2nd Value:
 Value Percent: **5.000**
 Continuous Index: **F01**
 Within 8" of Joint: **YES**
 Remarks:

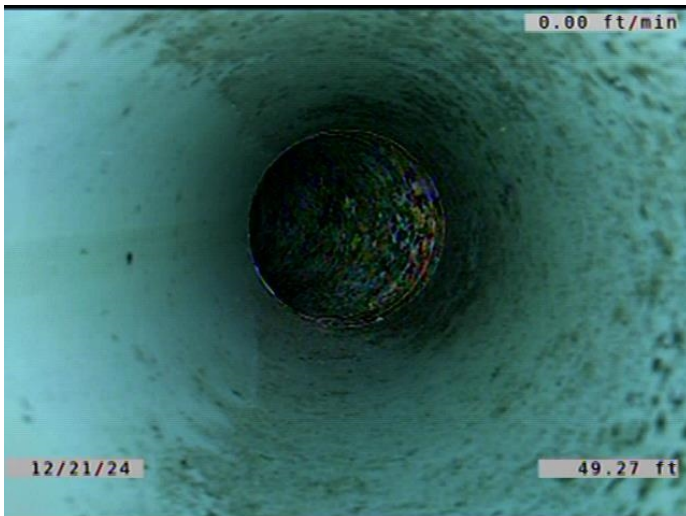
Code: **TF**
 Description: **Tap Factory**

Distance (ft): **49.3**
 Structural Grade: **0**
 O&M Grade: **0**
 Clock Start/From: **10**
 Clock To:
 1st Value: **6.000**
 2nd Value:
 Value Percent:
 Continuous Index:
 Within 8" of Joint: **NO**
 Remarks:

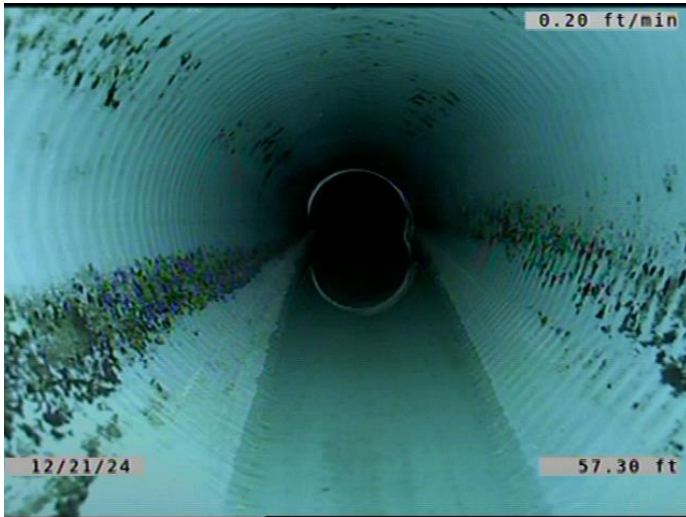
Code: **MWLS**
Description: **Miscellaneous Water Level Sag**

Distance (ft): **57.3**
Structural Grade: **2**
O&M Grade: **0**
Clock Start/From:
Clock To:
1st Value:
2nd Value:
Value Percent: **15.000**
Continuous Index: **S02**
Within 8" of Joint: **NO**
Remarks:

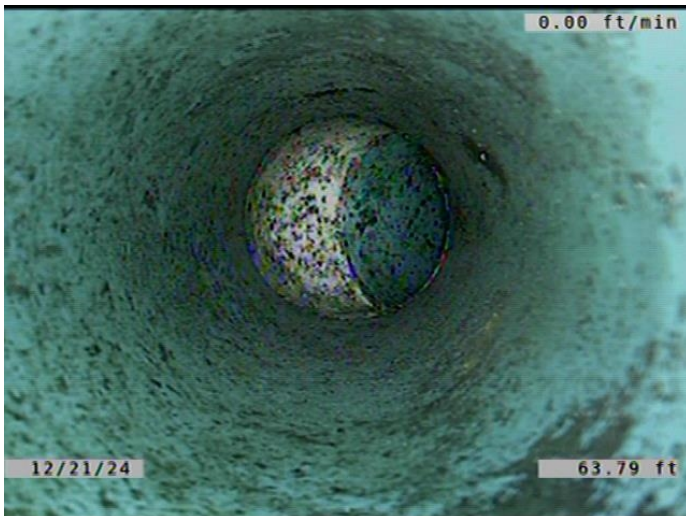
Code: **TF**
Description: **Tap Factory**

Distance (ft): **63.8**
Structural Grade: **0**
O&M Grade: **0**
Clock Start/From: **1**
Clock To:
1st Value: **6.000**
2nd Value:
Value Percent:
Continuous Index:
Within 8" of Joint: **NO**
Remarks:

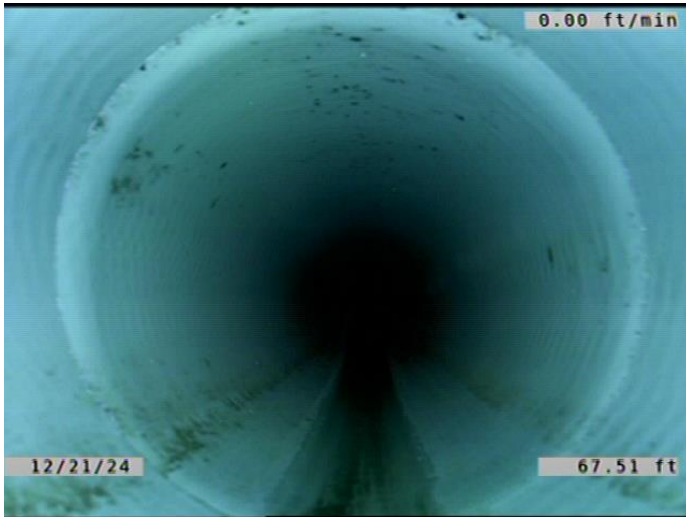
Code: **MWLS**
Description: **Miscellaneous Water Level Sag**

Distance (ft): **67.5**
Structural Grade: **2**
O&M Grade: **0**
Clock Start/From:
Clock To:
1st Value:
2nd Value:
Value Percent: **15.000**
Continuous Index: **F02**
Within 8" of Joint: **NO**
Remarks:

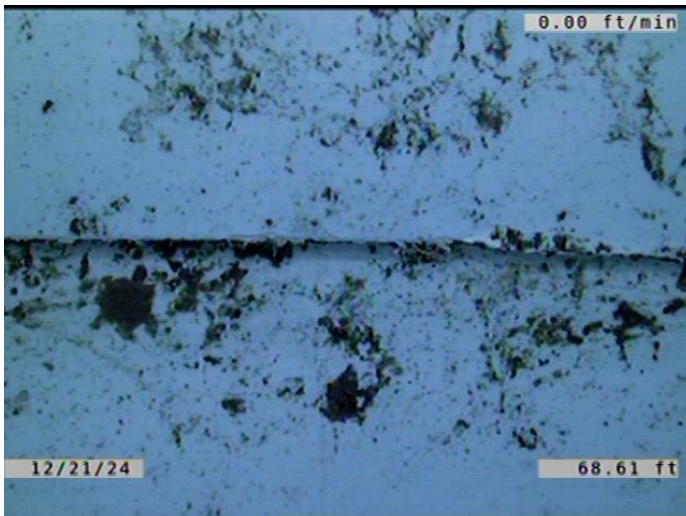
Code: **JAM**
Description: **Joint Angular Medium**

Distance (ft): **68.6**
Structural Grade: **3**
O&M Grade: **0**
Clock Start/From:
Clock To:
1st Value:
2nd Value:
Value Percent:
Continuous Index:
Within 8" of Joint: **NO**
Remarks:

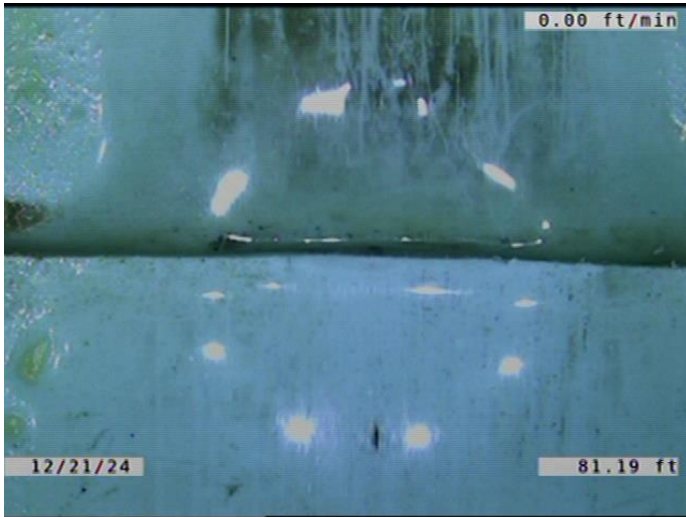
Code: **JAM**
Description: **Joint Angular Medium**

Distance (ft): **81.2**
Structural Grade: **3**
O&M Grade: **0**
Clock Start/From:
Clock To:
1st Value:
2nd Value:
Value Percent:
Continuous Index:
Within 8" of Joint: **NO**
Remarks:

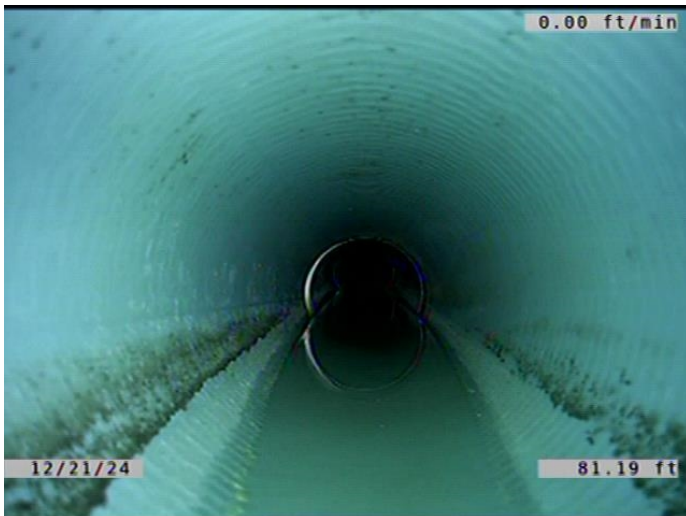
Code: **MWLS**
Description: **Miscellaneous Water Level Sag**

Distance (ft): **81.2**
Structural Grade: **2**
O&M Grade: **0**
Clock Start/From:
Clock To:
1st Value:
2nd Value:
Value Percent: **20.000**
Continuous Index: **S03**
Within 8" of Joint: **NO**
Remarks:

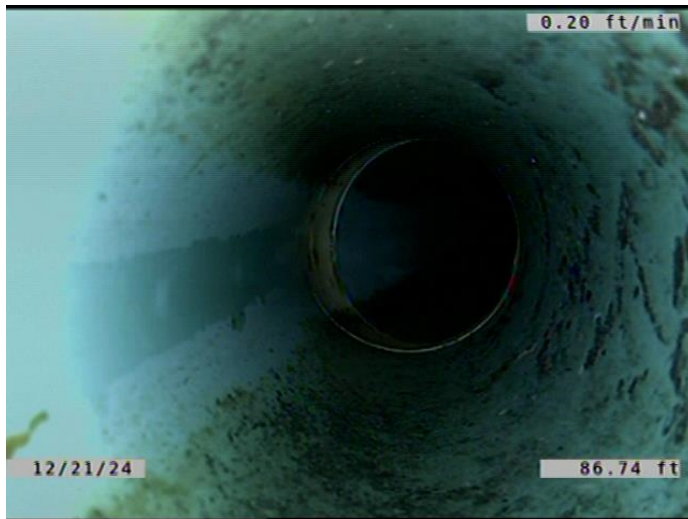
Code: **TF**
Description: **Tap Factory**

Distance (ft): **86.7**
Structural Grade: **0**
O&M Grade: **0**
Clock Start/From: **10**
Clock To:
1st Value: **6.000**
2nd Value:
Value Percent:
Continuous Index:
Within 8" of Joint: **NO**
Remarks: **CONSTANTLY RUNNING WATER.**

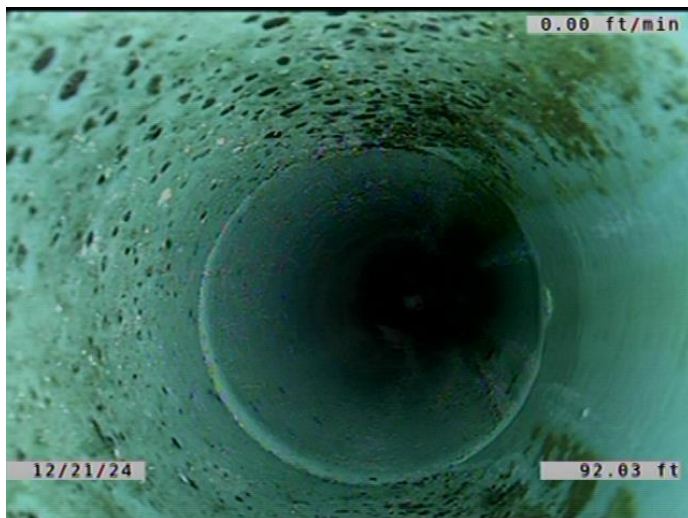
Code: **TFA**
Description: **Tap Factory Activity**

Distance (ft): **92.0**
Structural Grade: **0**
O&M Grade: **0**
Clock Start/From: **2**
Clock To:
1st Value: **6.000**
2nd Value:
Value Percent:
Continuous Index:
Within 8" of Joint: **NO**
Remarks:

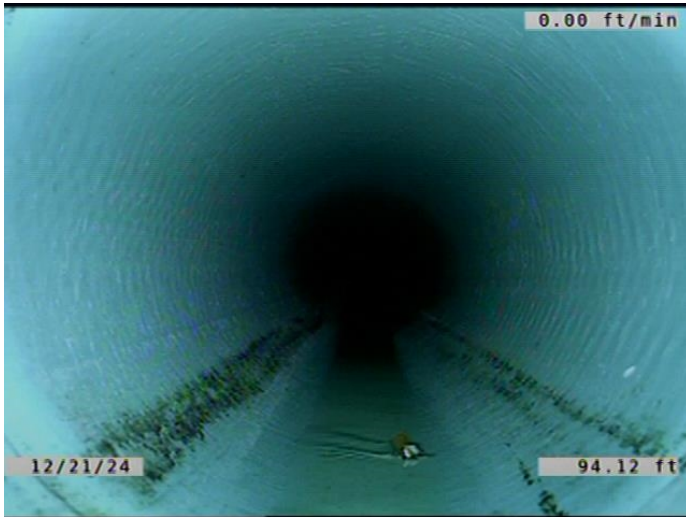
Code: **MWLS**
Description: **Miscellaneous Water Level Sag**

Distance (ft): **94.1**
Structural Grade: **2**
O&M Grade: **0**
Clock Start/From:
Clock To:
1st Value:
2nd Value:
Value Percent: **20.000**
Continuous Index: **F03**
Within 8" of Joint: **NO**
Remarks:

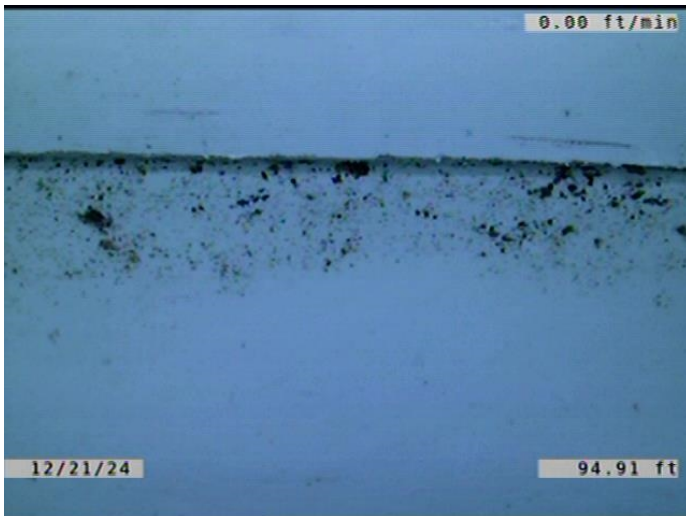
Code: **JAM**
Description: **Joint Angular Medium**

Distance (ft): **94.9**
Structural Grade: **3**
O&M Grade: **0**
Clock Start/From:
Clock To:
1st Value:
2nd Value:
Value Percent:
Continuous Index:
Within 8" of Joint: **NO**
Remarks:

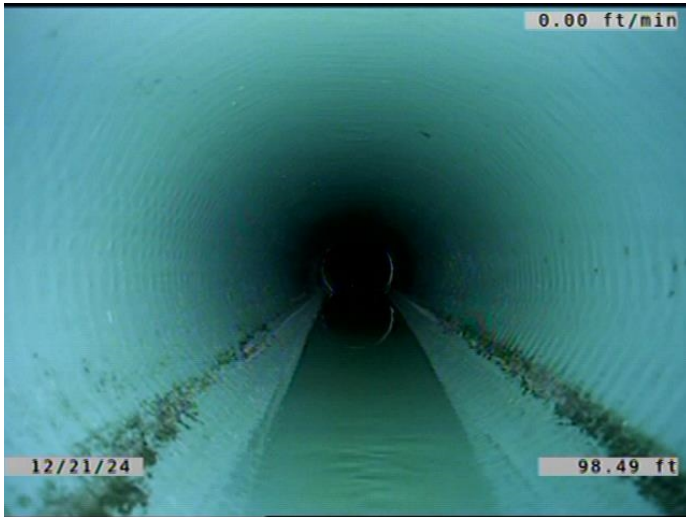
Code: **MWLS**
Description: **Miscellaneous Water Level Sag**

Distance (ft): **98.5**
Structural Grade: **2**
O&M Grade: **0**
Clock Start/From:
Clock To:
1st Value:
2nd Value:
Value Percent: **10.000**
Continuous Index: **S04**
Within 8" of Joint: **NO**
Remarks:

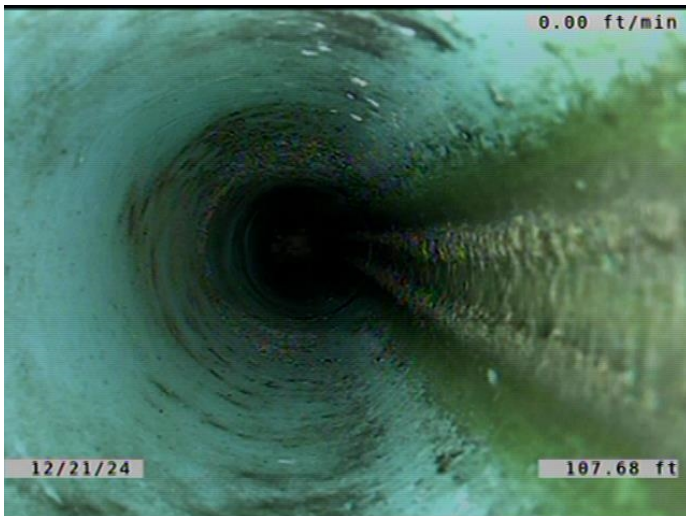
Code: **TF**
Description: **Tap Factory**

Distance (ft): **107.7**
Structural Grade: **0**
O&M Grade: **0**
Clock Start/From: **2**
Clock To:
1st Value: **6.000**
2nd Value:
Value Percent:
Continuous Index:
Within 8" of Joint: **NO**
Remarks:

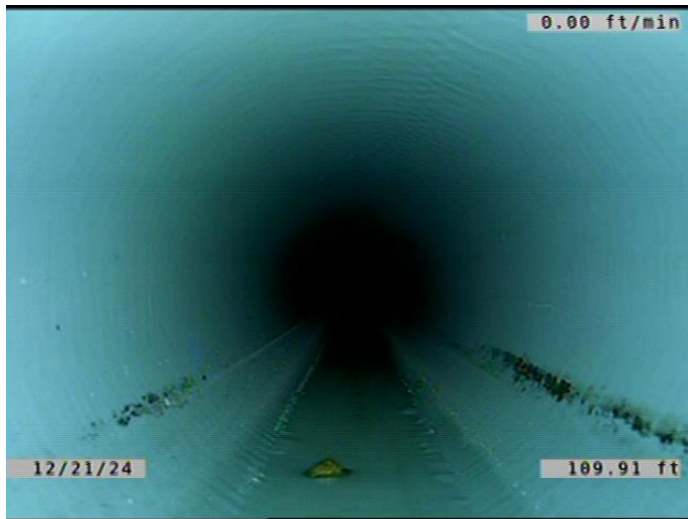
Code: **MWLS**
Description: **Miscellaneous Water Level Sag**

Distance (ft): **109.9**
Structural Grade: **2**
O&M Grade: **0**
Clock Start/From:
Clock To:
1st Value:
2nd Value:
Value Percent: **10.000**
Continuous Index: **F04**
Within 8" of Joint: **NO**
Remarks:

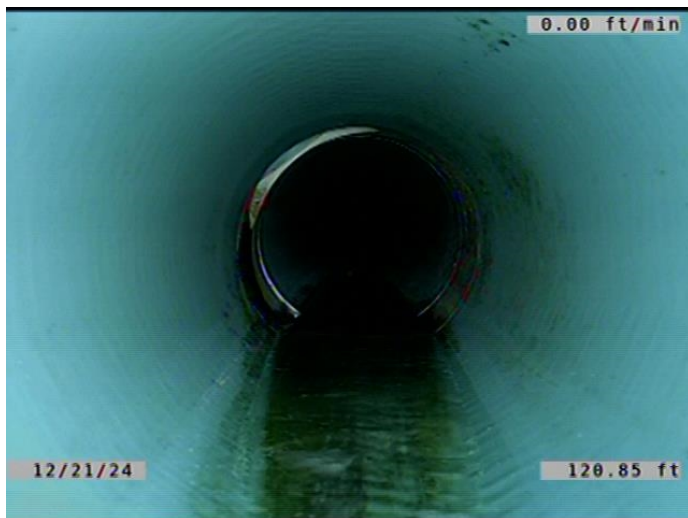
Code: **MWLS**
Description: **Miscellaneous Water Level Sag**

Distance (ft): **120.8**
Structural Grade: **2**
O&M Grade: **0**
Clock Start/From:
Clock To:
1st Value:
2nd Value:
Value Percent: **5.000**
Continuous Index: **S05**
Within 8" of Joint: **NO**
Remarks:

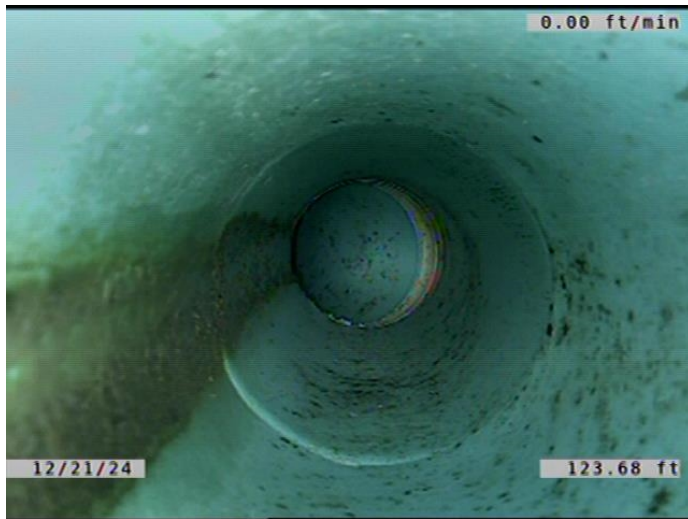
Code: **TF**
 Description: **Tap Factory**

Distance (ft): **123.7**
 Structural Grade: **0**
 O&M Grade: **0**
 Clock Start/From: **10**
 Clock To:
 1st Value: **6.000**
 2nd Value:
 Value Percent:
 Continuous Index:
 Within 8" of Joint: **NO**
 Remarks:

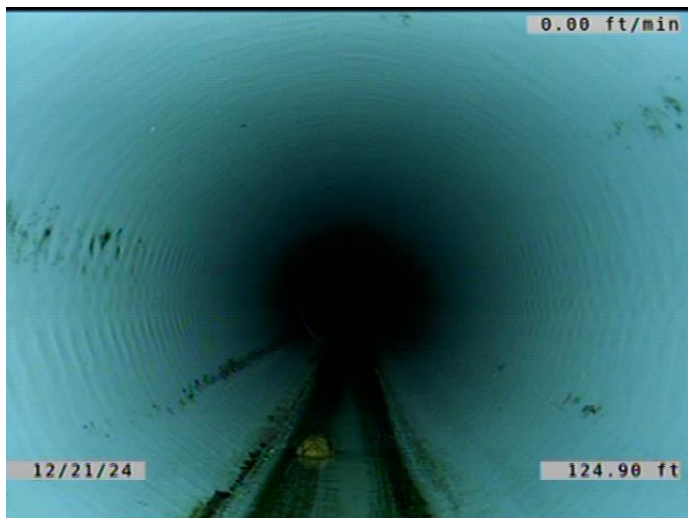
Code: **MWLS**
 Description: **Miscellaneous Water Level Sag**

Distance (ft): **124.9**
 Structural Grade: **2**
 O&M Grade: **0**
 Clock Start/From:
 Clock To:
 1st Value:
 2nd Value:
 Value Percent: **5.000**
 Continuous Index: **F05**
 Within 8" of Joint: **NO**
 Remarks:

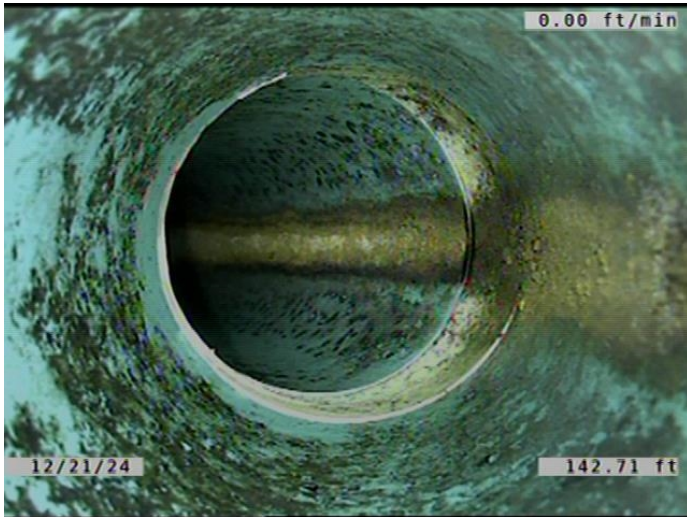
Code: **TF**
Description: **Tap Factory**

Distance (ft): **142.7**
Structural Grade: **0**
O&M Grade: **0**
Clock Start/From: **2**
Clock To:
1st Value: **6.000**
2nd Value:
Value Percent:
Continuous Index:
Within 8" of Joint: **NO**
Remarks:

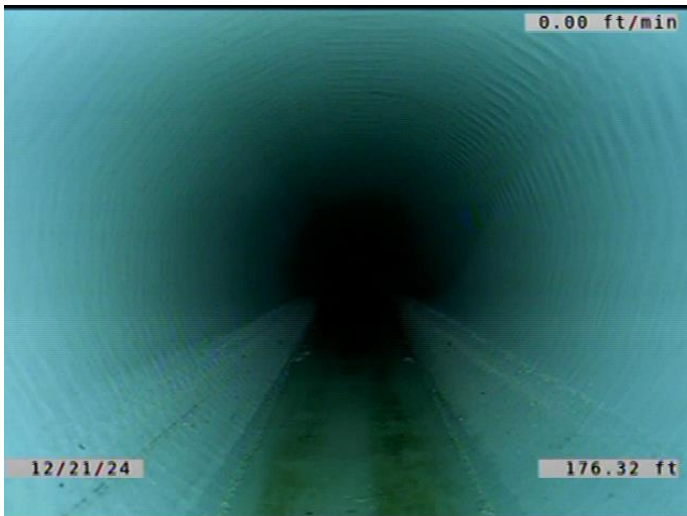
Code: **MWLS**
Description: **Miscellaneous Water Level Sag**

Distance (ft): **176.3**
Structural Grade: **2**
O&M Grade: **0**
Clock Start/From:
Clock To:
1st Value:
2nd Value:
Value Percent: **15.000**
Continuous Index: **S06**
Within 8" of Joint: **NO**
Remarks:

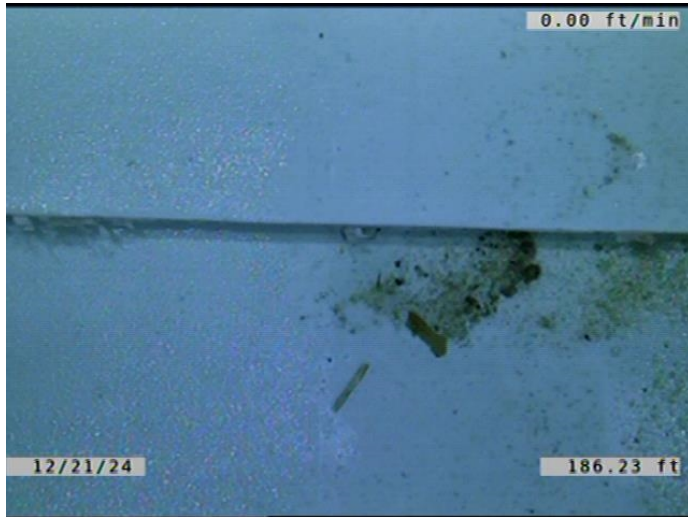
Code: **JAM**
Description: **Joint Angular Medium**

Distance (ft): **186.2**
Structural Grade: **3**
O&M Grade: **0**
Clock Start/From:
Clock To:
1st Value:
2nd Value:
Value Percent:
Continuous Index:
Within 8" of Joint: **NO**
Remarks:

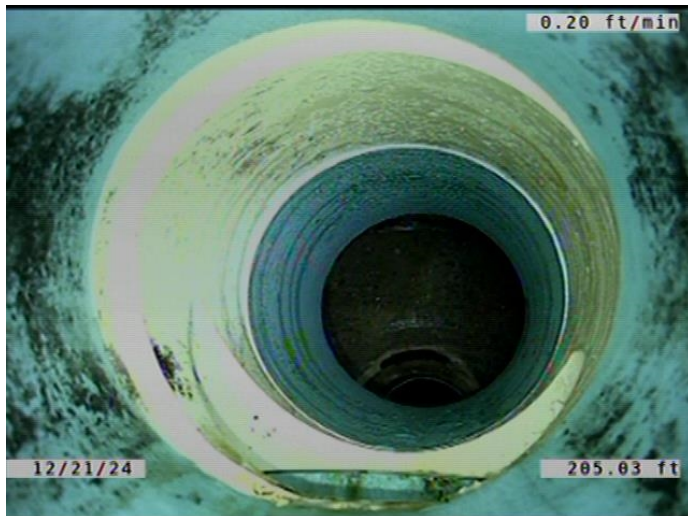
Code: **MWLS**
Description: **Miscellaneous Water Level Sag**

Distance (ft): **205.0**
Structural Grade: **2**
O&M Grade: **0**
Clock Start/From:
Clock To:
1st Value:
2nd Value:
Value Percent: **15.000**
Continuous Index: **F06**
Within 8" of Joint: **NO**
Remarks:

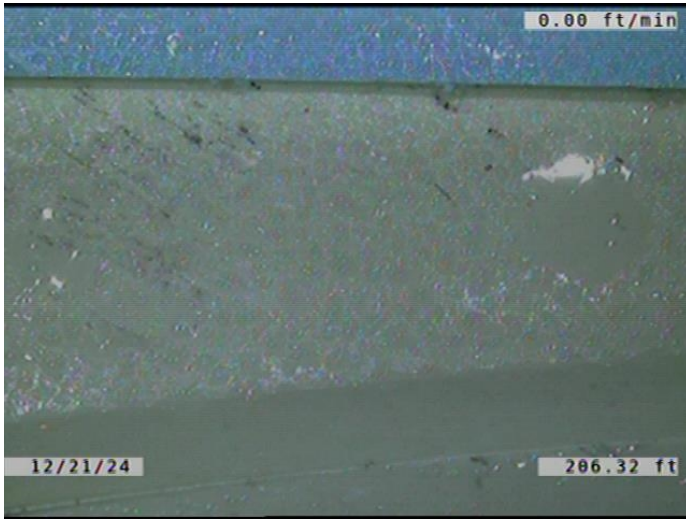
Code: **LRD**
 Description: **Line Right Down**

Distance (ft): **206.3**
 Structural Grade: **0**
 O&M Grade: **2**
 Clock Start/From:
 Clock To:
 1st Value:
 2nd Value:
 Value Percent: **15.000**
 Continuous Index:
 Within 8" of Joint: **NO**
 Remarks:

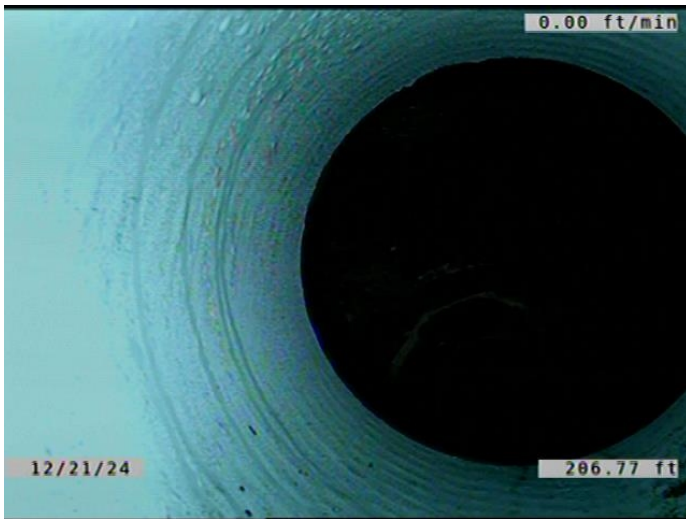
Code: **AMH**
 Description: **Manhole**

Distance (ft): **206.8**
 Structural Grade: **0**
 O&M Grade: **0**
 Clock Start/From:
 Clock To:
 1st Value:
 2nd Value:
 Value Percent:
 Continuous Index:
 Within 8" of Joint: **NO**
 Remarks: **M-103-127**
