Profile/Photo Observation Report

Street:	ALLEY BEWTWEEN SWIFT ST & ALAB	Flow Control:	Not Controlled
City:	Hobart, IN	Year Renewed:	
Location:	Other	Tape/Media #:	
Purpose:	Not Known	Dia/Height:	8"
Use:	Sanitary	Material:	PVC
Drain Area:	NA	Lining:	
Category:	NA		
Comment:

Location Details:		Direction of Survey:	Downstream
US MH:	M-103-127	DS MH:	M-103-129
		Total Length Surveyed (ft):	255.1

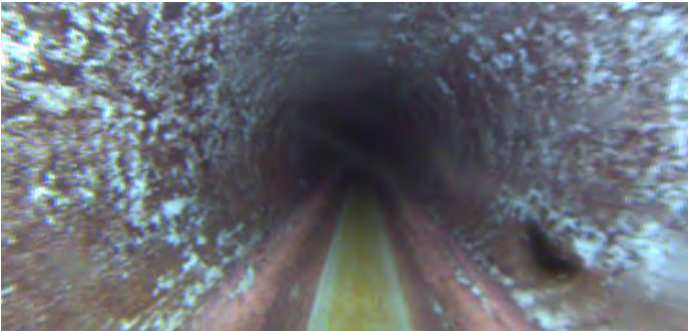
177.1	TF	Tap Factory	473	NA
	213.0	TF	Tap Factory	560	NA
	255.1	AMH	Manhole	657	NA
<div> <div>Code:</div> <div>AMH</div> </div> <div> <div>Description:</div> <div>Manhole</div> </div> <div>

</div> <div> <div>Distance (ft):</div> <div>.0</div> </div> <div> <div>Structural Grade:</div> <div>0</div> </div> <div> <div>O&M Grade:</div> <div>0</div> </div> <div> <div>Clock Start/From:</div> <div></div> </div> <div> <div>Clock To:</div> <div></div> </div> <div> <div>1st Value:</div> <div></div> </div> <div> <div>2nd Value:</div> <div></div> </div> <div> <div>Value Percent:</div> <div></div> </div> <div> <div>Continuous Index:</div> <div></div> </div> <div> <div>Within 8" of Joint:</div> <div>NO</div> </div> <div> <div>Remarks:</div> <div>M-103-127</div> </div>

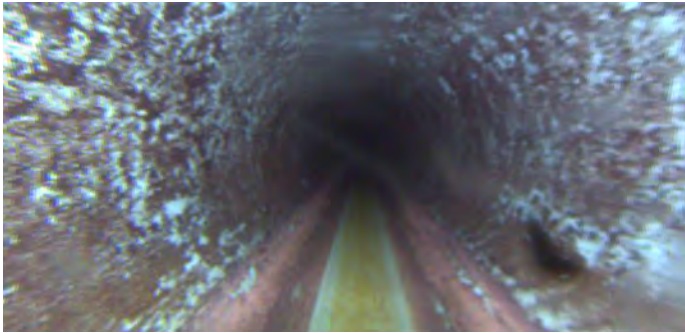
Code:	MWL
Description:	Water Level

Distance (ft):	.0
Structural Grade:	0
O&M Grade:	0
Clock Start/From:	
Clock To:	
1st Value:	
2nd Value:	
Value Percent:	5.000
Continuous Index:	
Within 8" of Joint:	NO
Remarks:

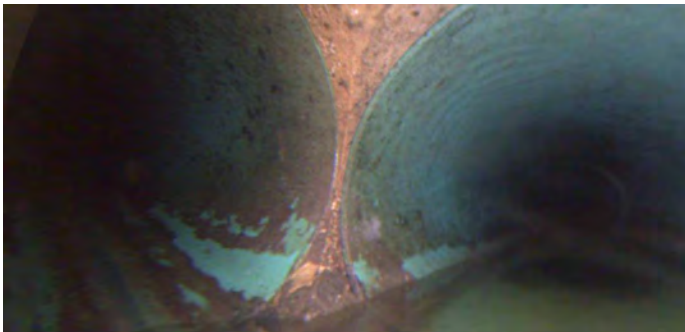
Code:	TFA
Description:	Tap Factory Active

Distance (ft):	46.5
Structural Grade:	0
O&M Grade:	0
Clock Start/From:	9
Clock To:	
1st Value:	4.000
2nd Value:	
Value Percent:	
Continuous Index:	
Within 8" of Joint:	
Remarks:

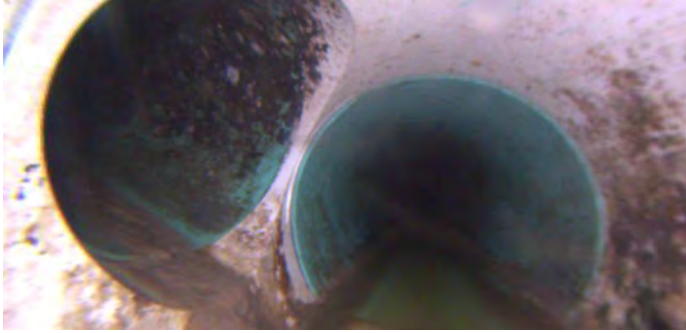
Code: **TFA**
Description: **Tap Factory Active**

Distance (ft): **70.9**
Structural Grade: **0**
O&M Grade: **0**
Clock Start/From: **9**
Clock To:
1st Value: **4.000**
2nd Value:
Value Percent:
Continuous Index:
Within 8" of Joint:
Remarks:

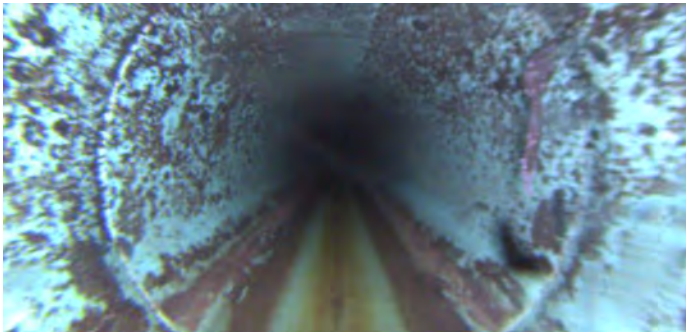
Code: **RFJ**
Description: **Roots Fine Joint**

Distance (ft): **74.3**
Structural Grade: **0**
O&M Grade: **1**
Clock Start/From: **2**
Clock To:
1st Value:
2nd Value:
Value Percent:
Continuous Index:
Within 8" of Joint: **YES**
Remarks:

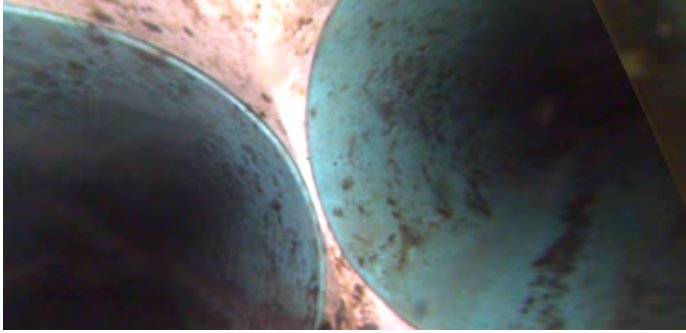
Code: **TF**
Description: **Tap Factory**

Distance (ft): **101.7**
Structural Grade: **0**
O&M Grade: **0**
Clock Start/From: **2**
Clock To:
1st Value: **4.000**
2nd Value:
Value Percent:
Continuous Index:
Within 8" of Joint:
Remarks:

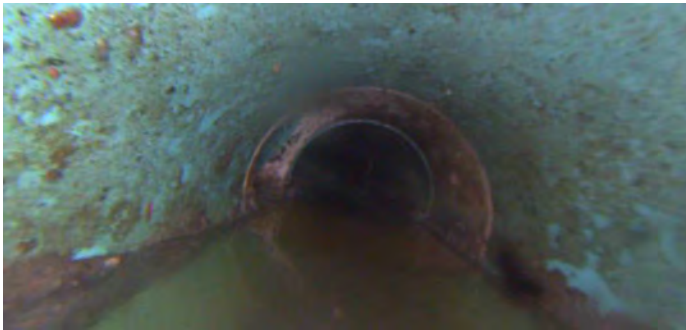
Code: **MWL**
Description: **Water Level**

Distance (ft): **132.2**
Structural Grade: **0**
O&M Grade: **0**
Clock Start/From:
Clock To:
1st Value:
2nd Value:
Value Percent: **30.000**
Continuous Index:
Within 8" of Joint: **NO**
Remarks:

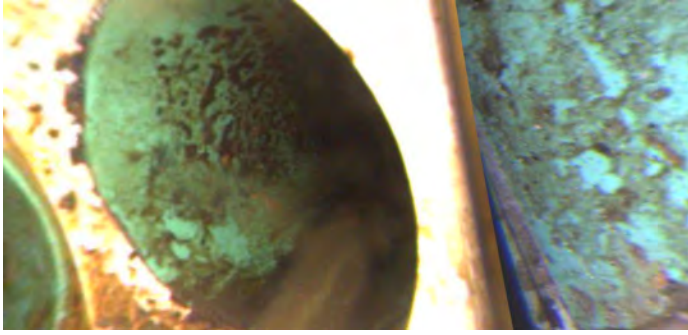
Code: **TFA**
Description: **Tap Factory Active**

Distance (ft): **133.5**
Structural Grade: **0**
O&M Grade: **0**
Clock Start/From: **9**
Clock To:
1st Value: **4.000**
2nd Value:
Value Percent:
Continuous Index:
Within 8" of Joint:
Remarks:

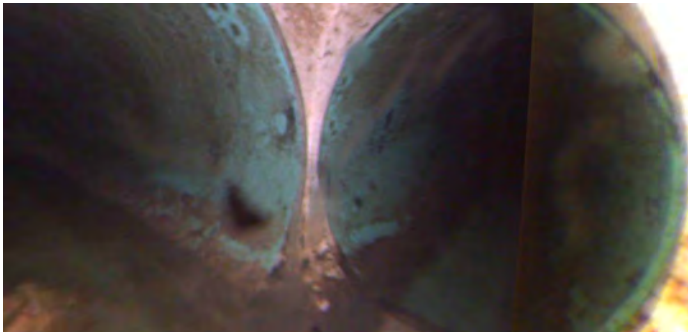
Code: **TFA**
Description: **Tap Factory Active**

Distance (ft): **137.8**
Structural Grade: **0**
O&M Grade: **0**
Clock Start/From: **3**
Clock To:
1st Value: **4.000**
2nd Value:
Value Percent:
Continuous Index:
Within 8" of Joint:
Remarks:

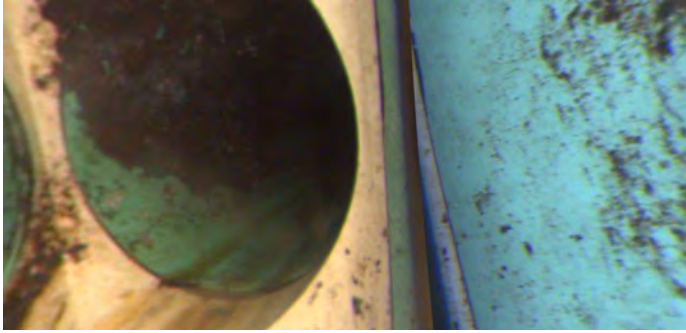
Code: **TF**
Description: **Tap Factory**

Distance (ft): **177.1**
Structural Grade: **0**
O&M Grade: **0**
Clock Start/From: **10**
Clock To:
1st Value: **4.000**
2nd Value:
Value Percent:
Continuous Index:
Within 8" of Joint:
Remarks:

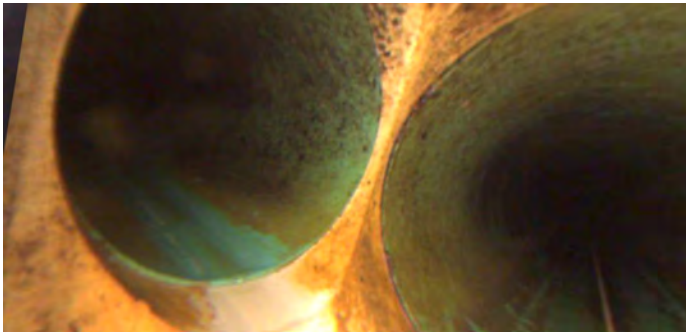
Code: **TF**
Description: **Tap Factory**

Distance (ft): **213.0**
Structural Grade: **0**
O&M Grade: **0**
Clock Start/From: **2**
Clock To:
1st Value: **4.000**
2nd Value:
Value Percent:
Continuous Index:
Within 8" of Joint:
Remarks:

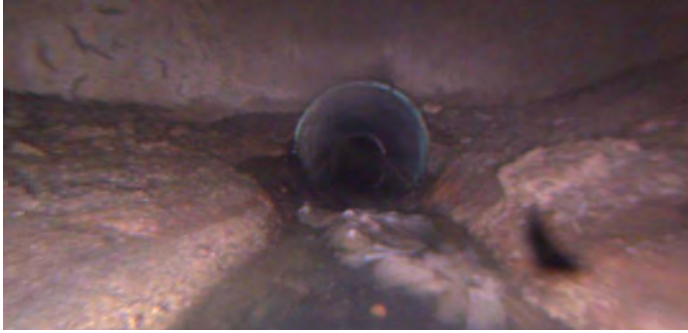
Code:	AMH
Description:	Manhole
Distance (ft):	255.1
Structural Grade:	0
O&M Grade:	0
Clock Start/From:	
Clock To:	
1st Value:	
2nd Value:	
Value Percent:	
Continuous Index:	
Within 8" of Joint:	NO
Remarks:	M-103-129
