Profile/Photo Observation Report

Street:	ALLEY BEWTWEEN SWIFT ST & ALAB	Flow Control:	Not Controlled
City:	Hobart, IN	Year Renewed:	
Location:	Other	Tape/Media #:	
Purpose:	Not Known	Dia/Height:	8"
Use:	Sanitary	Material:	PVC
Drain Area:	NA	Lining:	
Category:	NA		
Comment:

Location Details:		Direction of Survey:	Upstream
US MH:	M-103-129	DS MH:	M-103-130
		Total Length Surveyed (ft):	225.0

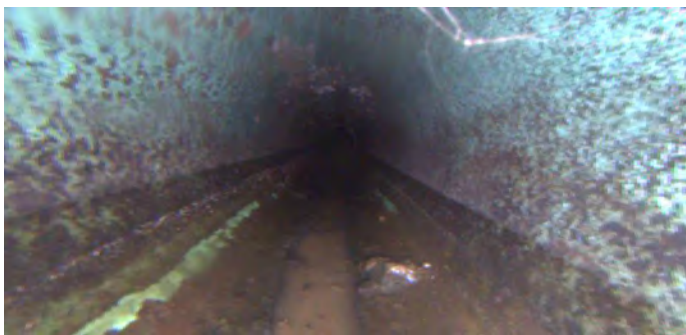
Code: **AMH**
Description: **Manhole**

Distance (ft): **.0**
Structural Grade: **0**
O&M Grade: **0**
Clock Start/From:
Clock To:
1st Value:
2nd Value:
Value Percent:
Continuous Index:
Within 8" of Joint: **NO**
Remarks: **M-103-130**

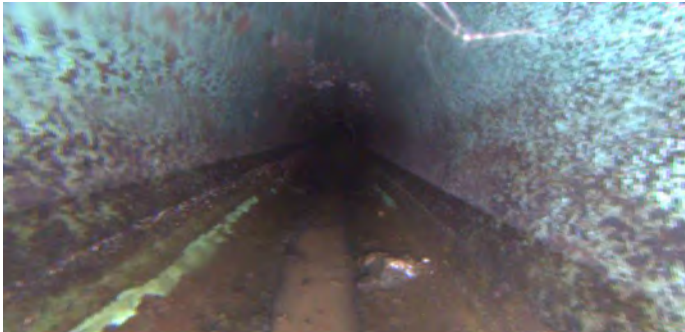
Code:	MWL
Description:	Water Level

Distance (ft):	.0
Structural Grade:	0
O&M Grade:	0
Clock Start/From:	
Clock To:	
1st Value:	
2nd Value:	
Value Percent:	5.000
Continuous Index:	
Within 8" of Joint:	NO
Remarks:

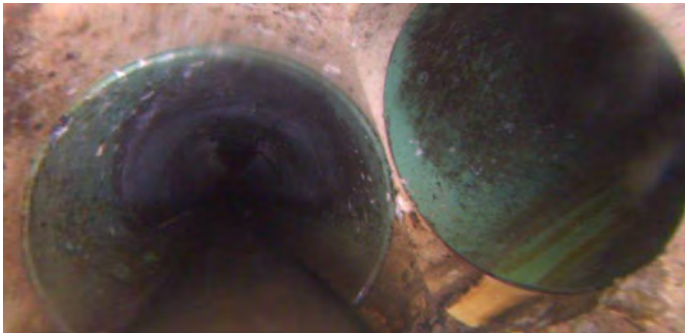
Code:	TF
Description:	Tap Factory

Distance (ft):	6.2
Structural Grade:	0
O&M Grade:	0
Clock Start/From:	3
Clock To:	
1st Value:	4.000
2nd Value:	
Value Percent:	
Continuous Index:	
Within 8" of Joint:	
Remarks:

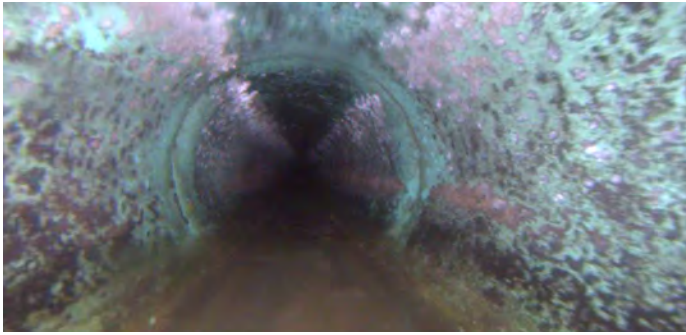
Code: **DAZ**
Description: **Deposits Attached Other**

Distance (ft): **8.1**
Structural Grade: **0**
O&M Grade: **2**
Clock Start/From: **8**
Clock To: **4**
1st Value:
2nd Value:
Value Percent: **5.000**
Continuous Index: **S01**
Within 8" of Joint: **NO**
Remarks:

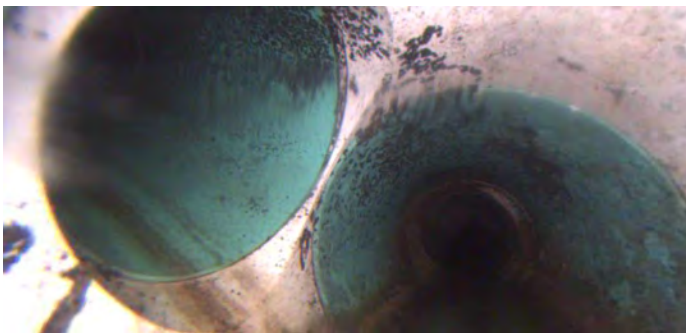
Code: **TF**
Description: **Tap Factory**

Distance (ft): **52.1**
Structural Grade: **0**
O&M Grade: **0**
Clock Start/From: **10**
Clock To:
1st Value: **4.000**
2nd Value:
Value Percent:
Continuous Index:
Within 8" of Joint:
Remarks:

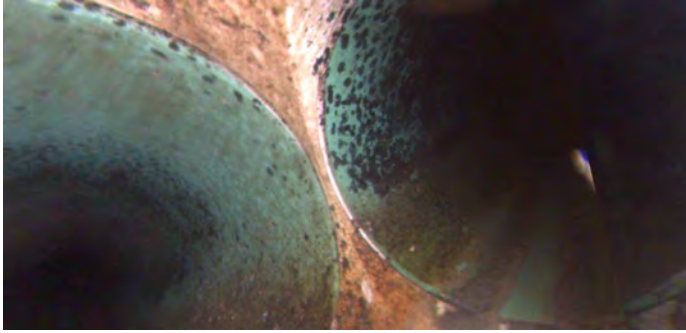
Code: **TF**
Description: **Tap Factory**

Distance (ft): **53.9**
Structural Grade: **0**
O&M Grade: **0**
Clock Start/From: **2**
Clock To:
1st Value: **4.000**
2nd Value:
Value Percent:
Continuous Index:
Within 8" of Joint:
Remarks:

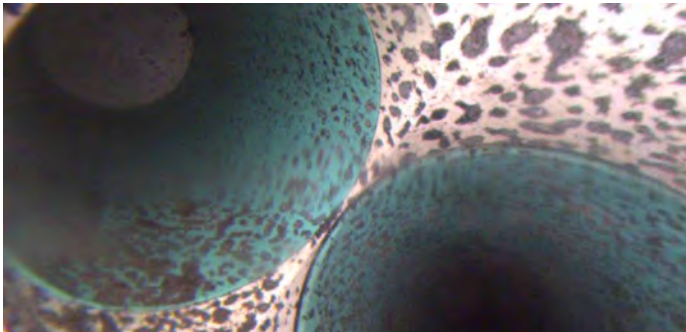
Code: **TFC**
Description: **Tap Factory Capped**

Distance (ft): **59.3**
Structural Grade: **0**
O&M Grade: **0**
Clock Start/From: **10**
Clock To:
1st Value: **4.000**
2nd Value:
Value Percent:
Continuous Index:
Within 8" of Joint:
Remarks:

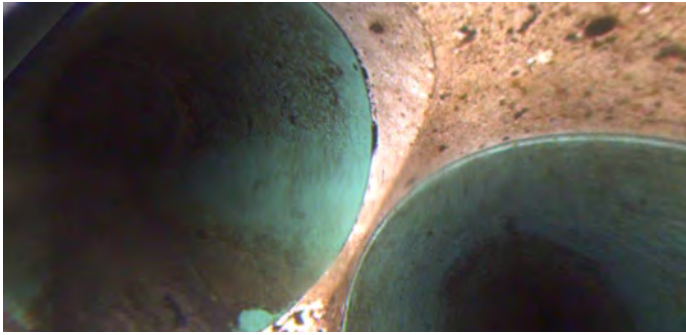
Code: **TF**
Description: **Tap Factory**

Distance (ft): **91.8**
Structural Grade: **0**
O&M Grade: **0**
Clock Start/From: **10**
Clock To:
1st Value: **4.000**
2nd Value:
Value Percent:
Continuous Index:
Within 8" of Joint:
Remarks:

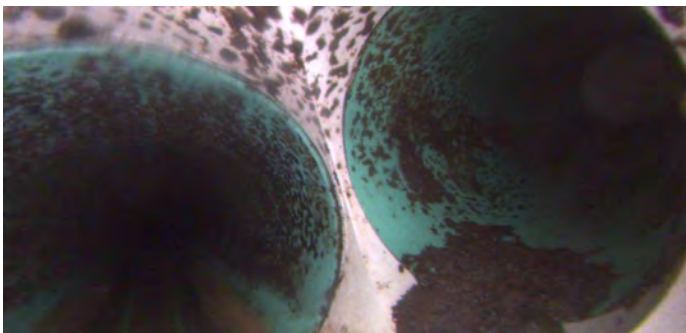
Code: **TF**
Description: **Tap Factory**

Distance (ft): **122.1**
Structural Grade: **0**
O&M Grade: **0**
Clock Start/From: **3**
Clock To:
1st Value: **4.000**
2nd Value:
Value Percent:
Continuous Index:
Within 8" of Joint:
Remarks:

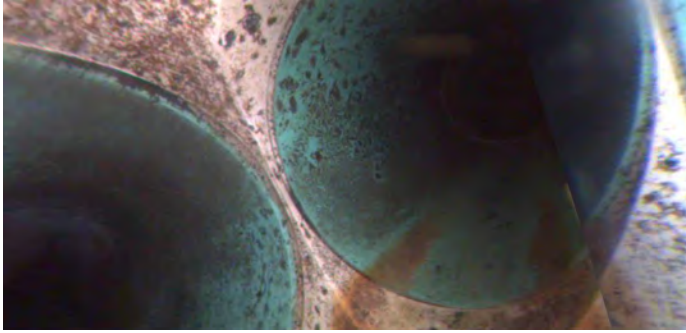
Code: **TF**
Description: **Tap Factory**

Distance (ft): **177.0**
Structural Grade: **0**
O&M Grade: **0**
Clock Start/From: **2**
Clock To:
1st Value: **4.000**
2nd Value:
Value Percent:
Continuous Index:
Within 8" of Joint:
Remarks:

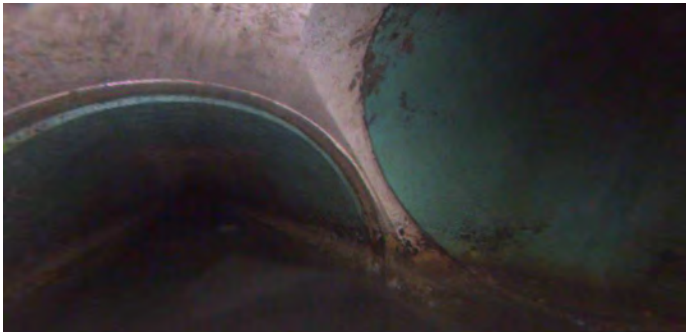
Code: **TF**
Description: **Tap Factory**

Distance (ft): **215.2**
Structural Grade: **0**
O&M Grade: **0**
Clock Start/From: **2**
Clock To:
1st Value: **4.000**
2nd Value:
Value Percent:
Continuous Index:
Within 8" of Joint:
Remarks:

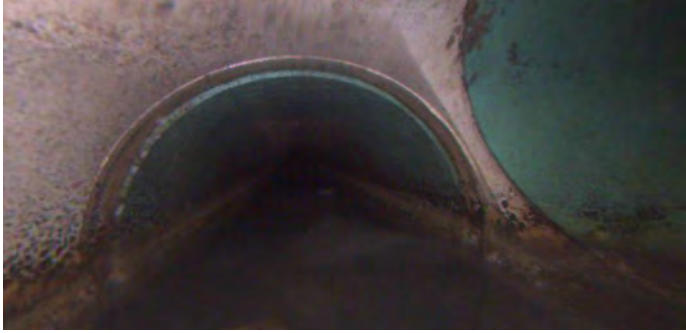
Code: **MWL**
Description: **Water Level**

Distance (ft): **215.2**
Structural Grade: **0**
O&M Grade: **0**
Clock Start/From:
Clock To:
1st Value:
2nd Value:
Value Percent: **40.000**
Continuous Index:
Within 8" of Joint: **NO**
Remarks:

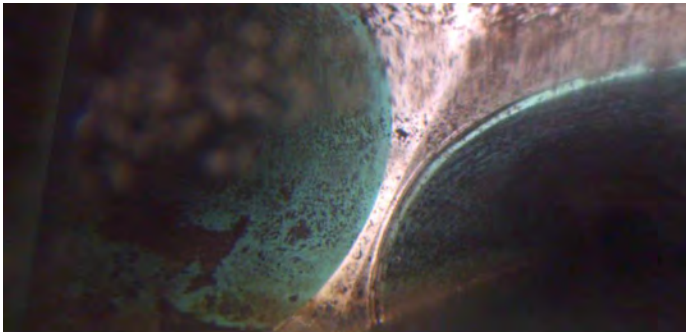
Code: **TF**
Description: **Tap Factory**

Distance (ft): **220.7**
Structural Grade: **0**
O&M Grade: **0**
Clock Start/From: **9**
Clock To:
1st Value: **4.000**
2nd Value:
Value Percent:
Continuous Index:
Within 8" of Joint:
Remarks:

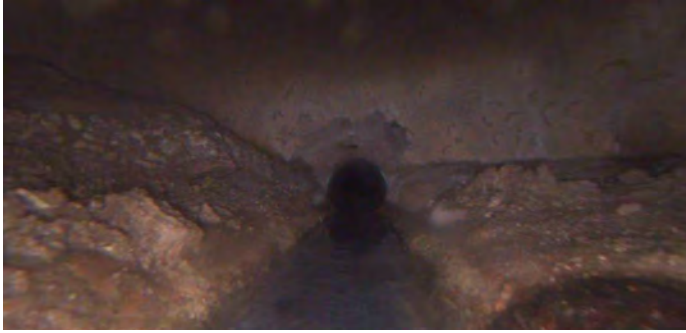
Code: **DAZ**
Description: **Deposits Attached Other**

Distance (ft): **223.1**
Structural Grade: **0**
O&M Grade: **2**
Clock Start/From: **8**
Clock To: **4**
1st Value:
2nd Value:
Value Percent: **5.000**
Continuous Index: **F01**
Within 8" of Joint: **NO**
Remarks:

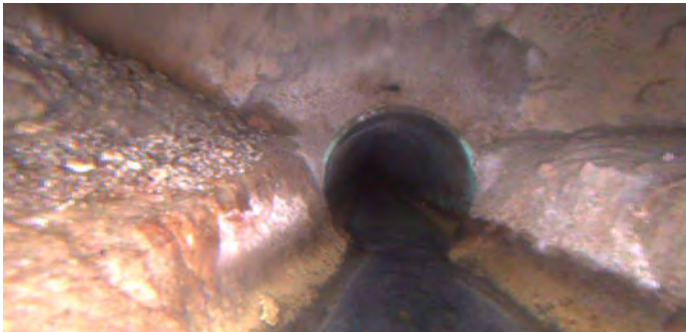
Code: **AMH**
Description: **Manhole**

Distance (ft): **225.0**
Structural Grade: **0**
O&M Grade: **0**
Clock Start/From:
Clock To:
1st Value:
2nd Value:
Value Percent:
Continuous Index:
Within 8" of Joint: **NO**
Remarks: **M-103-129**
