## Profile/Photo Observation Report

Street:	<b>E 38th Ave</b>	Flow Control:	<b>Not Controlled</b>
City:	<b>Hobart, IN</b>	Year Renewed:	
Location:	<b>Other</b>	Tape/Media #:	
Purpose:	<b>Not Known</b>	Dia/Height:	<b>8"</b>
Use:	<b>Sanitary</b>	Material:	<b>PVC</b>
Drain Area:	<b>NA</b>	Lining:	
Category:	<b>NA</b>		
Comment:

Location Details:		Direction of Survey:	<b>Upstream</b>
US MH:	<b>M-103-129</b>	DS MH:	<b>M-103-130</b>
		Total Length Surveyed (ft):	<b>225.0</b>

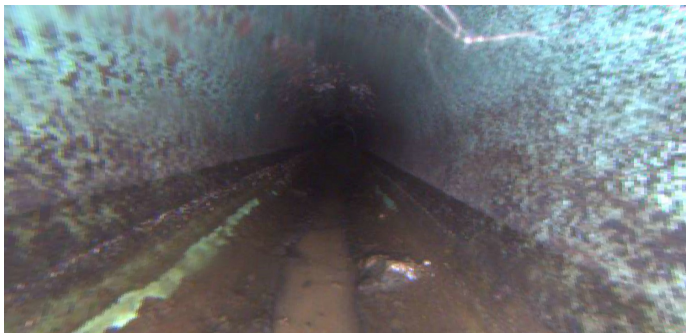
Code: **AMH**  
Description: **Manhole**

Distance (ft): **.0**  
Structural Grade: **0**  
O&M Grade: **0**  
Clock Start/From:  
Clock To:  
1st Value:  
2nd Value:  
Value Percent:  
Continuous Index:  
Within 8" of Joint: **NO**  
Remarks: **M-103-130**

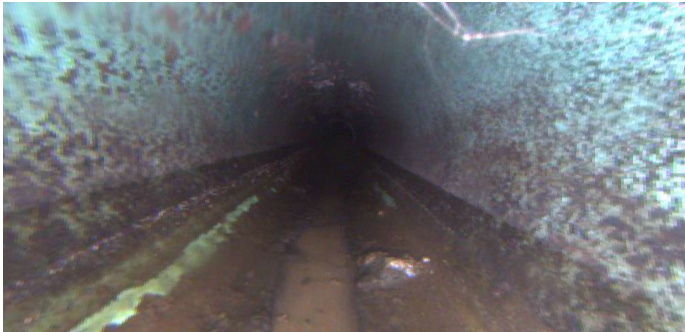
Code:	<b>MWL</b>
Description:	<b>Water Level</b>

Distance (ft):	<b>.0</b>
Structural Grade:	<b>0</b>
O&M Grade:	<b>0</b>
Clock Start/From:	
Clock To:	
1st Value:	
2nd Value:	
Value Percent:	<b>5.000</b>
Continuous Index:	
Within 8" of Joint:	<b>NO</b>
Remarks:

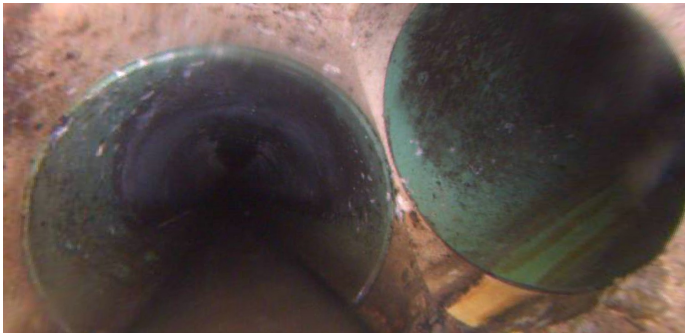
Code:	<b>TF</b>
Description:	<b>Tap Factory</b>

Distance (ft):	<b>6.2</b>
Structural Grade:	<b>0</b>
O&M Grade:	<b>0</b>
Clock Start/From:	<b>3</b>
Clock To:	
1st Value:	<b>4.000</b>
2nd Value:	
Value Percent:	
Continuous Index:	
Within 8" of Joint:	
Remarks:

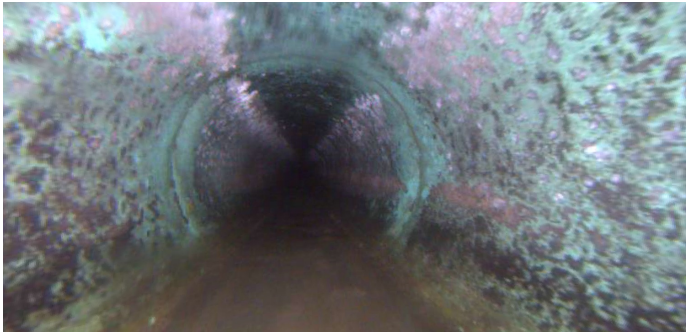
Code: **DAZ**  
Description: **Deposits Attached Other**

Distance (ft): **8.1**  
Structural Grade: **0**  
O&M Grade: **2**  
Clock Start/From: **8**  
Clock To: **4**  
1st Value:  
2nd Value:  
Value Percent: **5.000**  
Continuous Index: **S01**  
Within 8" of Joint: **NO**  
Remarks:

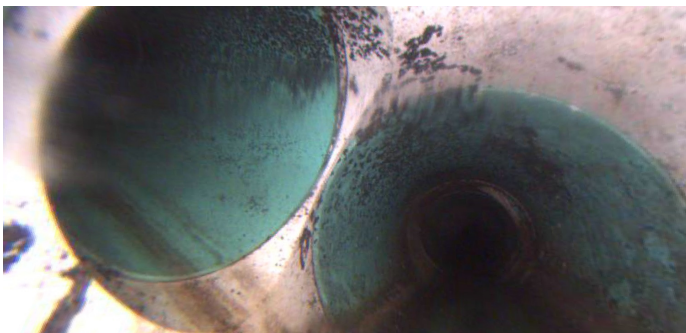
Code: **TF**  
Description: **Tap Factory**

Distance (ft): **52.1**  
Structural Grade: **0**  
O&M Grade: **0**  
Clock Start/From: **10**  
Clock To:  
1st Value: **4.000**  
2nd Value:  
Value Percent:  
Continuous Index:  
Within 8" of Joint:  
Remarks:

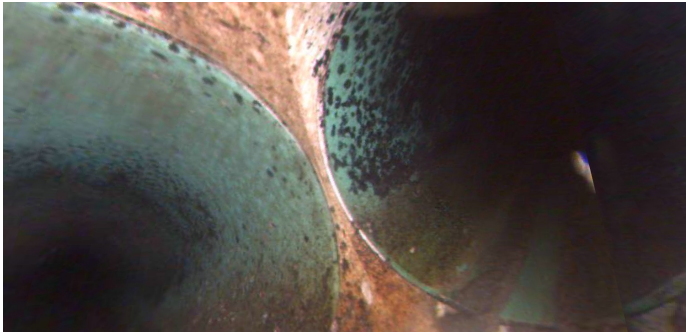
Code: **TF**  
Description: **Tap Factory**

Distance (ft): **53.9**  
Structural Grade: **0**  
O&M Grade: **0**  
Clock Start/From: **2**  
Clock To:  
1st Value: **4.000**  
2nd Value:  
Value Percent:  
Continuous Index:  
Within 8" of Joint:  
Remarks:

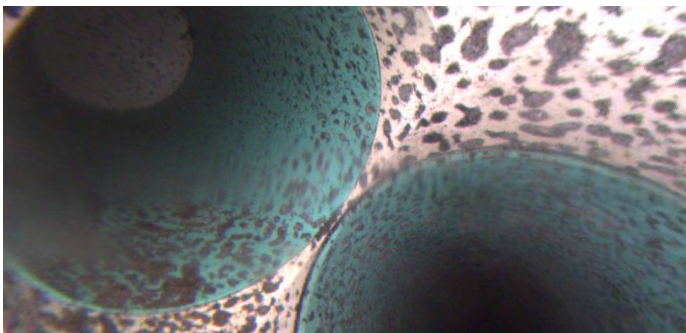
Code: **TFC**  
Description: **Tap Factory Capped**

Distance (ft): **59.3**  
Structural Grade: **0**  
O&M Grade: **0**  
Clock Start/From: **10**  
Clock To:  
1st Value: **4.000**  
2nd Value:  
Value Percent:  
Continuous Index:  
Within 8" of Joint:  
Remarks:

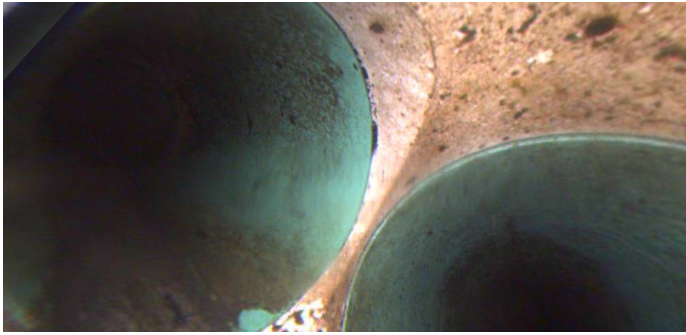
Code: **TF**  
Description: **Tap Factory**

Distance (ft): **91.8**  
Structural Grade: **0**  
O&M Grade: **0**  
Clock Start/From: **10**  
Clock To:  
1st Value: **4.000**  
2nd Value:  
Value Percent:  
Continuous Index:  
Within 8" of Joint:  
Remarks:

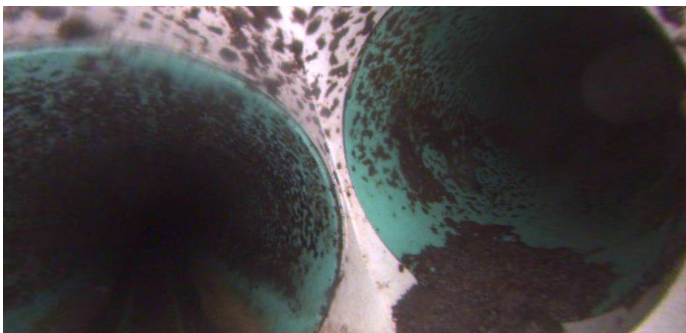
Code: **TF**  
Description: **Tap Factory**

Distance (ft): **122.1**  
Structural Grade: **0**  
O&M Grade: **0**  
Clock Start/From: **3**  
Clock To:  
1st Value: **4.000**  
2nd Value:  
Value Percent:  
Continuous Index:  
Within 8" of Joint:  
Remarks:

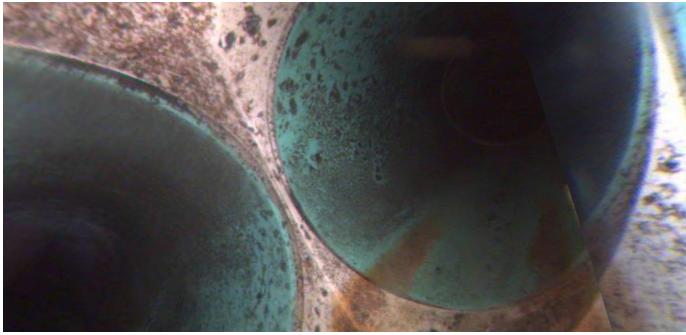
Code: **TF**  
Description: **Tap Factory**

Distance (ft): **177.0**  
Structural Grade: **0**  
O&M Grade: **0**  
Clock Start/From: **2**  
Clock To:  
1st Value: **4.000**  
2nd Value:  
Value Percent:  
Continuous Index:  
Within 8" of Joint:  
Remarks:

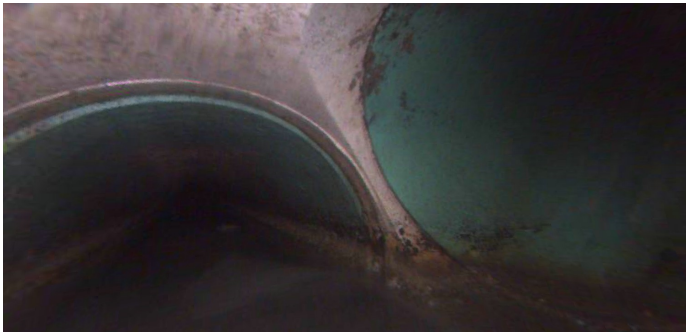
Code: **TF**  
Description: **Tap Factory**

Distance (ft): **215.2**  
Structural Grade: **0**  
O&M Grade: **0**  
Clock Start/From: **2**  
Clock To:  
1st Value: **4.000**  
2nd Value:  
Value Percent:  
Continuous Index:  
Within 8" of Joint:  
Remarks:

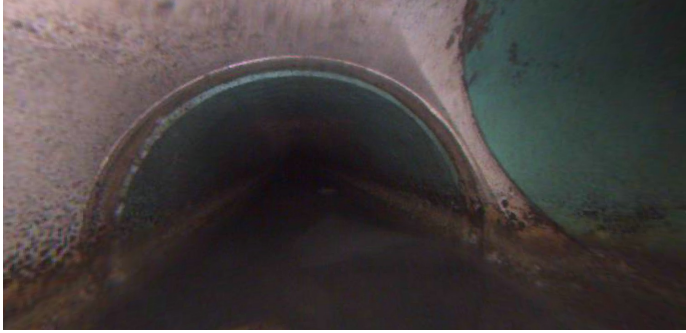
Code: **MWL**  
Description: **Water Level**

Distance (ft): **215.2**  
Structural Grade: **0**  
O&M Grade: **0**  
Clock Start/From:  
Clock To:  
1st Value:  
2nd Value:  
Value Percent: **40.000**  
Continuous Index:  
Within 8" of Joint: **NO**  
Remarks:

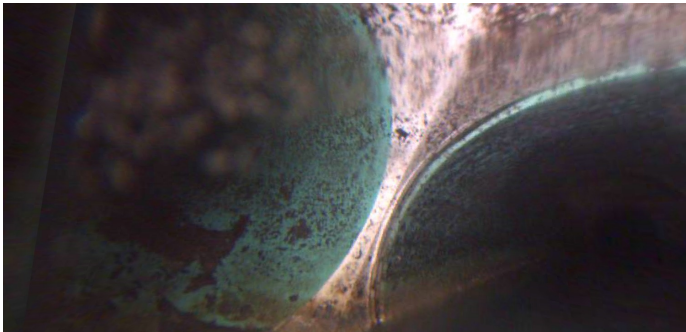
Code: **TF**  
Description: **Tap Factory**

Distance (ft): **220.7**  
Structural Grade: **0**  
O&M Grade: **0**  
Clock Start/From: **9**  
Clock To:  
1st Value: **4.000**  
2nd Value:  
Value Percent:  
Continuous Index:  
Within 8" of Joint:  
Remarks:

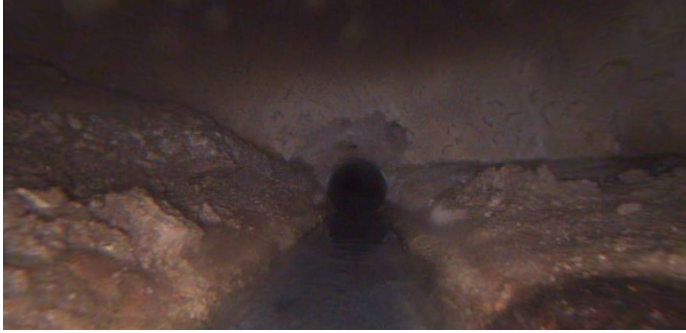
Code: **DAZ**  
Description: **Deposits Attached Other**

Distance (ft): **223.1**  
Structural Grade: **0**  
O&M Grade: **2**  
Clock Start/From: **8**  
Clock To: **4**  
1st Value:  
2nd Value:  
Value Percent: **5.000**  
Continuous Index: **F01**  
Within 8" of Joint: **NO**  
Remarks:

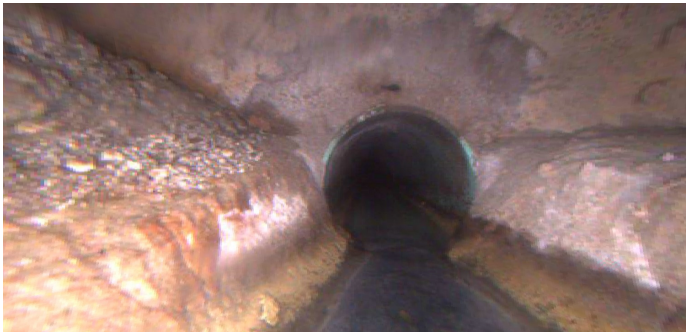
Code: **AMH**  
Description: **Manhole**

Distance (ft): **225.0**  
Structural Grade: **0**  
O&M Grade: **0**  
Clock Start/From:  
Clock To:  
1st Value:  
2nd Value:  
Value Percent:  
Continuous Index:  
Within 8" of Joint: **NO**  
Remarks: **M-103-129**
