## Profile/Photo Observation Report

Street:	<b>E 38th Ave</b>	Flow Control:	<b>Not Controlled</b>
City:	<b>Hobart, IN</b>	Year Renewed:	
Location:	<b>Other</b>	Tape/Media #:	
Purpose:	<b>Not Known</b>	Dia/Height:	<b>8"</b>
Use:	<b>Sanitary</b>	Material:	<b>PVC</b>
Drain Area:	<b>NA</b>	Lining:	
Category:	<b>NA</b>		
Comment:

Location Details:		Direction of Survey:	<b>Upstream</b>
US MH:	<b>M-103-131</b>	DS MH:	<b>M-103-127</b>
		Total Length Surveyed (ft):	<b>285.8</b>

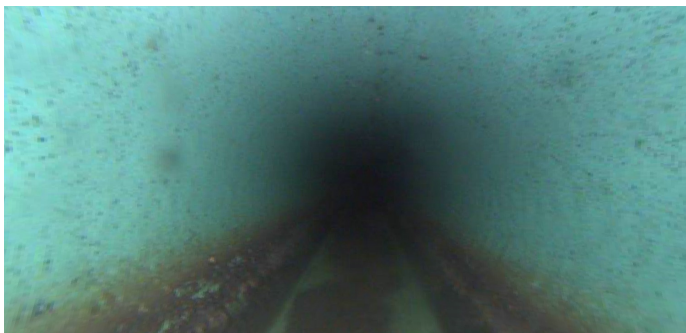
Code: **AMH**  
Description: **Manhole**

Distance (ft): **.0**  
Structural Grade: **0**  
O&M Grade: **0**  
Clock Start/From:  
Clock To:  
1st Value:  
2nd Value:  
Value Percent:  
Continuous Index:  
Within 8" of Joint: **NO**  
Remarks: **M-103-127**

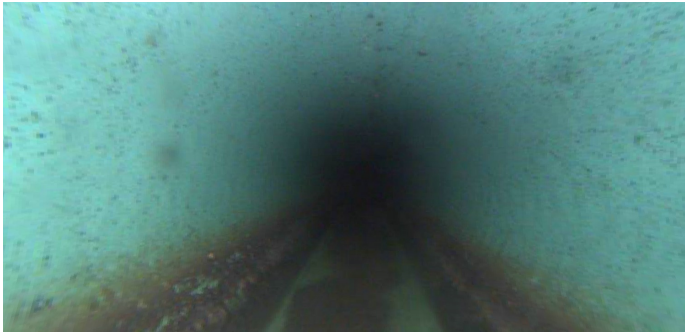
Code:	<b>MWL</b>
Description:	<b>Water Level</b>

Distance (ft):	<b>.0</b>
Structural Grade:	<b>0</b>
O&M Grade:	<b>0</b>
Clock Start/From:	
Clock To:	
1st Value:	
2nd Value:	
Value Percent:	<b>5.000</b>
Continuous Index:	
Within 8" of Joint:	<b>NO</b>
Remarks:

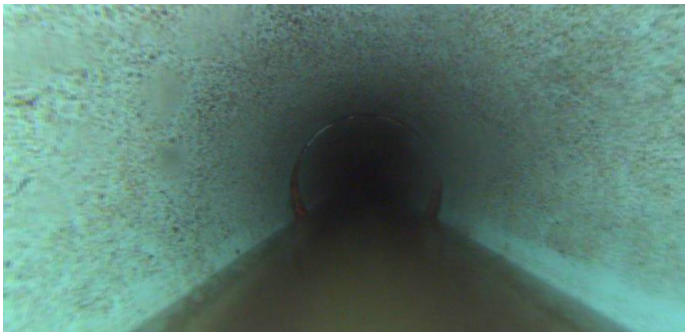
Code:	<b>DAE</b>
Description:	<b>Deposits Attached Encrustation</b>

Distance (ft):	<b>121.9</b>
Structural Grade:	<b>0</b>
O&M Grade:	<b>2</b>
Clock Start/From:	<b>7</b>
Clock To:	<b>5</b>
1st Value:	
2nd Value:	
Value Percent:	<b>5.000</b>
Continuous Index:	
Within 8" of Joint:	<b>YES</b>
Remarks:

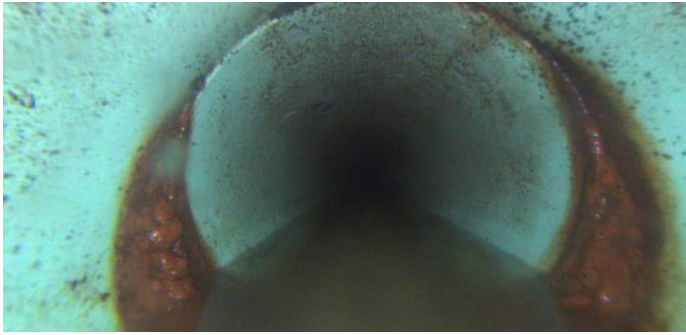
Code: **IW**  
Description: **Infil Weeper**

Distance (ft): **122.9**  
Structural Grade: **0**  
O&M Grade: **2**  
Clock Start/From: **8**  
Clock To: **4**  
1st Value:  
2nd Value:  
Value Percent:  
Continuous Index:  
Within 8" of Joint: **YES**  
Remarks:

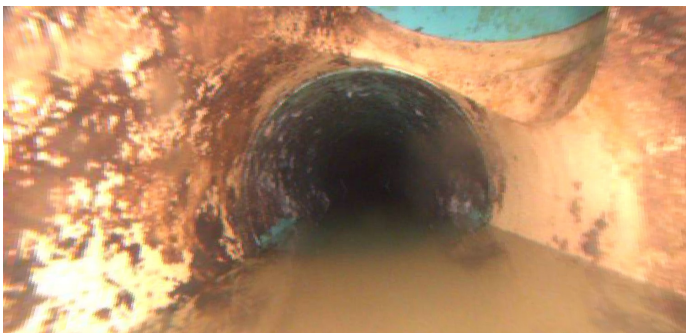
Code: **TF**  
Description: **Tap Factory**

Distance (ft): **280.5**  
Structural Grade: **0**  
O&M Grade: **0**  
Clock Start/From: **12**  
Clock To:  
1st Value: **4.000**  
2nd Value:  
Value Percent:  
Continuous Index:  
Within 8" of Joint:  
Remarks:

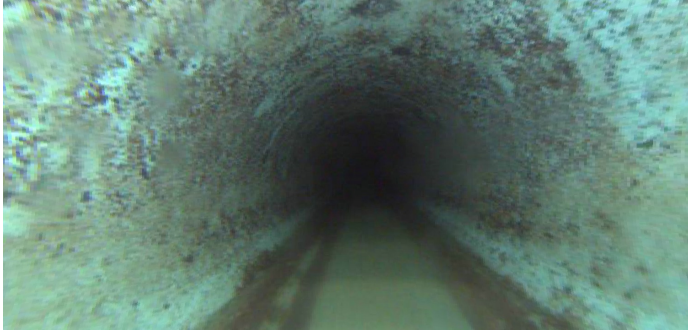
Code:	<b>MSA</b>
Description:	<b>Abandoned Survey</b>
Distance (ft):	<b>285.8</b>
Structural Grade:	<b>0</b>
O&M Grade:	<b>0</b>
Clock Start/From:	
Clock To:	
1st Value:	
2nd Value:	
Value Percent:	
Continuous Index:	
Within 8" of Joint:	<b>NO</b>
Remarks:	<b>camera stopped</b>
