## Profile/Photo Observation Report

| Street: | <b>E 38th Ave</b> | Flow Control: | <b>Not Controlled</b> |
| City: | <b>Hobart, IN</b> | Year Renewed: | |

| US MH: | <b>M-103-131</b> | DS MH: | <b>M-103-127</b> |

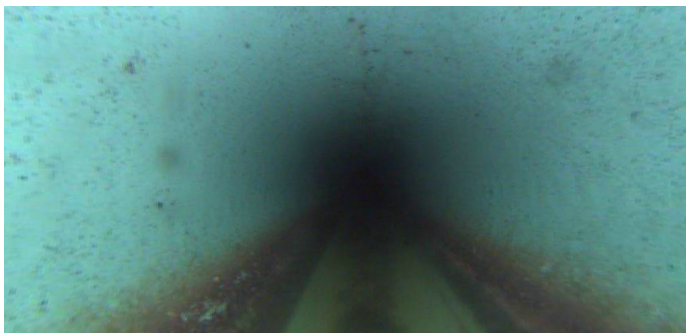
Code: **AMH**  
Description: **Manhole**

Distance (ft): **.0**  
Structural Grade: **0**  
O&M Grade: **0**  
Clock Start/From:  
Clock To:  
1st Value:  
2nd Value:  
Value Percent:  
Continuous Index:  
Within 8" of Joint: **NO**  
Remarks: **M-103-127**

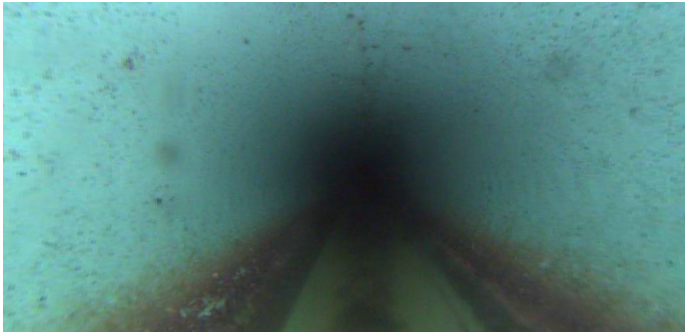
| Code: | <b>MWL</b> |
| Description: | <b>Water Level</b> |

| Value Percent: | <b>5.000</b> |

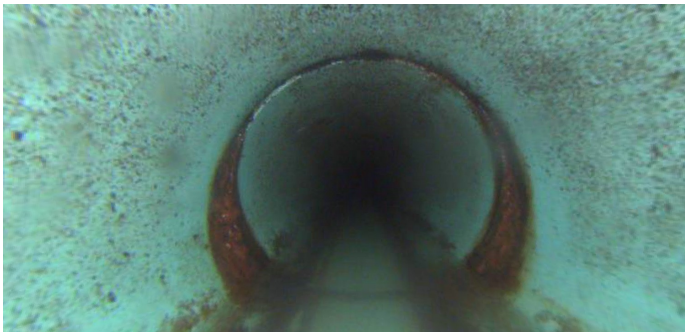
| Code: | <b>IW</b> |
| Description: | <b>Infil Weeper</b> |

| Distance (ft): | <b>122.1</b> |
| O&M Grade: | <b>2</b> |
| Clock Start/From: | <b>8</b> |
| Clock To: | <b>4</b> |
| Within 8" of Joint: | <b>YES</b> |

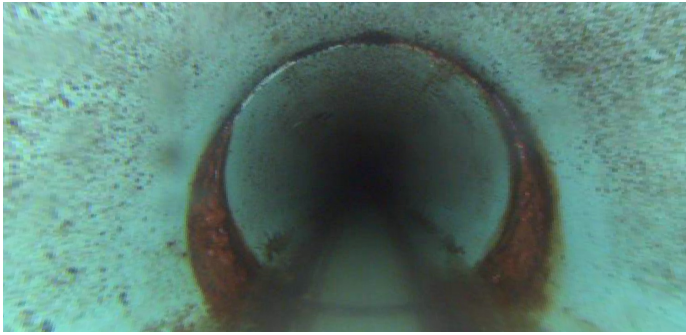
Code: **DAE**  
Description: **Deposits Attached Encrustation**

Distance (ft): **122.1**  
Structural Grade: **0**  
O&M Grade: **2**  
Clock Start/From: **7**  
Clock To: **5**  
1st Value:  
2nd Value:  
Value Percent: **5.000**  
Continuous Index:  
Within 8" of Joint: **YES**  
Remarks:

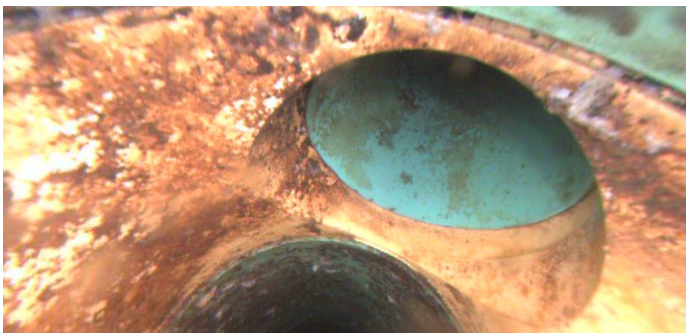
Code: **TF**  
Description: **Tap Factory**

Distance (ft): **279.7**  
Structural Grade: **0**  
O&M Grade: **0**  
Clock Start/From: **1**  
Clock To:  
1st Value: **4.000**  
2nd Value:  
Value Percent:  
Continuous Index:  
Within 8" of Joint:  
Remarks:

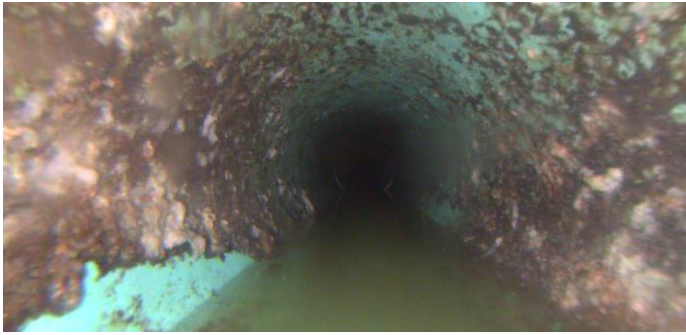
Code: **DAGS**  
Description: **Deposits Attached Grease**

Distance (ft): **280.3**  
Structural Grade: **0**  
O&M Grade: **2**  
Clock Start/From: **8**  
Clock To: **4**  
1st Value:  
2nd Value:  
Value Percent: **5.000**  
Continuous Index:  
Within 8" of Joint: **NO**  
Remarks:

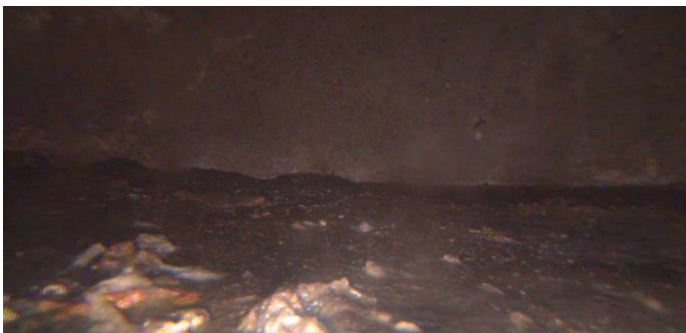
Code: **AMH**  
Description: **Manhole**

Distance (ft): **330.6**  
Structural Grade: **0**  
O&M Grade: **0**  
Clock Start/From:  
Clock To:  
1st Value:  
2nd Value:  
Value Percent:  
Continuous Index:  
Within 8" of Joint: **NO**  
Remarks: **M-103-131**
