## Profile/Photo Observation Report

| Street: | <b>W 38TH AVE</b> | Flow Control: | <b>Not Controlled</b> |
| City: | <b>Hobart, IN</b> | Year Renewed: | |

| US MH: | <b>M-103-131</b> | DS MH: | <b>M-103-132</b> |

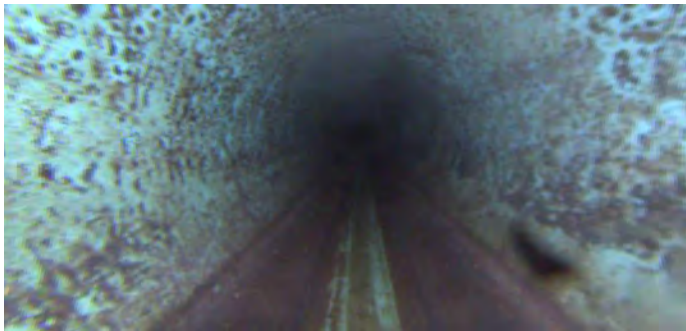
Code: **AMH**  
Description: **Manhole**

Distance (ft): **.0**  
Structural Grade: **0**  
O&M Grade: **0**  
Clock Start/From:  
Clock To:  
1st Value:  
2nd Value:  
Value Percent:  
Continuous Index:  
Within 8" of Joint: **NO**  
Remarks: **M-103-131**

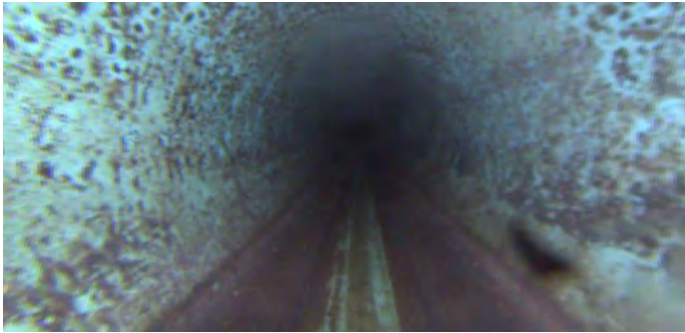
| Code: | <b>MWL</b> |
| Description: | <b>Water Level</b> |

| Distance (ft): | <b>.0</b> |
| Value Percent: | <b>5.000</b> |

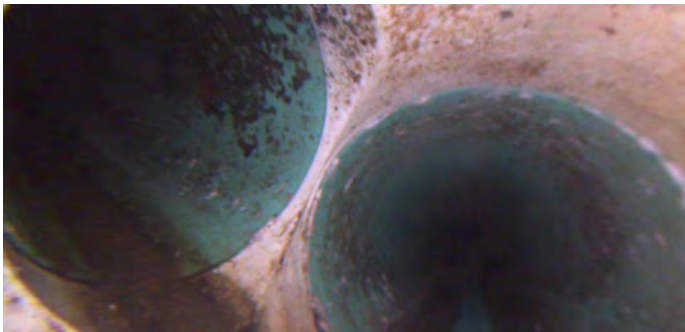
| Code: | <b>TF</b> |
| Description: | <b>Tap Factory</b> |

| Distance (ft): | <b>91.7</b> |
| Clock Start/From: | <b>9</b> |
| 1st Value: | <b>4.000</b> |

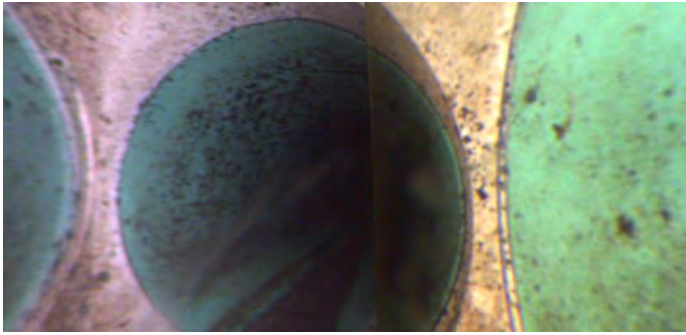
Code: **TF**  
Description: **Tap Factory**

Distance (ft): **96.9**  
Structural Grade: **0**  
O&M Grade: **0**  
Clock Start/From: **3**  
Clock To:  
1st Value: **4.000**  
2nd Value:  
Value Percent:  
Continuous Index:  
Within 8" of Joint:  
Remarks:

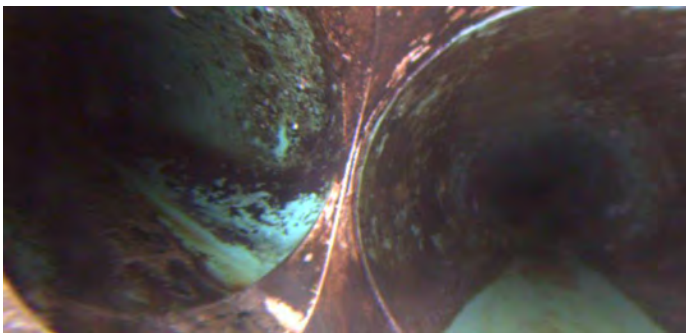
Code: **TF**  
Description: **Tap Factory**

Distance (ft): **121.0**  
Structural Grade: **0**  
O&M Grade: **0**  
Clock Start/From: **9**  
Clock To:  
1st Value: **4.000**  
2nd Value:  
Value Percent:  
Continuous Index:  
Within 8" of Joint:  
Remarks:

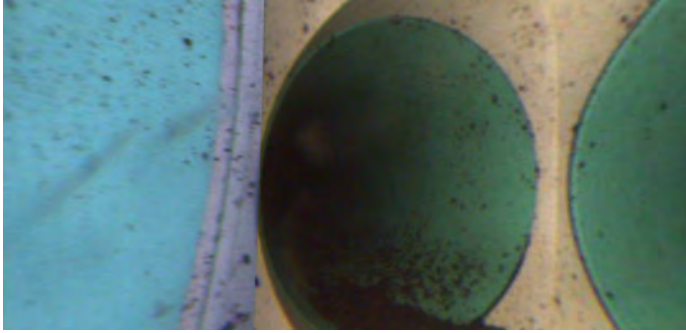
Code: **TF**  
Description: **Tap Factory**

Distance (ft): **155.7**  
Structural Grade: **0**  
O&M Grade: **0**  
Clock Start/From: **3**  
Clock To:  
1st Value: **4.000**  
2nd Value:  
Value Percent:  
Continuous Index:  
Within 8" of Joint:  
Remarks:

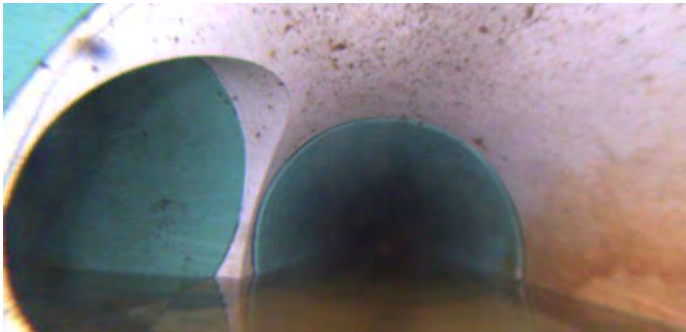
Code: **TFA**  
Description: **Tap Factory Active**

Distance (ft): **175.2**  
Structural Grade: **0**  
O&M Grade: **0**  
Clock Start/From: **9**  
Clock To:  
1st Value: **4.000**  
2nd Value:  
Value Percent:  
Continuous Index:  
Within 8" of Joint:  
Remarks:

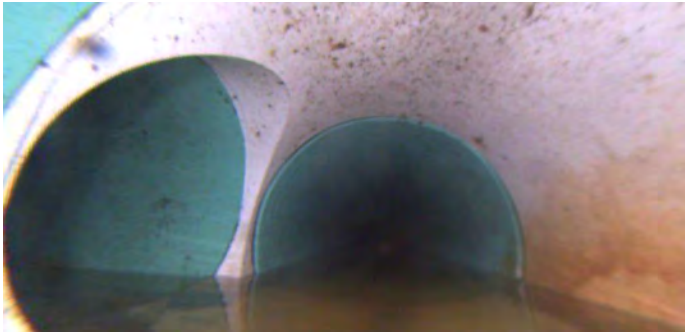
Code: **MWL**  
Description: **Water Level**

Distance (ft): **175.2**  
Structural Grade: **0**  
O&M Grade: **0**  
Clock Start/From:  
Clock To:  
1st Value:  
2nd Value:  
Value Percent: **30.000**  
Continuous Index:  
Within 8" of Joint: **NO**  
Remarks:

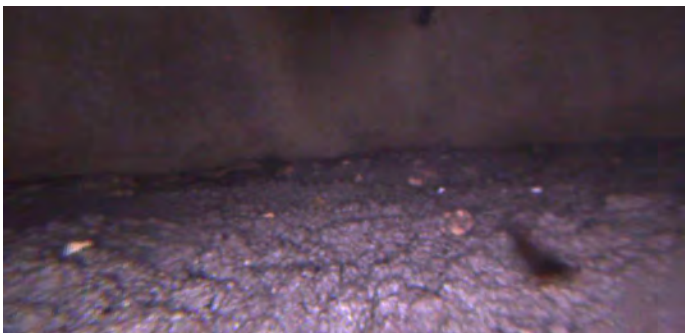
Code: **AMH**  
Description: **Manhole**

Distance (ft): **181.5**  
Structural Grade: **0**  
O&M Grade: **0**  
Clock Start/From:  
Clock To:  
1st Value:  
2nd Value:  
Value Percent:  
Continuous Index:  
Within 8" of Joint: **NO**  
Remarks: **M-103-132**
