## Profile/Photo Observation Report

Street:	<b>ALLEY BEWTWEEN SWIFT ST &amp; MISS</b>	Flow Control:	<b>Not Controlled</b>
City:	<b>Hobart, IN</b>	Year Renewed:	
Location:	<b>Other</b>	Tape/Media #:	
Purpose:	<b>Not Known</b>	Dia/Height:	<b>8"</b>
Use:	<b>Sanitary</b>	Material:	<b>PVC</b>
Drain Area:	<b>NA</b>	Lining:	
Category:	<b>NA</b>		
Comment:

Location Details:		Direction of Survey:	<b>Downstream</b>
US MH:	<b>M-103-134</b>	DS MH:	<b>M-103-135</b>
		Total Length Surveyed (ft):	<b>140.8</b>

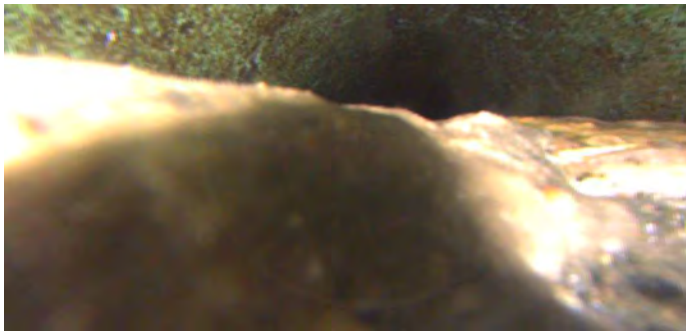
Code: **AMH**  
Description: **Manhole**

Distance (ft): **.0**  
Structural Grade: **0**  
O&M Grade: **0**  
Clock Start/From:  
Clock To:  
1st Value:  
2nd Value:  
Value Percent:  
Continuous Index:  
Within 8" of Joint: **NO**  
Remarks: **M-103-134**

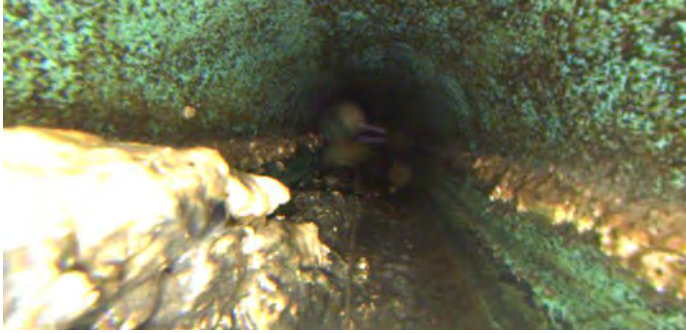
Code:	<b>DAGS</b>
Description:	<b>Deposits Attached Grease</b>
Distance (ft):	<b>5.2</b>
Structural Grade:	<b>0</b>
O&M Grade:	<b>3</b>
Clock Start/From:	<b>7</b>
Clock To:	<b>5</b>
1st Value:	
2nd Value:	
Value Percent:	<b>20.000</b>
Continuous Index:	
Within 8" of Joint:	<b>NO</b>
Remarks:

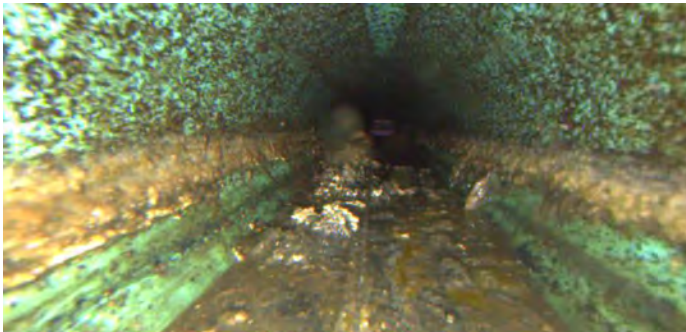
Code:	<b>DAGS</b>
Description:	<b>Deposits Attached Grease</b>
Distance (ft):	<b>7.2</b>
Structural Grade:	<b>0</b>
O&M Grade:	<b>2</b>
Clock Start/From:	<b>8</b>
Clock To:	<b>4</b>
1st Value:	
2nd Value:	
Value Percent:	<b>5.000</b>
Continuous Index:	<b>S03</b>
Within 8" of Joint:	<b>NO</b>
Remarks:

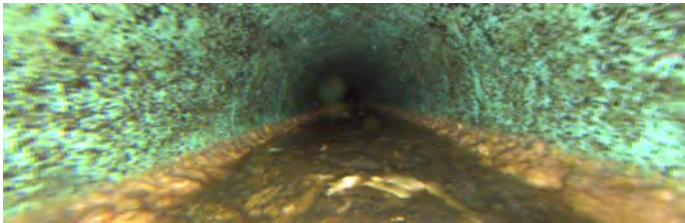
Code: **MGO**  
Description: **General Observation**

Distance (ft): **33.8**  
Structural Grade: **0**  
O&M Grade: **0**  
Clock Start/From:  
Clock To:  
1st Value:  
2nd Value:  
Value Percent:  
Continuous Index:  
Within 8" of Joint: **NO**  
Remarks: **switching to rear camera**

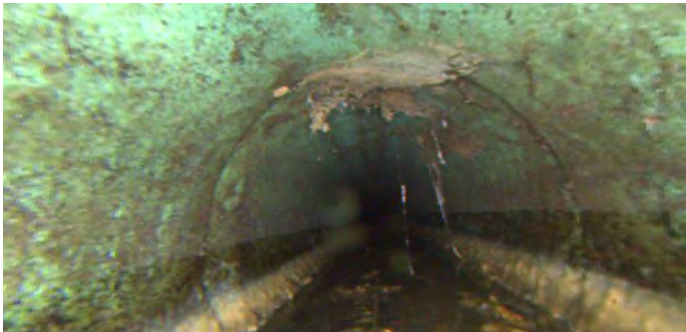
Code: **RFJ**  
Description: **Roots Fine Joint**

Distance (ft): **50.5**  
Structural Grade: **0**  
O&M Grade: **1**  
Clock Start/From: **11**  
Clock To: **1**  
1st Value:  
2nd Value:  
Value Percent:  
Continuous Index:  
Within 8" of Joint: **YES**  
Remarks:
