Profile/Photo Observation Report

Street:	Alabama Street	Flow Control:	
City:	Hobart, IN	Year Renewed:	
Location:	Light Highway	Tape/Media #:	837
Purpose:	Routine Assessment	Dia/Height:	10"
Use:	Sanitary	Material:	VCP
Drain Area:		Lining:	
Category:	NA		
Comment:

Location Details:		Direction of Survey:	Upstream
US MH:	M-104-4	DS MH:	M-104-3
		Total Length Surveyed (ft):	33.7

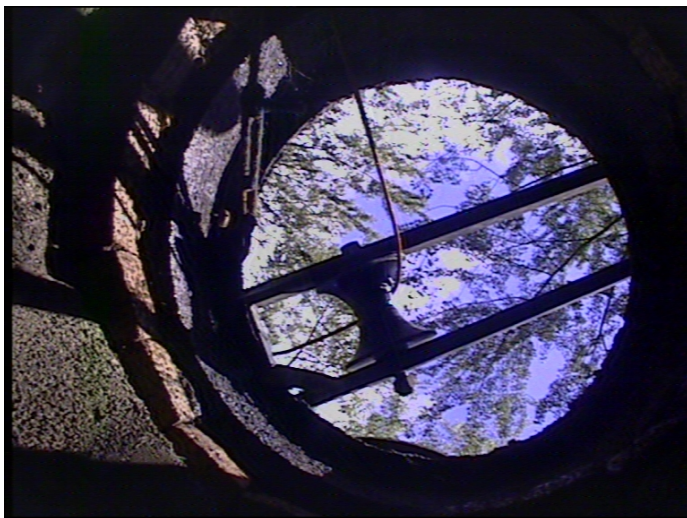
Code: **AMH**
Description: **Manhole**

Distance (ft): **.0**
Structural Grade: **0**
O&M Grade: **0**
Clock Start/From:
Clock To:
1st Value:
2nd Value:
Value Percent:
Continuous Index:
Within 8" of Joint: **NO**
Remarks: **M-104-3**

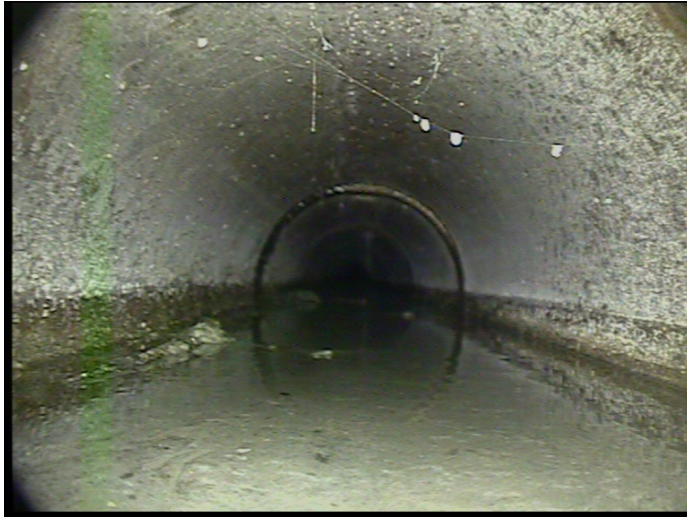
Code: **MWL**
Description: **Water Level**

Distance (ft): **.0**
Structural Grade: **0**
O&M Grade: **0**
Clock Start/From:
Clock To:
1st Value:
2nd Value:
Value Percent: **5.000**
Continuous Index:
Within 8" of Joint: **NO**
Remarks:

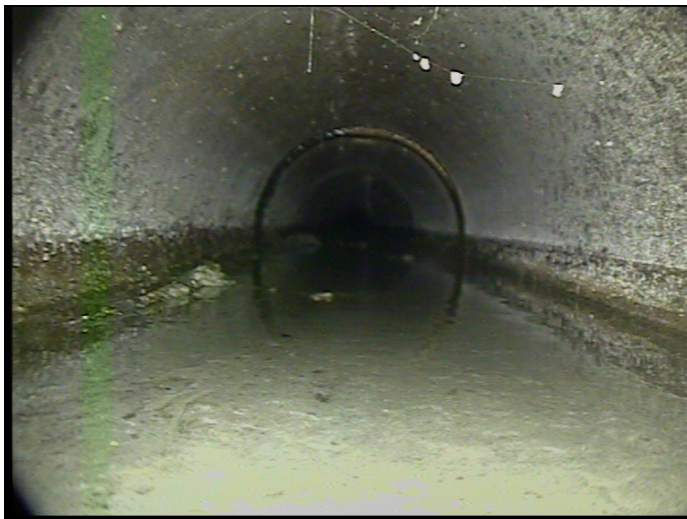
Code: **DSF**
Description: **Deposits Settled Fine**

Distance (ft): **.0**
Structural Grade: **0**
O&M Grade: **2**
Clock Start/From: **4**
Clock To: **8**
1st Value:
2nd Value:
Value Percent: **5.000**
Continuous Index: **S01**
Within 8" of Joint: **YES**
Remarks:

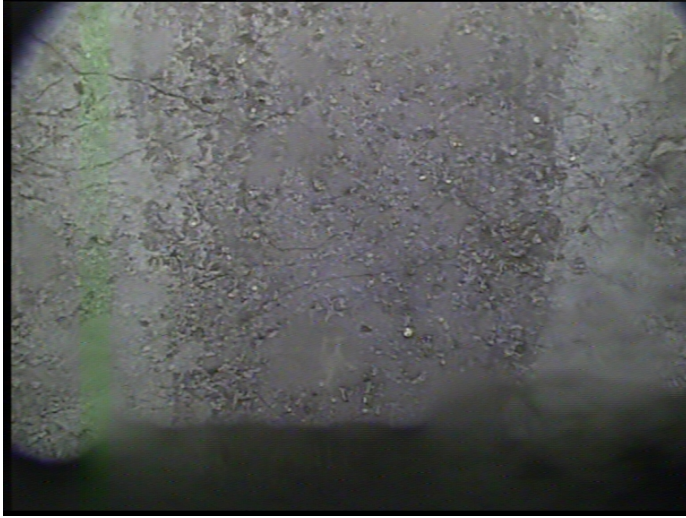
Code: **DSF**
Description: **Deposits Settled Fine**

Distance (ft): **33.1**
Structural Grade: **0**
O&M Grade: **3**
Clock Start/From: **4**
Clock To: **8**
1st Value:
2nd Value:
Value Percent: **20.000**
Continuous Index: **F01**
Within 8" of Joint: **NO**
Remarks:

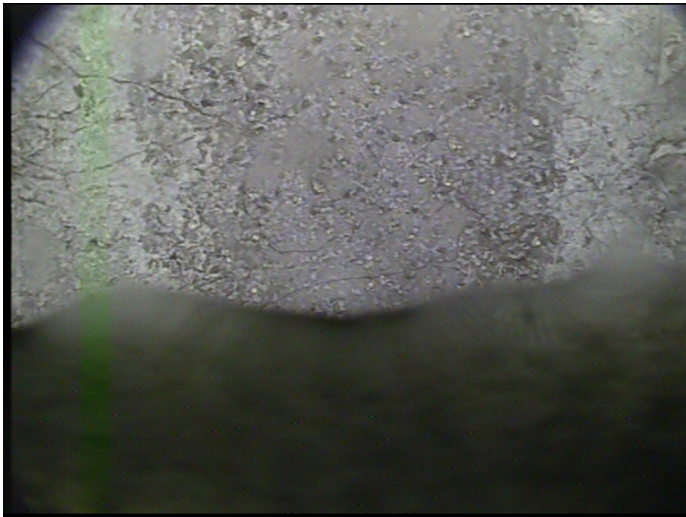
Code: **MSA**
Description: **Abandoned Survey**

Distance (ft): **33.1**
Structural Grade: **0**
O&M Grade: **0**
Clock Start/From:
Clock To:
1st Value:
2nd Value:
Value Percent:
Continuous Index:
Within 8" of Joint: **NO**
Remarks: **deep sediment**
