Profile/Photo Observation Report

Street:	Off 41st Avenue	Flow Control:	
City:	Hobart, IN	Year Renewed:	
Location:	Yard	Tape/Media #:	838
Purpose:	Routine Assessment	Dia/Height:	10"
Use:	Sanitary	Material:	VCP
Drain Area:		Lining:	
Category:	NA		
Comment:

Location Details:		Direction of Survey:	Downstream
US MH:	M-104-4	DS MH:	M-104-3
		Total Length Surveyed (ft):	8.4

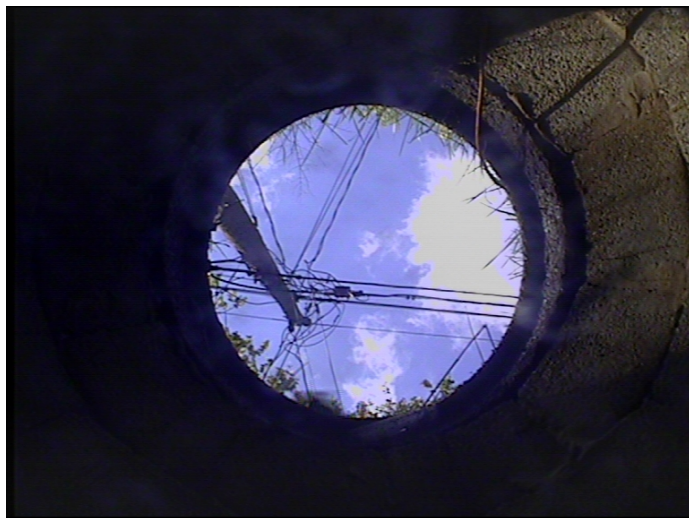
Code: **AMH**
Description: **Manhole**

Distance (ft): **.0**
Structural Grade: **0**
O&M Grade: **0**
Clock Start/From:
Clock To:
1st Value:
2nd Value:
Value Percent:
Continuous Index:
Within 8" of Joint: **NO**
Remarks: **M-104-4**

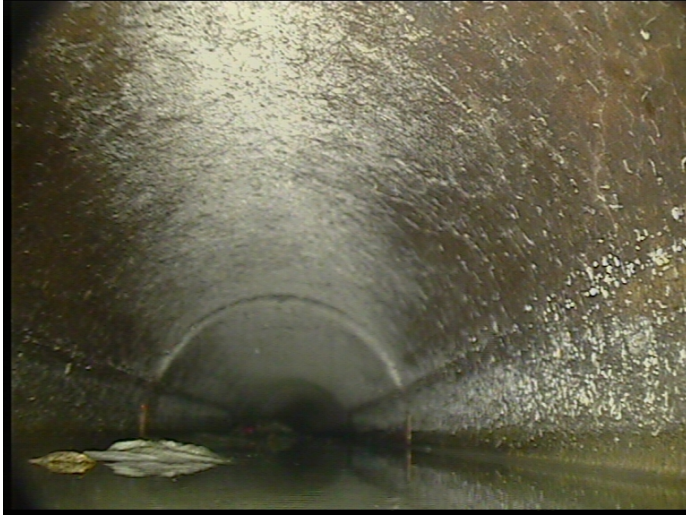
Code: **MWL**
Description: **Water Level**

Distance (ft): **.0**
Structural Grade: **0**
O&M Grade: **0**
Clock Start/From:
Clock To:
1st Value:
2nd Value:
Value Percent: **20.000**
Continuous Index:
Within 8" of Joint: **NO**
Remarks:

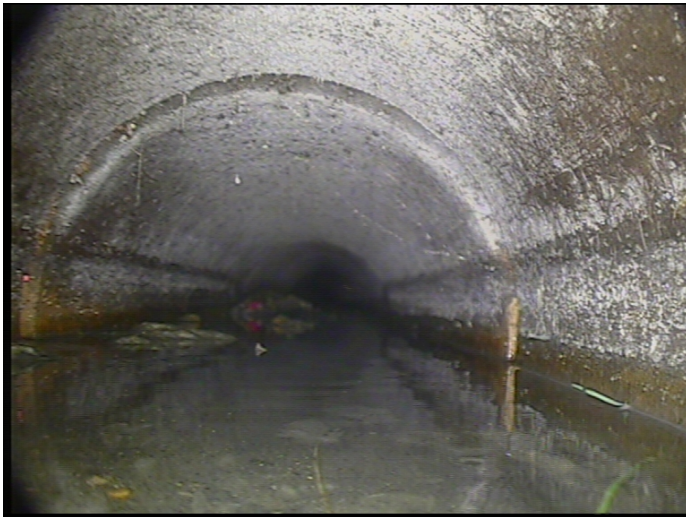
Code: **DSF**
Description: **Deposits Settled Fine**

Distance (ft): **1.0**
Structural Grade: **0**
O&M Grade: **3**
Clock Start/From: **4**
Clock To: **8**
1st Value:
2nd Value:
Value Percent: **15.000**
Continuous Index: **S01**
Within 8" of Joint: **YES**
Remarks:

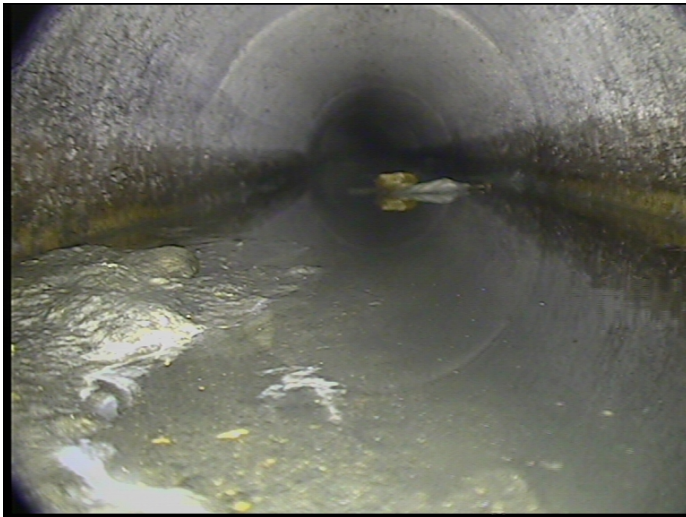
Code: **MSA**
Description: **Abandoned Survey**

Distance (ft): **8.4**
Structural Grade: **0**
O&M Grade: **0**
Clock Start/From:
Clock To:
1st Value:
2nd Value:
Value Percent:
Continuous Index:
Within 8" of Joint: **NO**
Remarks: **deep sediment**
