## Profile/Photo Observation Report

Street:	<b>Off 49th Avenue</b>	Flow Control:	
City:	<b>Hobart, IN</b>	Year Renewed:	
Location:	<b>Easement/Right of Way</b>	Tape/Media #:	<b>854</b>
Purpose:	<b>Routine Assessment</b>	Dia/Height:	<b>10"</b>
Use:	<b>Sanitary</b>	Material:	<b>VCP</b>
Drain Area:		Lining:	
Category:	<b>NA</b>		
Comment:

Location Details:		Direction of Survey:	<b>Upstream</b>
US MH:	<b>M-105-5</b>	DS MH:	<b>M-106-4</b>
		Total Length Surveyed (ft):	<b>6.5</b>

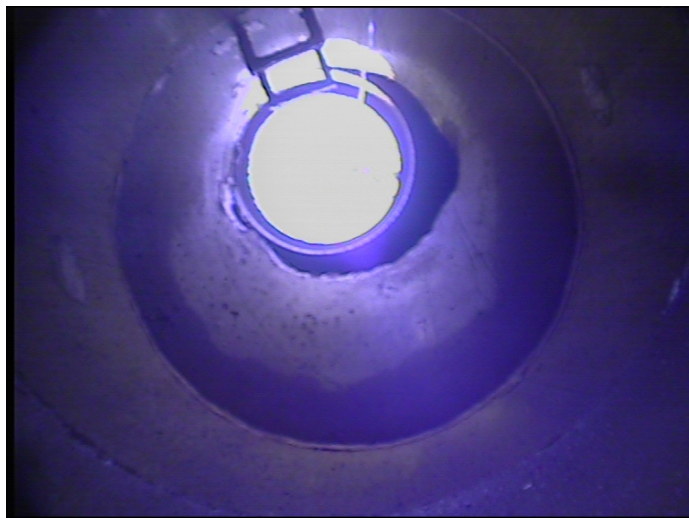
Code: **AMH**  
Description: **Manhole**

Distance (ft): **.0**  
Structural Grade: **0**  
O&M Grade: **0**  
Clock Start/From:  
Clock To:  
1st Value:  
2nd Value:  
Value Percent:  
Continuous Index:  
Within 8" of Joint: **NO**  
Remarks: **M-106-4**

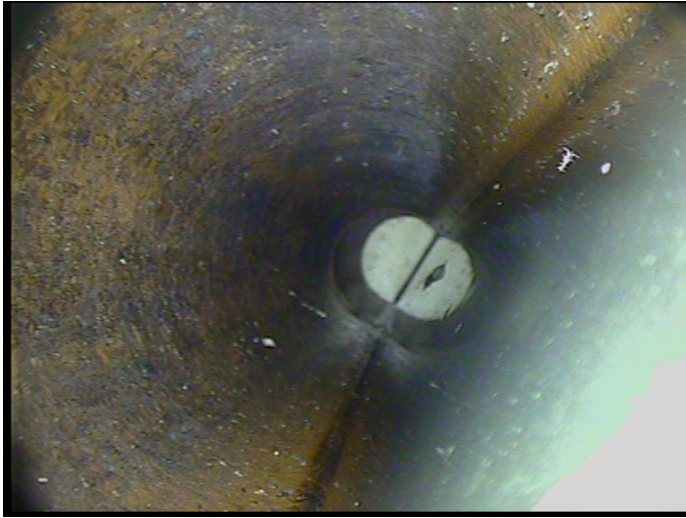
Code: **MWL**  
Description: **Water Level**

Distance (ft): **.0**  
Structural Grade: **0**  
O&M Grade: **0**  
Clock Start/From:  
Clock To:  
1st Value:  
2nd Value:  
Value Percent: **15.000**  
Continuous Index:  
Within 8" of Joint: **NO**  
Remarks:

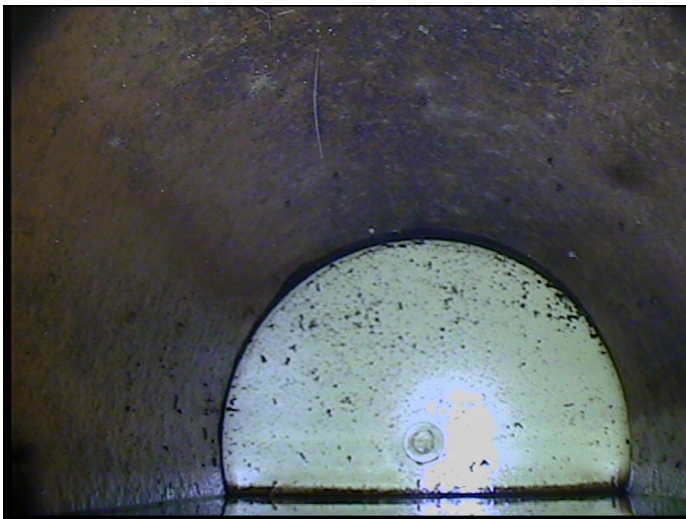
Code: **MGO**  
Description: **General Observation**

Distance (ft): **6.5**  
Structural Grade: **0**  
O&M Grade: **0**  
Clock Start/From:  
Clock To:  
1st Value:  
2nd Value:  
Value Percent:  
Continuous Index:  
Within 8" of Joint: **NO**  
Remarks: **Line is capped**

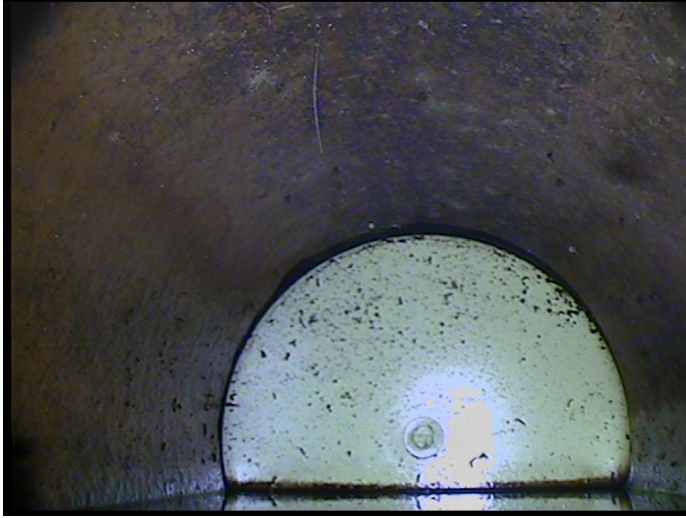
Code:	<b>MSA</b>
Description:	<b>Abandoned Survey</b>
Distance (ft):	<b>6.5</b>
Structural Grade:	<b>0</b>
O&M Grade:	<b>0</b>
Clock Start/From:	
Clock To:	
1st Value:	
2nd Value:	
Value Percent:	
Continuous Index:	
Within 8" of Joint:	<b>NO</b>
Remarks:	<b>Line is capped</b>
