Profile/Photo Observation Report

US MH: M-105-8 DS MH: M-105-9 Total Length Surveyed (ft): 23.0

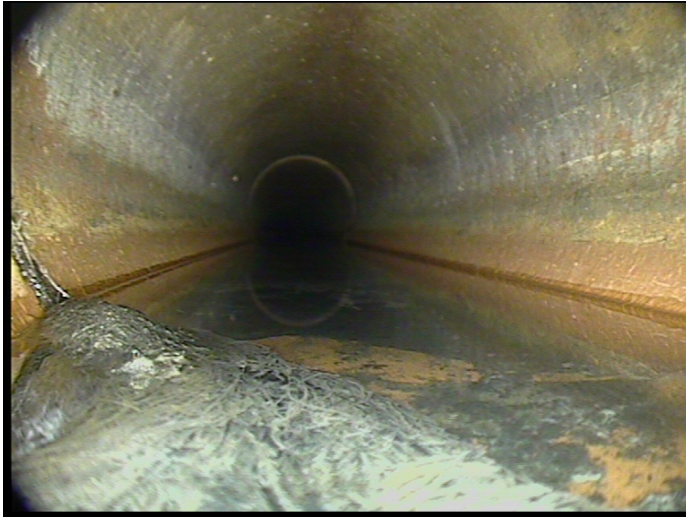
Code: **MWL**
Description: **Water Level**

Distance (ft): **.0**
Structural Grade: **0**
O&M Grade: **0**
Clock Start/From:
Clock To:
1st Value:
2nd Value:
Value Percent: **10.000**
Continuous Index:
Within 8" of Joint: **NO**
Remarks:

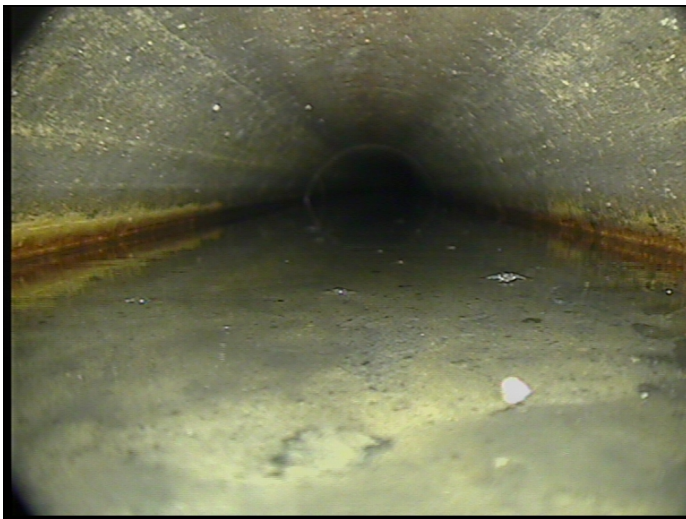
Code: **DSF**
Description: **Deposits Settled Fine**

Distance (ft): **22.6**
Structural Grade: **0**
O&M Grade: **4**
Clock Start/From: **4**
Clock To: **8**
1st Value:
2nd Value:
Value Percent: **30.000**
Continuous Index:
Within 8" of Joint: **NO**
Remarks:

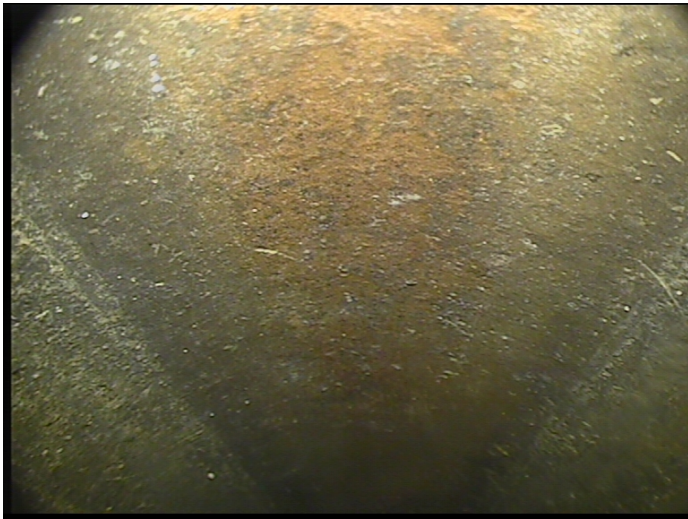
Code:	MSA
Description:	Abandoned Survey
Distance (ft):	22.6
Structural Grade:	0
O&M Grade:	0
Clock Start/From:	
Clock To:	
1st Value:	
2nd Value:	
Value Percent:	
Continuous Index:	
Within 8" of Joint:	NO
Remarks:	deep sediment
