Profile/Photo Observation Report

Date:	04/24/2018	Weather:		Coding:	PACP 6.0
Pipe Length (ft):		Owner:	City of Hobart	Pre Clean:	No Pre-Cleaning
P.O.#:	71	Surveyor:	M. Pielacha	PSR:	P-105-010-011
Customer:	City of Hobart	Clean Date:		Shape:	C

Street:	Off Willow Street	Flow Control:	Not Controlled
City:	Hobart, IN	Year Renewed:	
Location:	Light Highway	Tape/Media #:	DEP 71
Purpose:	Routine Assessment	Dia/Height:	6"
Use:	Sanitary	Material:	PVC
Drain Area:		Lining:	
Category:	NA		
Comment:	YES501824 Submittal 2		
Location Details:		Direction of Survey:	Upstream
US MH:	M-105-010	DS MH:	M-105-011
		Total Length Surveyed (ft):	56.1

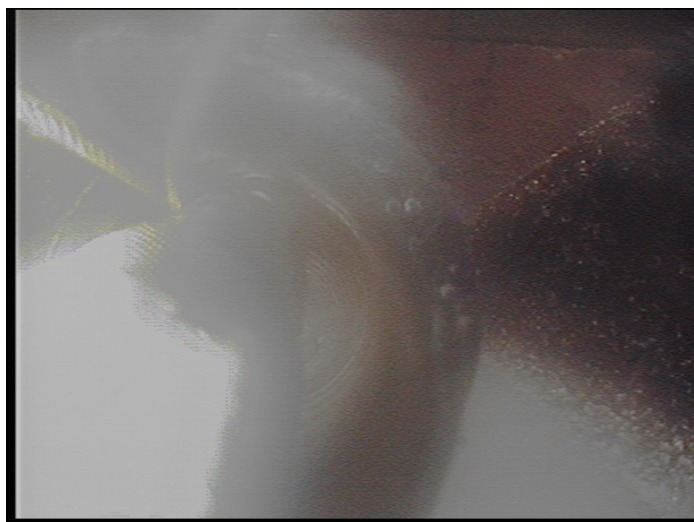
Code: **AMH**
 Description: **Manhole**

Distance (ft): **.0**
 Structural Grade: **0**
 O&M Grade: **0**
 Clock Start/From:
 Clock To:
 1st Value:
 2nd Value:
 Value Percent:
 Continuous Index:
 Within 8" of Joint: **NO**
 Remarks: **M-105-011**

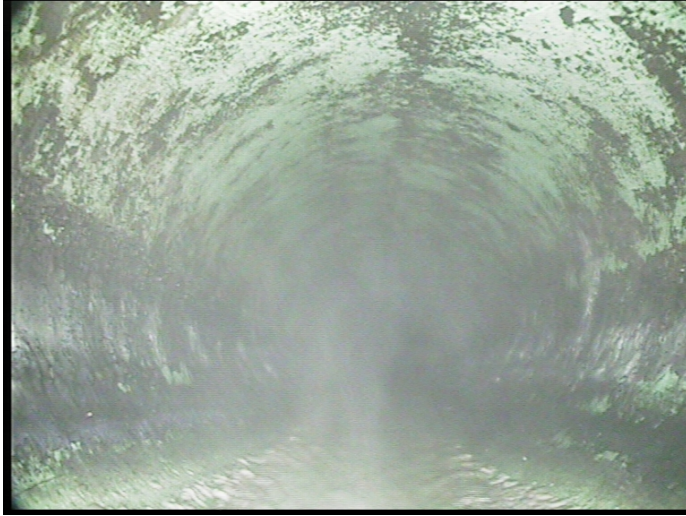
Code:	MWL
Description:	Water Level
Distance (ft):	.0
Structural Grade:	0
O&M Grade:	0
Clock Start/From:	
Clock To:	
1st Value:	
2nd Value:	
Value Percent:	10.000
Continuous Index:	
Within 8" of Joint:	NO
Remarks:

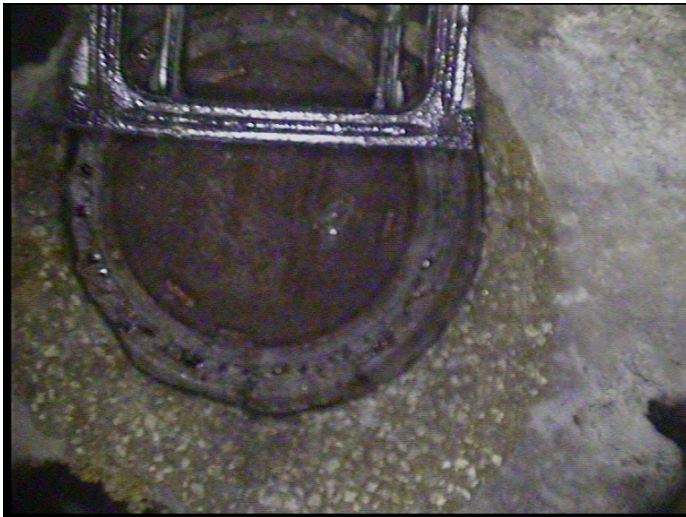
Code:	AMH
Description:	Manhole
Distance (ft):	56.1
Structural Grade:	0
O&M Grade:	0
Clock Start/From:	
Clock To:	
1st Value:	
2nd Value:	
Value Percent:	
Continuous Index:	
Within 8" of Joint:	NO
Remarks:	M-105-010
