RedZone
ROBOTICS

Total Length Surveyed (ft): **165.1**

Thursday, November 16, 2023

M-108-010

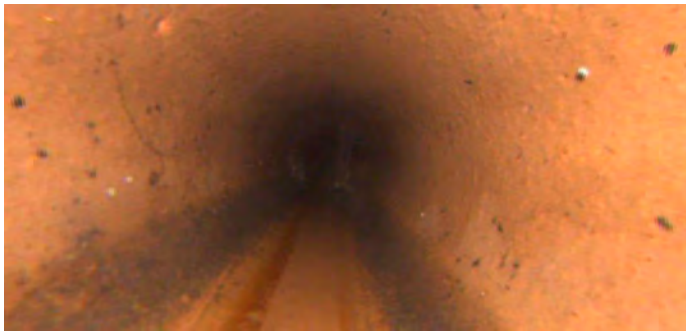
Code: **AMH**
Description: **Manhole**

Distance (ft): **.0**
Structural Grade: **0**
O&M Grade: **0**
Clock Start/From:
Clock To:
1st Value:
2nd Value:
Value Percent:
Continuous Index:
Within 8" of Joint: **NO**
Remarks: **M-108-011**

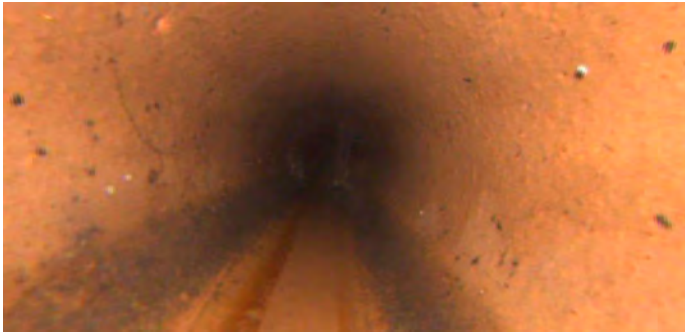
Code: **MWL**
Description: **Water Level**

Distance (ft): **.0**
Structural Grade: **0**
O&M Grade: **0**
Clock Start/From:
Clock To:
1st Value:
2nd Value:
Value Percent: **5.000**
Continuous Index:
Within 8" of Joint: **NO**
Remarks:

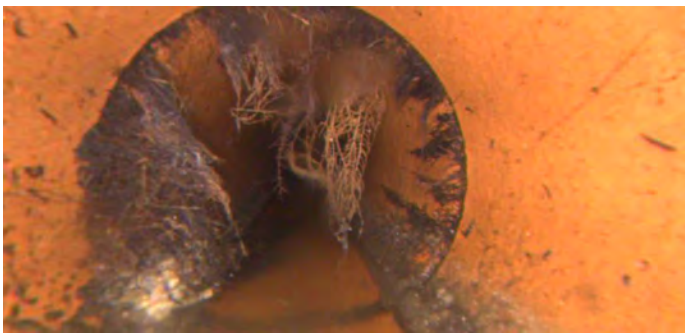
Code: **RMJ**
Description: **Roots Medium Joint**

Distance (ft): **7.8**
Structural Grade: **0**
O&M Grade: **3**
Clock Start/From: **8**
Clock To: **4**
1st Value:
2nd Value:
Value Percent: **20.000**
Continuous Index:
Within 8" of Joint: **YES**
Remarks:

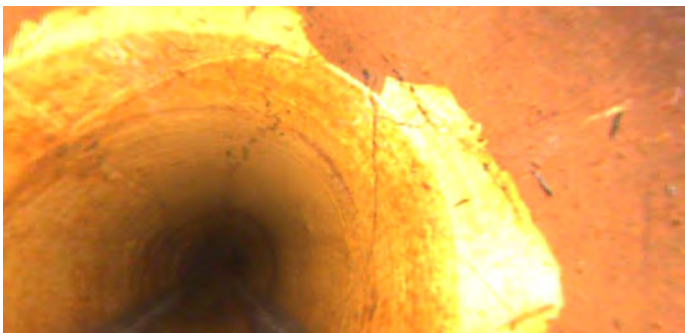
Code: **MLC**
Description: **Lining Change**

Distance (ft): **16.6**
Structural Grade: **0**
O&M Grade: **0**
Clock Start/From:
Clock To:
1st Value:
2nd Value:
Value Percent:
Continuous Index:
Within 8" of Joint: **NO**
Remarks: **CIP Liner**

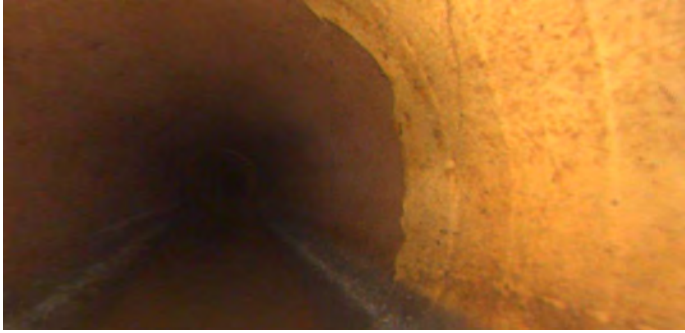
Code: **MLC**
Description: **Lining Change**

Distance (ft): **20.7**
Structural Grade: **0**
O&M Grade: **0**
Clock Start/From:
Clock To:
1st Value:
2nd Value:
Value Percent:
Continuous Index:
Within 8" of Joint: **NO**
Remarks: **end cip**

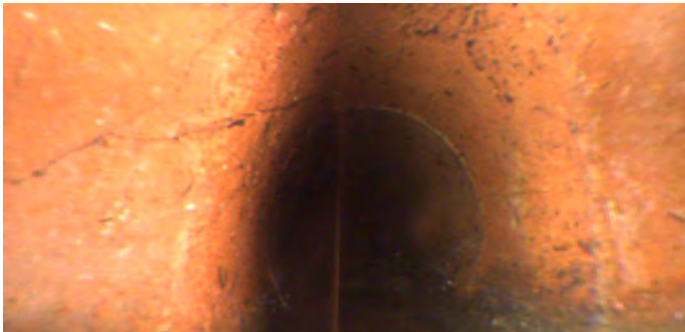
Code: **TF**
Description: **Tap Factory**

Distance (ft): **24.3**
Structural Grade: **0**
O&M Grade: **0**
Clock Start/From: **3**
Clock To:
1st Value: **4.000**
2nd Value:
Value Percent:
Continuous Index:
Within 8" of Joint: **YES**
Remarks:

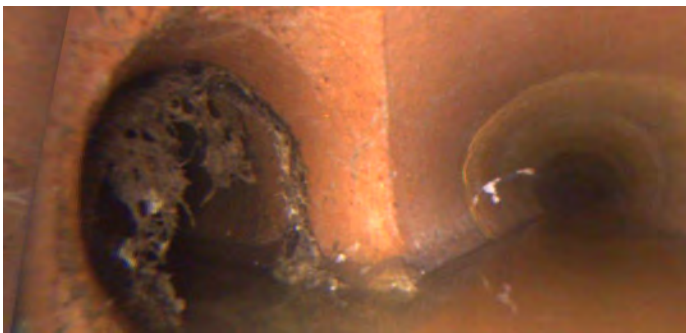
Code: **RFL**
Description: **Roots Fine Lateral**

Distance (ft): **26.0**
Structural Grade: **0**
O&M Grade: **1**
Clock Start/From: **7**
Clock To: **5**
1st Value:
2nd Value:
Value Percent:
Continuous Index:
Within 8" of Joint: **NO**
Remarks:

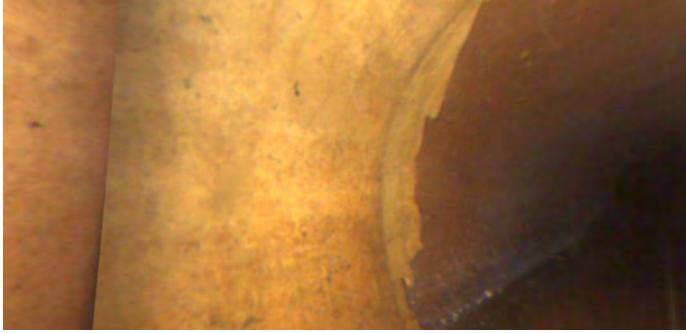
Code: **MLC**
Description: **Lining Change**

Distance (ft): **27.6**
Structural Grade: **0**
O&M Grade: **0**
Clock Start/From:
Clock To:
1st Value:
2nd Value:
Value Percent:
Continuous Index:
Within 8" of Joint: **NO**
Remarks: **CIP**

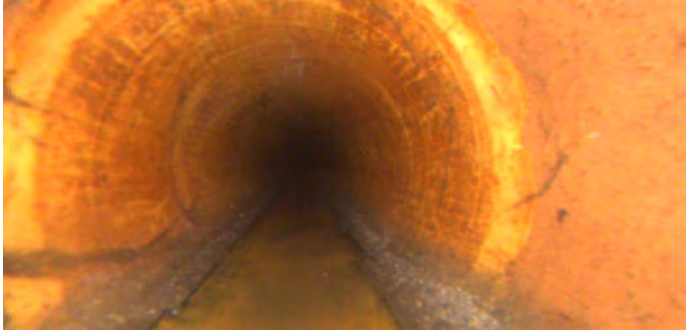
Code: **MLC**
Description: **Lining Change**

Distance (ft): **40.8**
Structural Grade: **0**
O&M Grade: **0**
Clock Start/From:
Clock To:
1st Value:
2nd Value:
Value Percent:
Continuous Index:
Within 8" of Joint: **NO**
Remarks: **CIP**

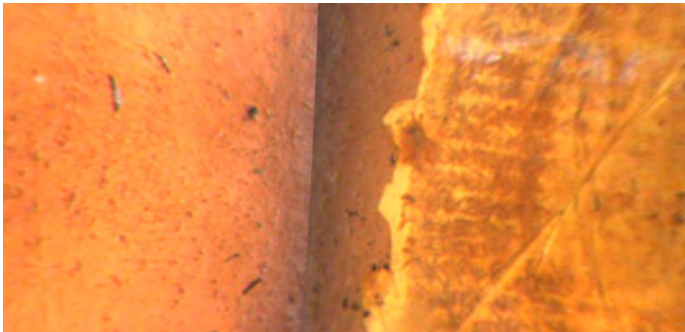
Code: **MLC**
Description: **Lining Change**

Distance (ft): **60.6**
Structural Grade: **0**
O&M Grade: **0**
Clock Start/From:
Clock To:
1st Value:
2nd Value:
Value Percent:
Continuous Index:
Within 8" of Joint: **NO**
Remarks: **END CIP**

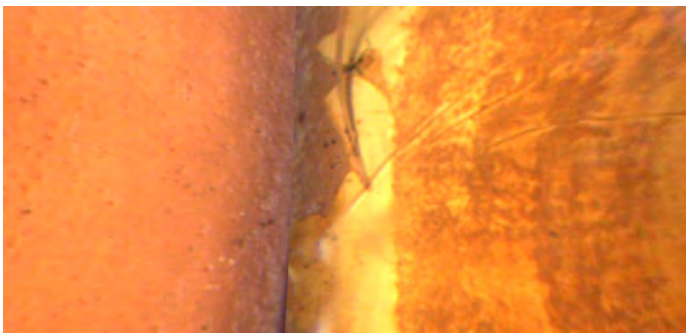
Code: **MLC**
Description: **Lining Change**

Distance (ft): **75.7**
Structural Grade: **0**
O&M Grade: **0**
Clock Start/From:
Clock To:
1st Value:
2nd Value:
Value Percent:
Continuous Index:
Within 8" of Joint: **NO**
Remarks: **END CIP**

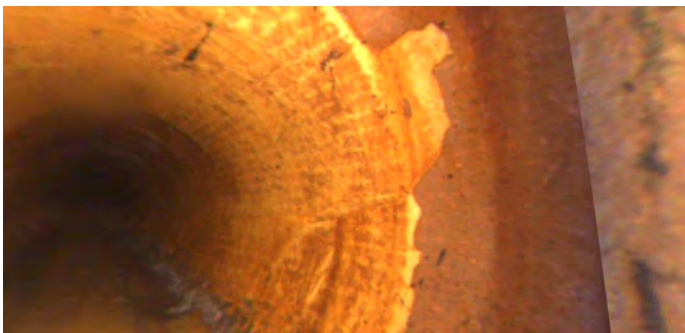
Code: **MLC**
Description: **Lining Change**

Distance (ft): **79.8**
Structural Grade: **0**
O&M Grade: **0**
Clock Start/From:
Clock To:
1st Value:
2nd Value:
Value Percent:
Continuous Index:
Within 8" of Joint: **NO**
Remarks: **CIP**

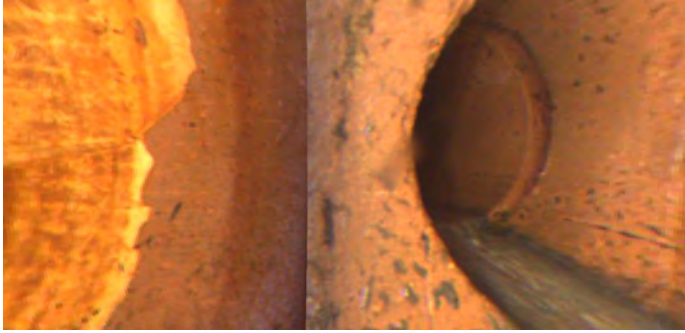
Code: **TF**
Description: **Tap Factory**

Distance (ft): **79.8**
Structural Grade: **0**
O&M Grade: **0**
Clock Start/From: **3**
Clock To:
1st Value: **4.000**
2nd Value:
Value Percent:
Continuous Index:
Within 8" of Joint: **YES**
Remarks:

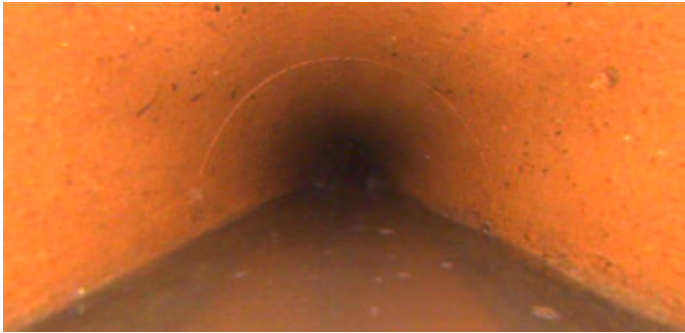
Code: **FC**
Description: **Fracture Circumferential**

Distance (ft): **95.4**
Structural Grade: **2**
O&M Grade: **0**
Clock Start/From: **8**
Clock To: **4**
1st Value:
2nd Value:
Value Percent:
Continuous Index:
Within 8" of Joint:
Remarks:

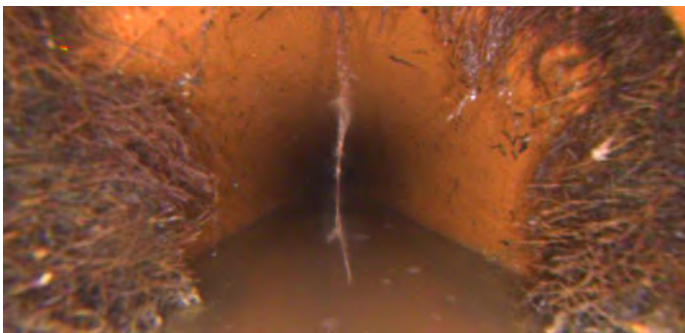
Code: **RMJ**
Description: **Roots Medium Joint**

Distance (ft): **97.9**
Structural Grade: **0**
O&M Grade: **3**
Clock Start/From: **8**
Clock To: **4**
1st Value:
2nd Value:
Value Percent: **30.000**
Continuous Index:
Within 8" of Joint: **YES**
Remarks:

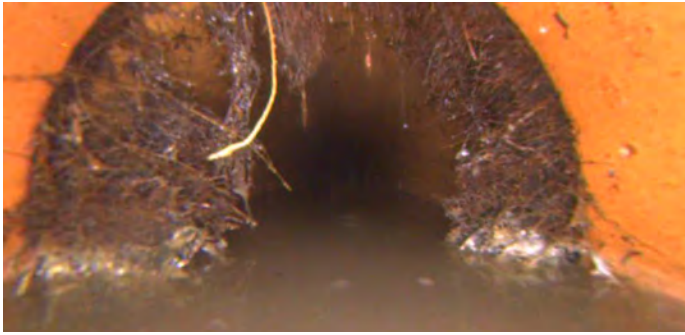
Code: **RMJ**
Description: **Roots Medium Joint**

Distance (ft): **108.1**
Structural Grade: **0**
O&M Grade: **3**
Clock Start/From: **8**
Clock To: **4**
1st Value:
2nd Value:
Value Percent: **30.000**
Continuous Index:
Within 8" of Joint: **YES**
Remarks:

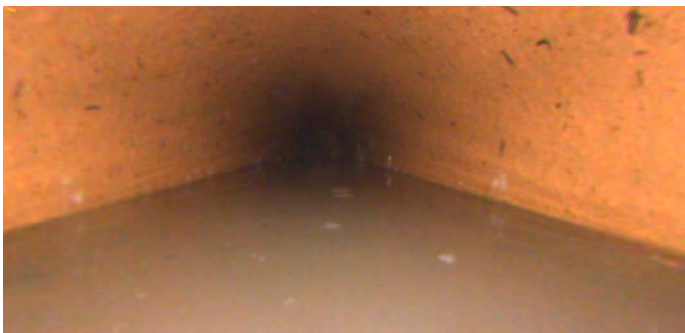
Code: **MWL**
Description: **Water Level**

Distance (ft): **109.2**
Structural Grade: **0**
O&M Grade: **0**
Clock Start/From:
Clock To:
1st Value:
2nd Value:
Value Percent: **25.000**
Continuous Index:
Within 8" of Joint: **NO**
Remarks:

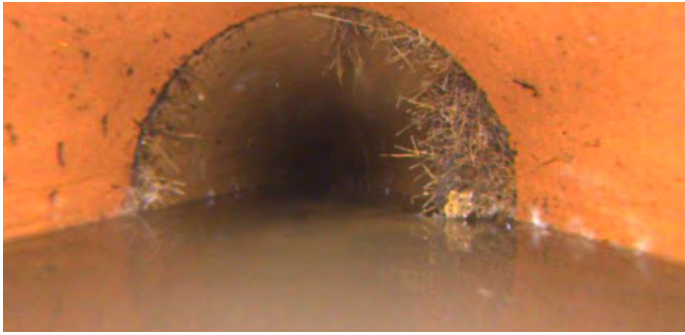
Code: **RMJ**
Description: **Roots Medium Joint**

Distance (ft): **113.0**
Structural Grade: **0**
O&M Grade: **3**
Clock Start/From: **8**
Clock To: **4**
1st Value:
2nd Value:
Value Percent: **10.000**
Continuous Index:
Within 8" of Joint: **YES**
Remarks:

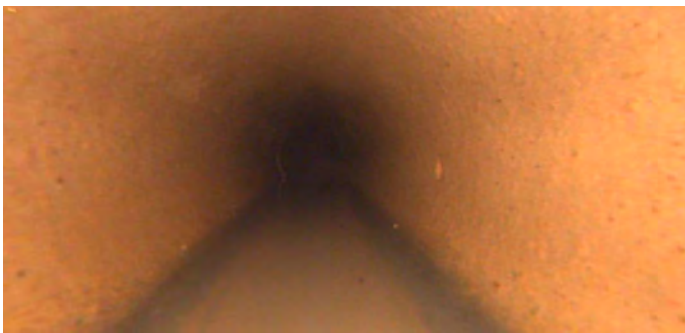
Code: **MWL**
Description: **Water Level**

Distance (ft): **125.8**
Structural Grade: **0**
O&M Grade: **0**
Clock Start/From:
Clock To:
1st Value:
2nd Value:
Value Percent: **5.000**
Continuous Index:
Within 8" of Joint: **NO**
Remarks:

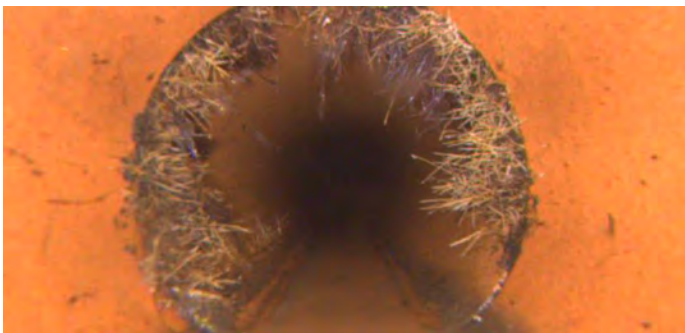
Code: **RMJ**
Description: **Roots Medium Joint**

Distance (ft): **138.5**
Structural Grade: **0**
O&M Grade: **3**
Clock Start/From: **8**
Clock To: **4**
1st Value:
2nd Value:
Value Percent: **10.000**
Continuous Index:
Within 8" of Joint: **YES**
Remarks:

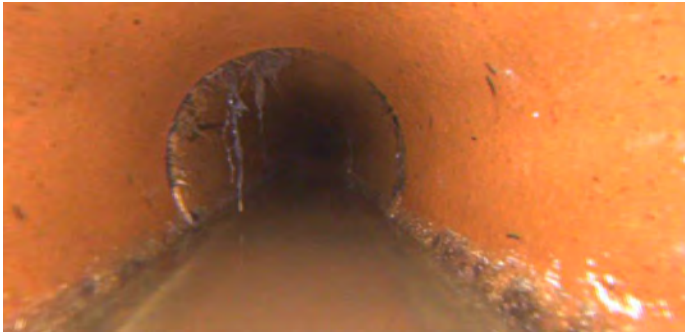
Code: **RFJ**
Description: **Roots Fine Joint**

Distance (ft): **148.3**
Structural Grade: **0**
O&M Grade: **1**
Clock Start/From: **7**
Clock To: **5**
1st Value:
2nd Value:
Value Percent:
Continuous Index:
Within 8" of Joint: **YES**
Remarks:

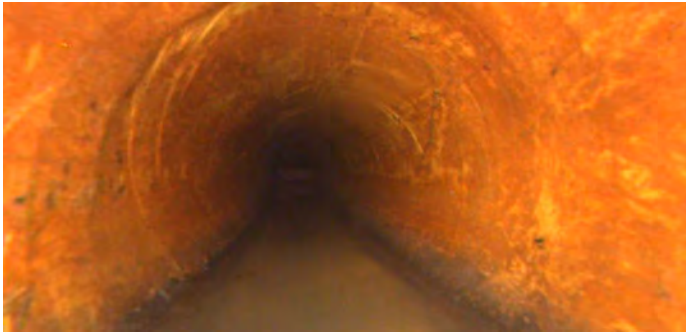
Code: **LL**
Description: **Alignment Left**

Distance (ft): **158.9**
Structural Grade: **0**
O&M Grade: **1**
Clock Start/From:
Clock To:
1st Value:
2nd Value:
Value Percent: **5.000**
Continuous Index:
Within 8" of Joint: **NO**
Remarks:

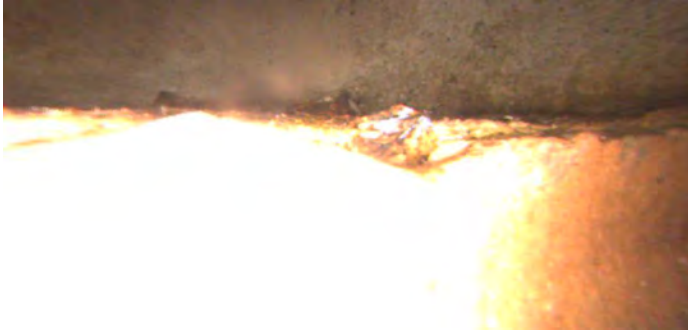
Code:	AMH
Description:	Manhole
Distance (ft):	165.1
Structural Grade:	0
O&M Grade:	0
Clock Start/From:	
Clock To:	
1st Value:	
2nd Value:	
Value Percent:	
Continuous Index:	
Within 8" of Joint:	NO
Remarks:	M-108-010
