Profile/Photo Observation Report

Date:	03/25/2018	Weather:		Coding:	PACP 6.0
Pipe Length (ft):	166.8	Owner:	NA	Pre Clean:	No Pre-Cleaning
P.O.#:		Surveyor:	Byrd Fitzgerald	PSR:	P-108-011-010
Customer:		Clean Date:	01/01/1900	Shape:	C

Street:	FOXCROFT STREET	Flow Control:	Not Controlled
City:	Hobart, IN	Year Renewed:	
Location:	Light Highway	Tape/Media #:	
Purpose:	Routine Assessment	Dia/Height:	8"
Use:	Sanitary	Material:	VCP
Drain Area:	NA	Lining:	
Category:	NA		
Comment:	Flow direction wrong		
Location Details:		Direction of Survey:	Upstream
US MH:	M-108-010	DS MH:	M-108-011
		Total Length Surveyed (ft):	165.1

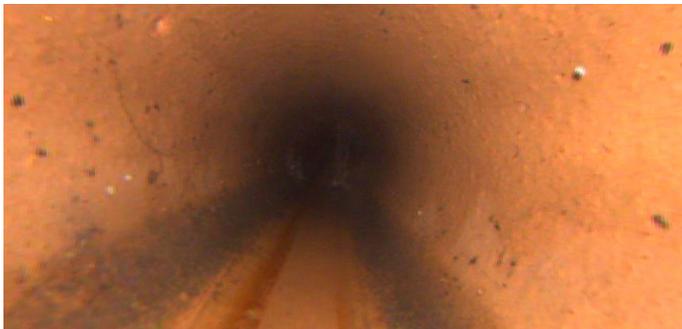
Code: **AMH**
Description: **Manhole**

Distance (ft): **.0**
Structural Grade: **0**
O&M Grade: **0**
Clock Start/From:
Clock To:
1st Value:
2nd Value:
Value Percent:
Continuous Index:
Within 8" of Joint: **NO**
Remarks: **M-108-011**

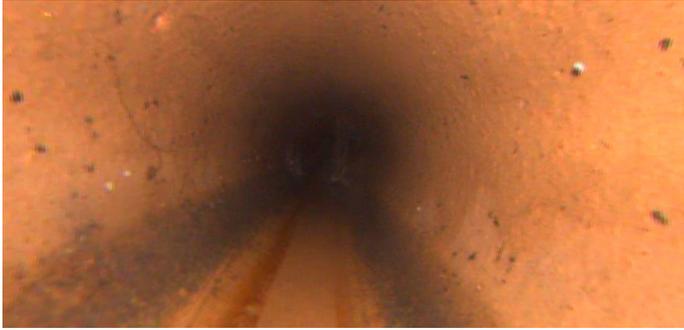
Code: **MWL**
Description: **Water Level**

Distance (ft): **.0**
Structural Grade: **0**
O&M Grade: **0**
Clock Start/From:
Clock To:
1st Value:
2nd Value:
Value Percent: **5.000**
Continuous Index:
Within 8" of Joint: **NO**
Remarks:

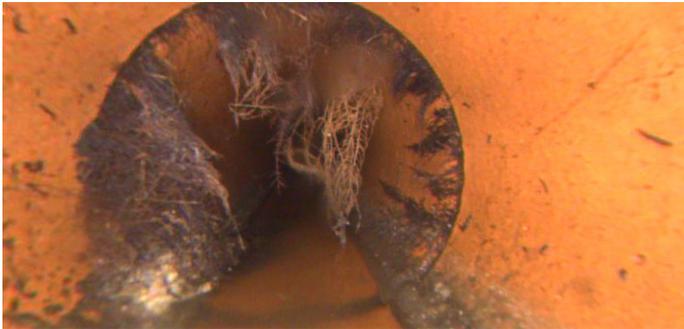
Code: **RMJ**
Description: **Roots Medium Joint**

Distance (ft): **7.8**
Structural Grade: **0**
O&M Grade: **3**
Clock Start/From: **8**
Clock To: **4**
1st Value:
2nd Value:
Value Percent: **20.000**
Continuous Index:
Within 8" of Joint: **YES**
Remarks:

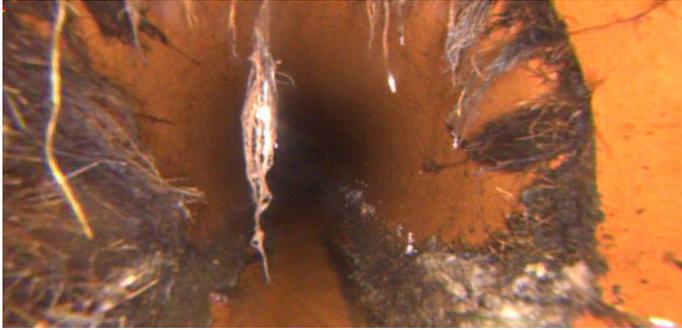
Code: **RMJ**
Description: **Roots Medium Joint**

Distance (ft): **13.1**
Structural Grade: **0**
O&M Grade: **3**
Clock Start/From: **8**
Clock To: **4**
1st Value:
2nd Value:
Value Percent: **10.000**
Continuous Index:
Within 8" of Joint: **YES**
Remarks:

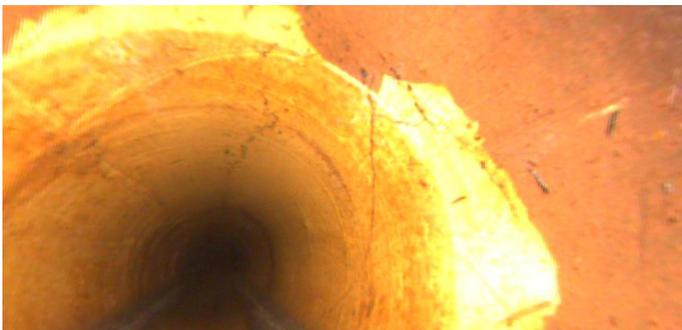
Code: **MLC**
Description: **Lining Change**

Distance (ft): **16.6**
Structural Grade: **0**
O&M Grade: **0**
Clock Start/From:
Clock To:
1st Value:
2nd Value:
Value Percent:
Continuous Index:
Within 8" of Joint: **NO**
Remarks: **CIP Liner**

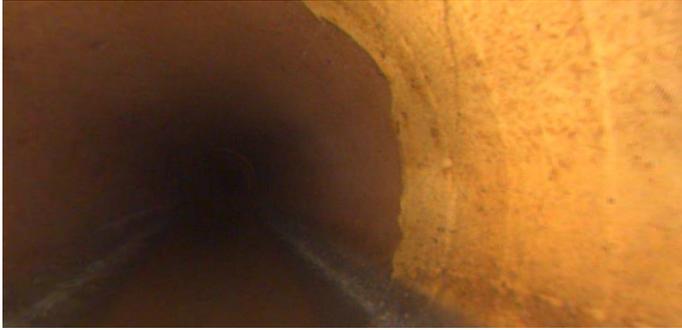
Code: **MLC**
Description: **Lining Change**

Distance (ft): **20.7**
Structural Grade: **0**
O&M Grade: **0**
Clock Start/From:
Clock To:
1st Value:
2nd Value:
Value Percent:
Continuous Index:
Within 8" of Joint: **NO**
Remarks: **end cip**

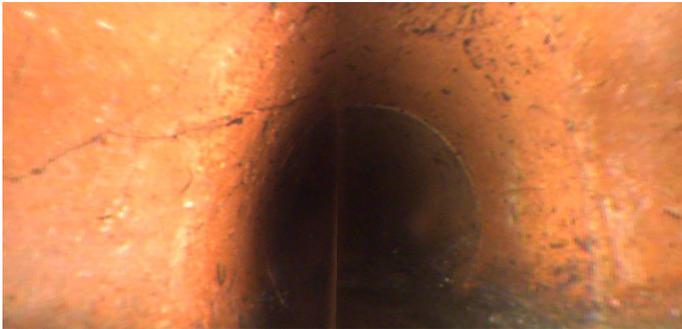
Code: **TF**
Description: **Tap Factory**

Distance (ft): **24.3**
Structural Grade: **0**
O&M Grade: **0**
Clock Start/From: **3**
Clock To:
1st Value: **4.000**
2nd Value:
Value Percent:
Continuous Index:
Within 8" of Joint: **YES**
Remarks:

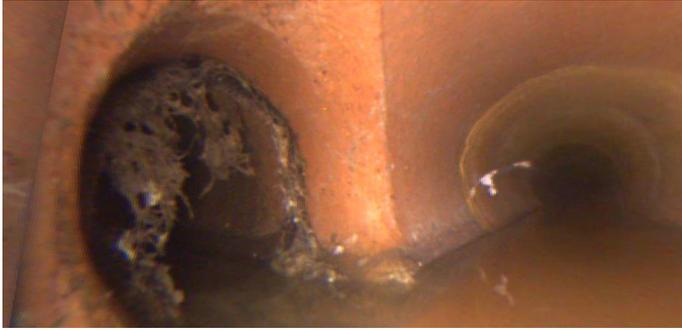
Code: **TFD**
Description: **Tap Factory Defective**

Distance (ft): **26.0**
Structural Grade: **0**
O&M Grade: **2**
Clock Start/From: **9**
Clock To:
1st Value: **4.000**
2nd Value:
Value Percent:
Continuous Index:
Within 8" of Joint: **YES**
Remarks: **ROOTS**

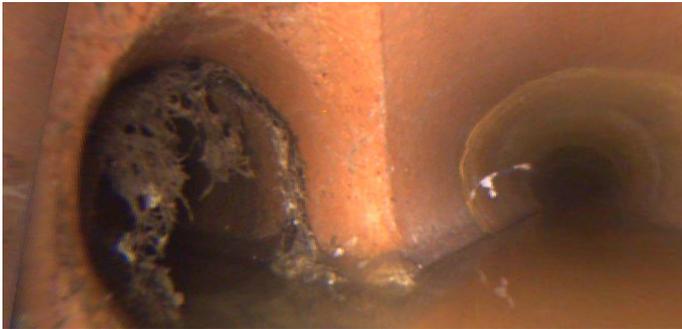
Code: **RFL**
Description: **Roots Fine Lateral**

Distance (ft): **26.0**
Structural Grade: **0**
O&M Grade: **1**
Clock Start/From: **7**
Clock To: **5**
1st Value:
2nd Value:
Value Percent:
Continuous Index:
Within 8" of Joint: **NO**
Remarks:

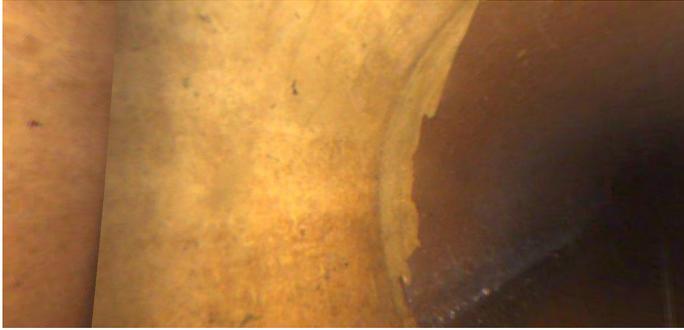
Code: **MLC**
 Description: **Lining Change**

Distance (ft): **27.6**
 Structural Grade: **0**
 O&M Grade: **0**
 Clock Start/From:
 Clock To:
 1st Value:
 2nd Value:
 Value Percent:
 Continuous Index:
 Within 8" of Joint: **NO**
 Remarks: **CIP**

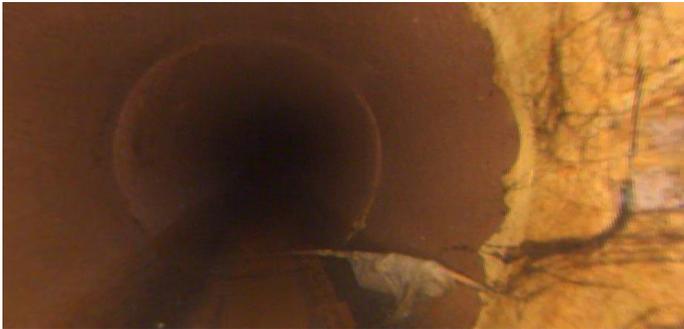
Code: **MLC**
 Description: **Lining Change**

Distance (ft): **32.1**
 Structural Grade: **0**
 O&M Grade: **0**
 Clock Start/From:
 Clock To:
 1st Value:
 2nd Value:
 Value Percent:
 Continuous Index:
 Within 8" of Joint: **NO**
 Remarks: **END CIP**

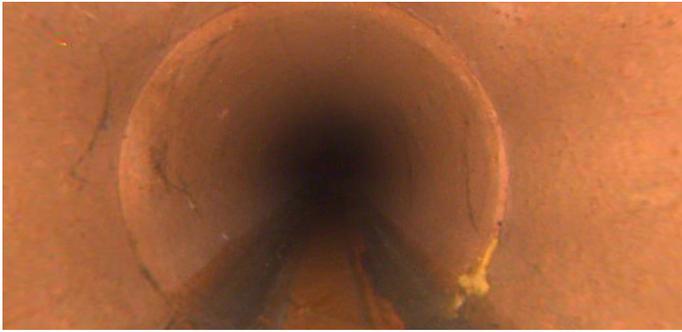
Code: **RFJ**
Description: **Roots Fine Joint**

Distance (ft): **32.3**
Structural Grade: **0**
O&M Grade: **1**
Clock Start/From: **8**
Clock To: **4**
1st Value:
2nd Value:
Value Percent:
Continuous Index:
Within 8" of Joint: **YES**
Remarks:

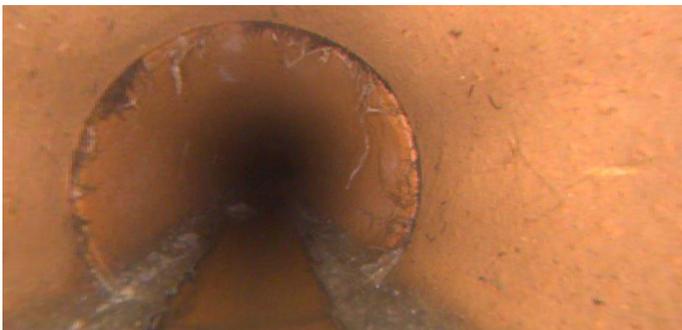
Code: **RFJ**
Description: **Roots Fine Joint**

Distance (ft): **37.4**
Structural Grade: **0**
O&M Grade: **1**
Clock Start/From: **7**
Clock To: **5**
1st Value:
2nd Value:
Value Percent:
Continuous Index:
Within 8" of Joint: **YES**
Remarks:

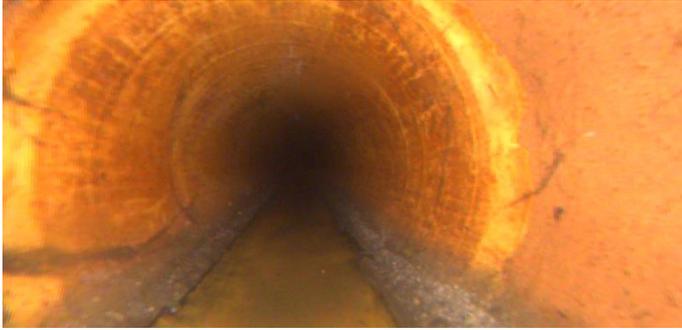
Code: **MLC**
Description: **Lining Change**

Distance (ft): **40.8**
Structural Grade: **0**
O&M Grade: **0**
Clock Start/From:
Clock To:
1st Value:
2nd Value:
Value Percent:
Continuous Index:
Within 8" of Joint: **NO**
Remarks: **CIP**

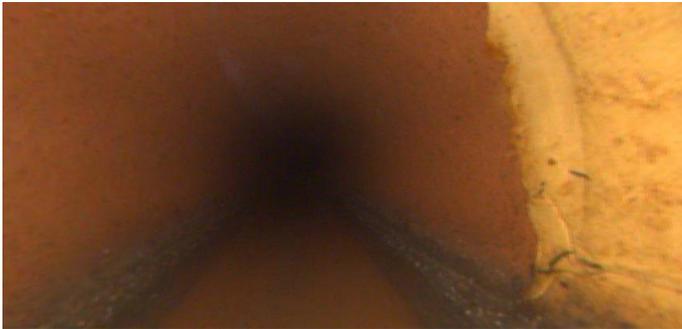
Code: **MLC**
Description: **Lining Change**

Distance (ft): **49.9**
Structural Grade: **0**
O&M Grade: **0**
Clock Start/From:
Clock To:
1st Value:
2nd Value:
Value Percent:
Continuous Index:
Within 8" of Joint: **NO**
Remarks: **END CIP**

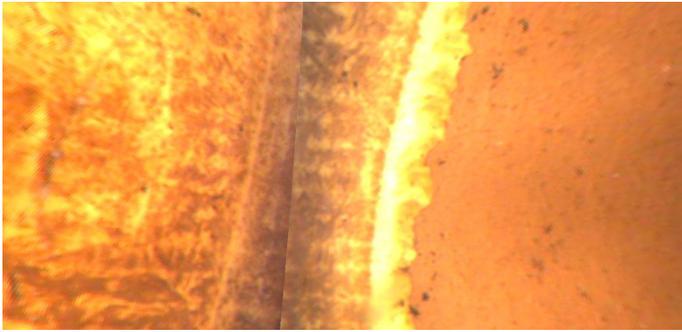
Code: **MLC**
Description: **Lining Change**

Distance (ft): **56.4**
Structural Grade: **0**
O&M Grade: **0**
Clock Start/From:
Clock To:
1st Value:
2nd Value:
Value Percent:
Continuous Index:
Within 8" of Joint: **NO**
Remarks: **CIP**

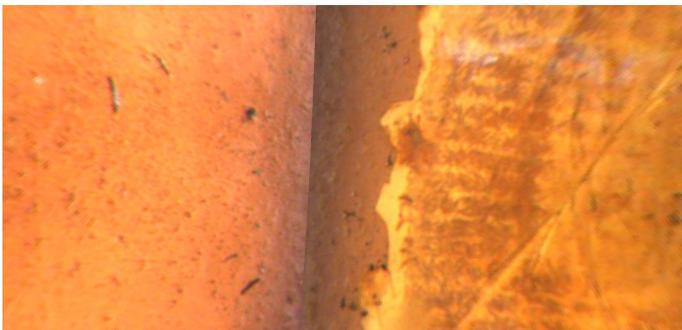
Code: **MLC**
Description: **Lining Change**

Distance (ft): **60.6**
Structural Grade: **0**
O&M Grade: **0**
Clock Start/From:
Clock To:
1st Value:
2nd Value:
Value Percent:
Continuous Index:
Within 8" of Joint: **NO**
Remarks: **END CIP**

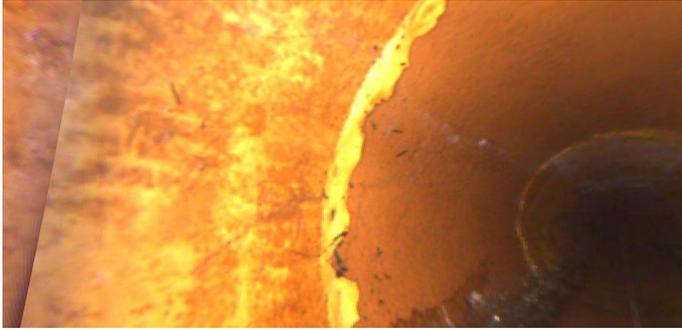
Code: **MLC**
Description: **Lining Change**

Distance (ft): **62.0**
Structural Grade: **0**
O&M Grade: **0**
Clock Start/From:
Clock To:
1st Value:
2nd Value:
Value Percent:
Continuous Index:
Within 8" of Joint: **NO**
Remarks: **CIP**

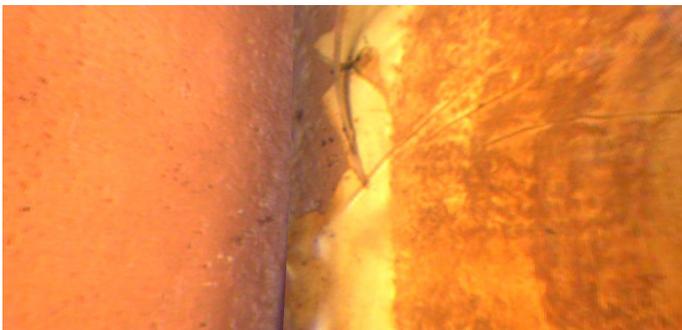
Code: **MLC**
Description: **Lining Change**

Distance (ft): **75.7**
Structural Grade: **0**
O&M Grade: **0**
Clock Start/From:
Clock To:
1st Value:
2nd Value:
Value Percent:
Continuous Index:
Within 8" of Joint: **NO**
Remarks: **END CIP**

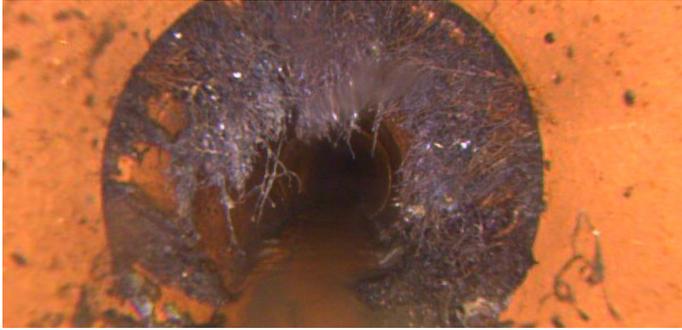
Code: **RMJ**
Description: **Roots Medium Joint**

Distance (ft): **78.4**
Structural Grade: **0**
O&M Grade: **3**
Clock Start/From: **8**
Clock To: **4**
1st Value:
2nd Value:
Value Percent: **30.000**
Continuous Index:
Within 8" of Joint: **YES**
Remarks:

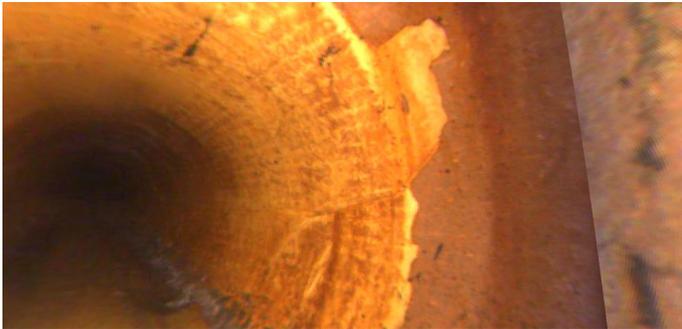
Code: **MLC**
Description: **Lining Change**

Distance (ft): **79.8**
Structural Grade: **0**
O&M Grade: **0**
Clock Start/From:
Clock To:
1st Value:
2nd Value:
Value Percent:
Continuous Index:
Within 8" of Joint: **NO**
Remarks: **CIP**

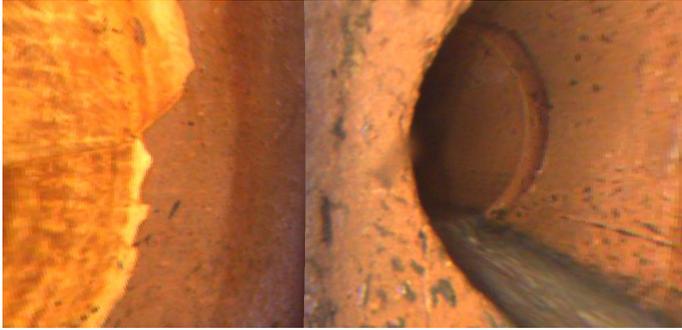
Code: **TF**
Description: **Tap Factory**

Distance (ft): **79.8**
Structural Grade: **0**
O&M Grade: **0**
Clock Start/From: **3**
Clock To:
1st Value: **4.000**
2nd Value:
Value Percent:
Continuous Index:
Within 8" of Joint: **YES**
Remarks:

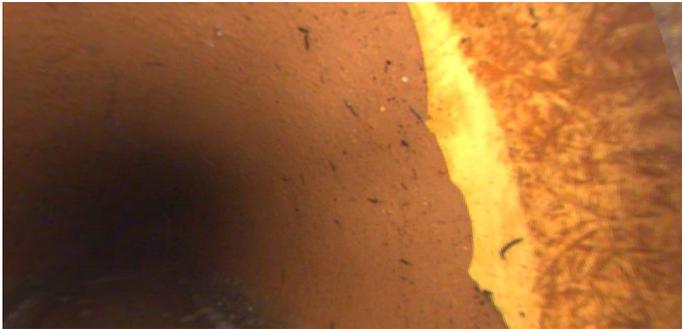
Code: **MLC**
Description: **Lining Change**

Distance (ft): **84.0**
Structural Grade: **0**
O&M Grade: **0**
Clock Start/From:
Clock To:
1st Value:
2nd Value:
Value Percent:
Continuous Index:
Within 8" of Joint: **NO**
Remarks: **END CIP**

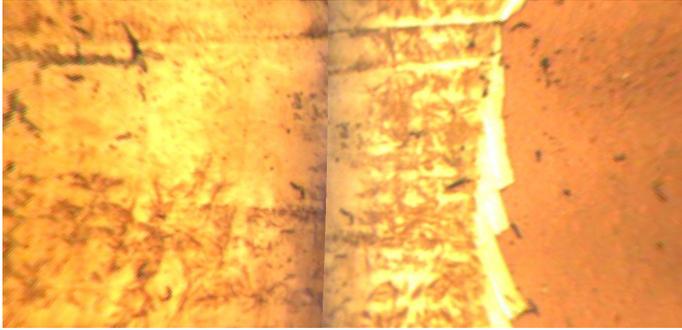
Code: **MLC**
Description: **Lining Change**

Distance (ft): **91.4**
Structural Grade: **0**
O&M Grade: **0**
Clock Start/From:
Clock To:
1st Value:
2nd Value:
Value Percent:
Continuous Index:
Within 8" of Joint: **NO**
Remarks: **CIP**

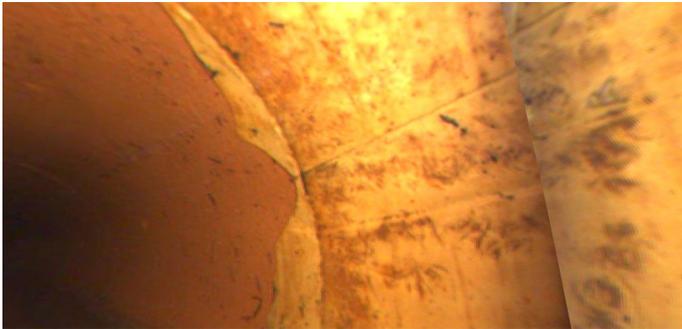
Code: **MLC**
Description: **Lining Change**

Distance (ft): **94.8**
Structural Grade: **0**
O&M Grade: **0**
Clock Start/From:
Clock To:
1st Value:
2nd Value:
Value Percent:
Continuous Index:
Within 8" of Joint: **NO**
Remarks: **END CIP**

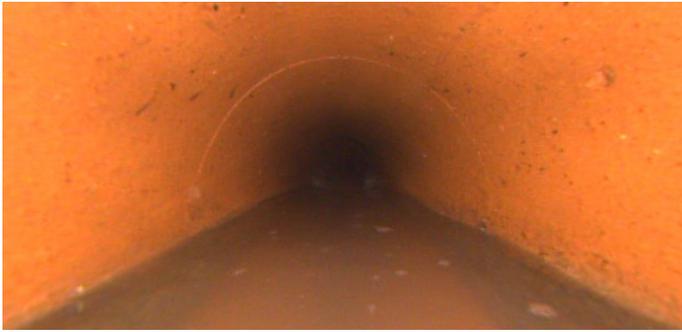
Code: **FC**
Description: **Fracture Circumferential**

Distance (ft): **95.4**
Structural Grade: **2**
O&M Grade: **0**
Clock Start/From: **8**
Clock To: **4**
1st Value:
2nd Value:
Value Percent:
Continuous Index:
Within 8" of Joint:
Remarks:

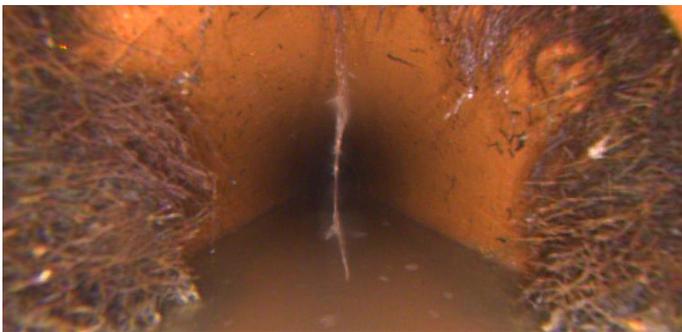
Code: **RMJ**
Description: **Roots Medium Joint**

Distance (ft): **97.9**
Structural Grade: **0**
O&M Grade: **3**
Clock Start/From: **8**
Clock To: **4**
1st Value:
2nd Value:
Value Percent: **30.000**
Continuous Index:
Within 8" of Joint: **YES**
Remarks:

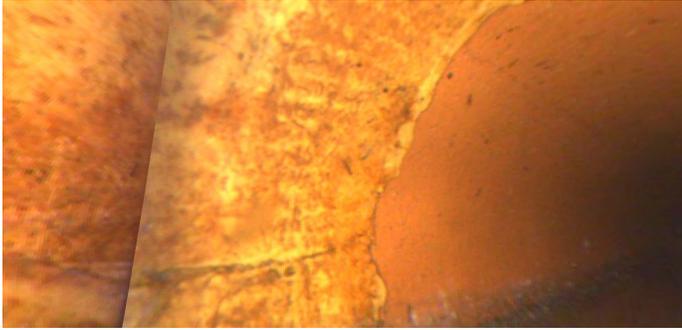
Code: **MLC**
Description: **Lining Change**

Distance (ft): **101.8**
Structural Grade: **0**
O&M Grade: **0**
Clock Start/From:
Clock To:
1st Value:
2nd Value:
Value Percent:
Continuous Index:
Within 8" of Joint: **NO**
Remarks: **CIP**

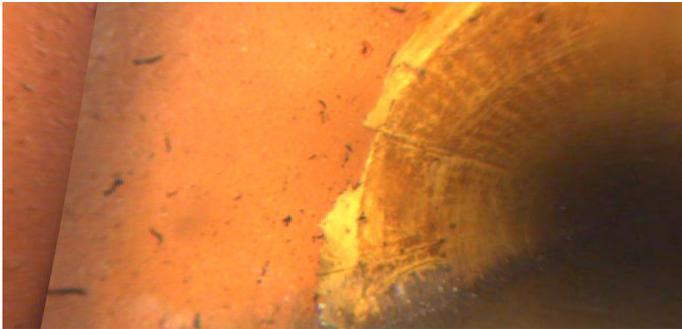
Code: **MLC**
Description: **Lining Change**

Distance (ft): **105.9**
Structural Grade: **0**
O&M Grade: **0**
Clock Start/From:
Clock To:
1st Value:
2nd Value:
Value Percent:
Continuous Index:
Within 8" of Joint: **NO**
Remarks: **END CIP**

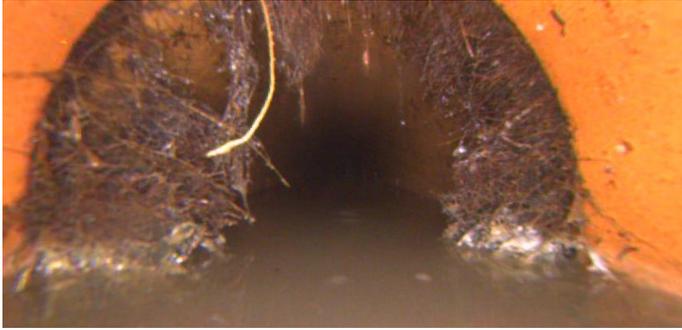
Code: **RMJ**
Description: **Roots Medium Joint**

Distance (ft): **108.1**
Structural Grade: **0**
O&M Grade: **3**
Clock Start/From: **8**
Clock To: **4**
1st Value:
2nd Value:
Value Percent: **30.000**
Continuous Index:
Within 8" of Joint: **YES**
Remarks:

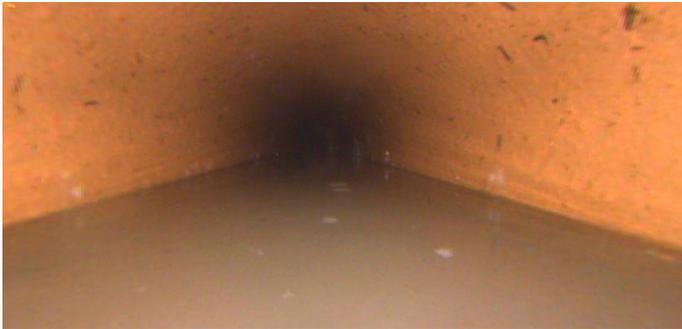
Code: **MWL**
Description: **Water Level**

Distance (ft): **109.2**
Structural Grade: **0**
O&M Grade: **0**
Clock Start/From:
Clock To:
1st Value:
2nd Value:
Value Percent: **25.000**
Continuous Index:
Within 8" of Joint: **NO**
Remarks:

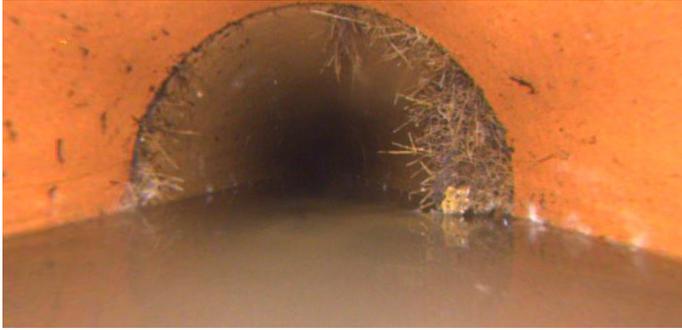
Code: **RMJ**
Description: **Roots Medium Joint**

Distance (ft): **113.0**
Structural Grade: **0**
O&M Grade: **3**
Clock Start/From: **8**
Clock To: **4**
1st Value:
2nd Value:
Value Percent: **10.000**
Continuous Index:
Within 8" of Joint: **YES**
Remarks:

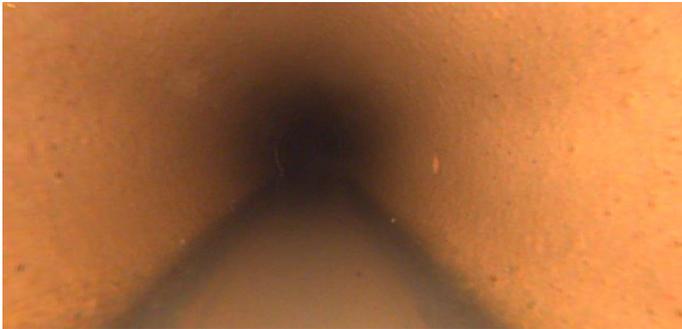
Code: **MWL**
Description: **Water Level**

Distance (ft): **125.8**
Structural Grade: **0**
O&M Grade: **0**
Clock Start/From:
Clock To:
1st Value:
2nd Value:
Value Percent: **5.000**
Continuous Index:
Within 8" of Joint: **NO**
Remarks:

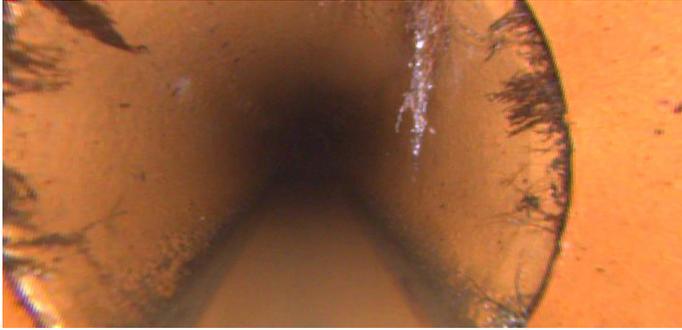
Code: **RFJ**
Description: **Roots Fine Joint**

Distance (ft): **133.5**
Structural Grade: **0**
O&M Grade: **1**
Clock Start/From: **7**
Clock To: **5**
1st Value:
2nd Value:
Value Percent:
Continuous Index:
Within 8" of Joint: **YES**
Remarks:

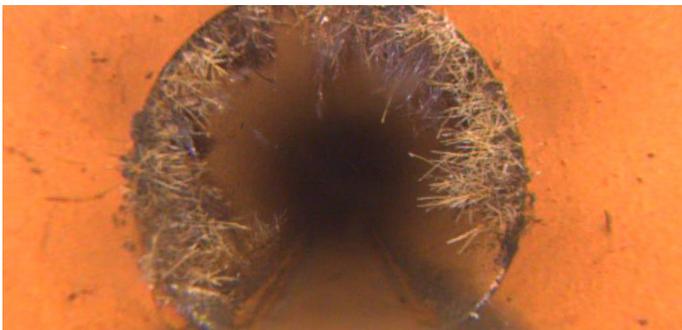
Code: **RMJ**
Description: **Roots Medium Joint**

Distance (ft): **138.5**
Structural Grade: **0**
O&M Grade: **3**
Clock Start/From: **8**
Clock To: **4**
1st Value:
2nd Value:
Value Percent: **10.000**
Continuous Index:
Within 8" of Joint: **YES**
Remarks:

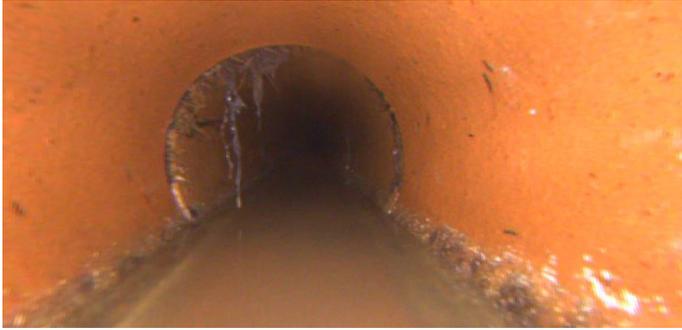
Code: **RFJ**
Description: **Roots Fine Joint**

Distance (ft): **148.3**
Structural Grade: **0**
O&M Grade: **1**
Clock Start/From: **7**
Clock To: **5**
1st Value:
2nd Value:
Value Percent:
Continuous Index:
Within 8" of Joint: **YES**
Remarks:

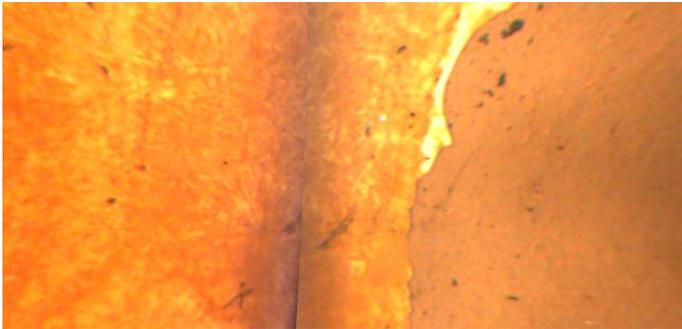
Code: **MLC**
Description: **Lining Change**

Distance (ft): **157.4**
Structural Grade: **0**
O&M Grade: **0**
Clock Start/From:
Clock To:
1st Value:
2nd Value:
Value Percent:
Continuous Index:
Within 8" of Joint: **NO**
Remarks: **cip**

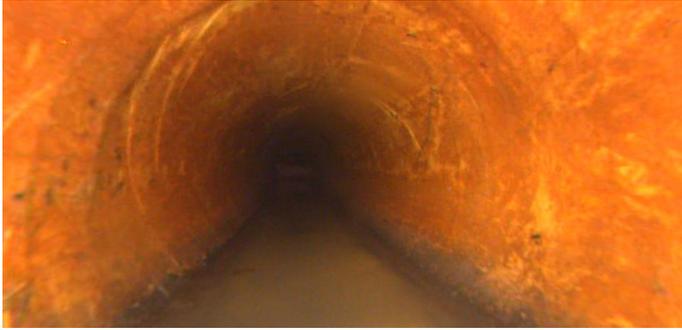
Code: **LL**
Description: **Alignment Left**

Distance (ft): **158.9**
Structural Grade: **0**
O&M Grade: **1**
Clock Start/From:
Clock To:
1st Value:
2nd Value:
Value Percent: **5.000**
Continuous Index:
Within 8" of Joint: **NO**
Remarks:

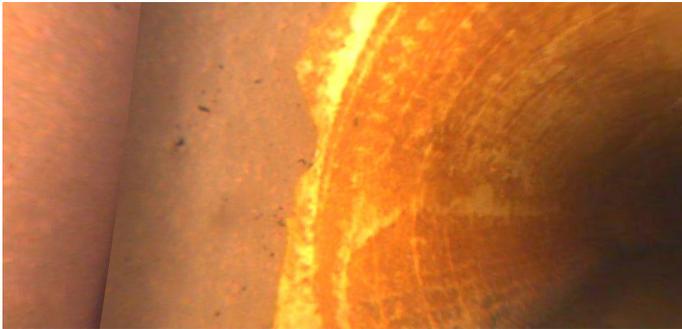
Code: **MLC**
Description: **Lining Change**

Distance (ft): **161.7**
Structural Grade: **0**
O&M Grade: **0**
Clock Start/From:
Clock To:
1st Value:
2nd Value:
Value Percent:
Continuous Index:
Within 8" of Joint: **NO**
Remarks: **END CIP**
