Profile/Photo Observation Report

Date:	03/24/2018	Weather:		Coding:	PACP 6.0
Pipe Length (ft):	149.7	Owner:	NA	Pre Clean:	No Pre-Cleaning
P.O.#:		Surveyor:	Justin Gonzales	PSR:	P-108-008-015
Customer:		Clean Date:	01/01/1900	Shape:	C

Street:	14TH LN	Flow Control:	Not Controlled
City:	Hobart, IN	Year Renewed:	
Location:	Light Highway	Tape/Media #:	
Purpose:	Routine Assessment	Dia/Height:	12"
Use:	Sanitary	Material:	VCP
Drain Area:	NA	Lining:	
Category:	NA		
Comment:	Flow direction wrong		
Location Details:		Direction of Survey:	Upstream
US MH:	M-108-015	DS MH:	M-108-008
		Total Length Surveyed (ft):	146.2

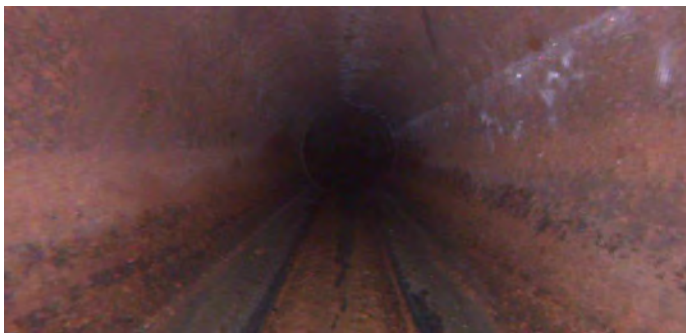
Code: **AMH**
Description: **Manhole**

Distance (ft): **.0**
Structural Grade: **0**
O&M Grade: **0**
Clock Start/From:
Clock To:
1st Value:
2nd Value:
Value Percent:
Continuous Index:
Within 8" of Joint: **NO**
Remarks: **M-108-008**

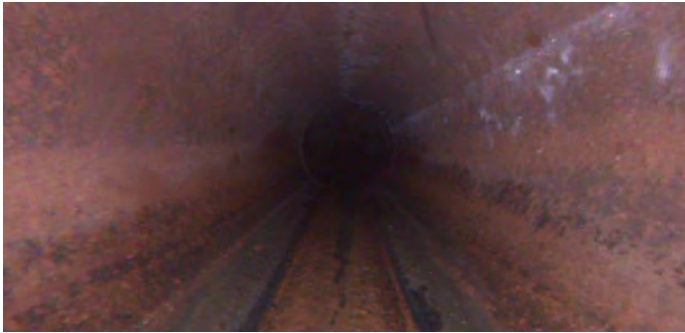
Code:	MWL
Description:	Water Level

Distance (ft):	.0
Structural Grade:	0
O&M Grade:	0
Clock Start/From:	
Clock To:	
1st Value:	
2nd Value:	
Value Percent:	5.000
Continuous Index:	
Within 8" of Joint:	NO
Remarks:

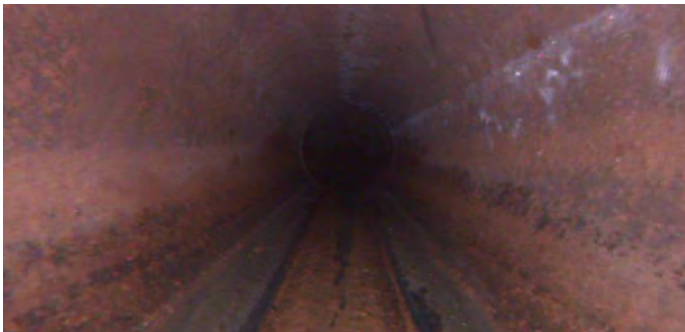
Code:	DAGS
Description:	Deposits Attached Grease

Distance (ft):	.0
Structural Grade:	0
O&M Grade:	2
Clock Start/From:	7
Clock To:	5
1st Value:	
2nd Value:	
Value Percent:	5.000
Continuous Index:	S01
Within 8" of Joint:	YES
Remarks:	WANDER

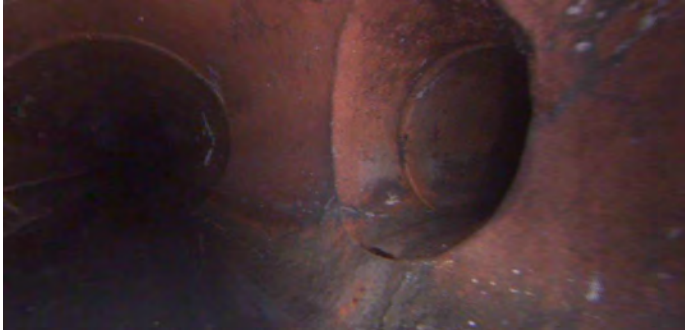
Code: **TF**
Description: **Tap Factory**

Distance (ft): **51.7**
Structural Grade: **0**
O&M Grade: **0**
Clock Start/From: **3**
Clock To:
1st Value: **4.000**
2nd Value:
Value Percent:
Continuous Index:
Within 8" of Joint:
Remarks:

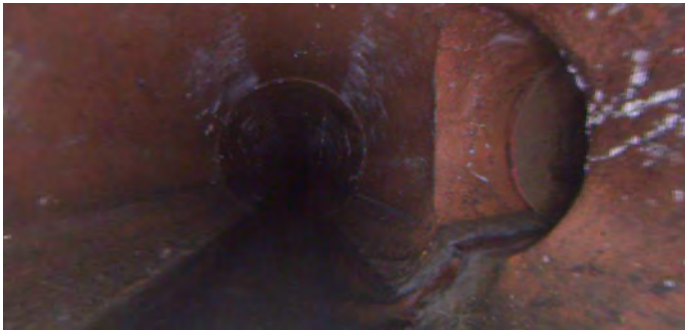
Code: **TF**
Description: **Tap Factory**

Distance (ft): **107.4**
Structural Grade: **0**
O&M Grade: **0**
Clock Start/From: **3**
Clock To:
1st Value: **4.000**
2nd Value:
Value Percent:
Continuous Index:
Within 8" of Joint:
Remarks:

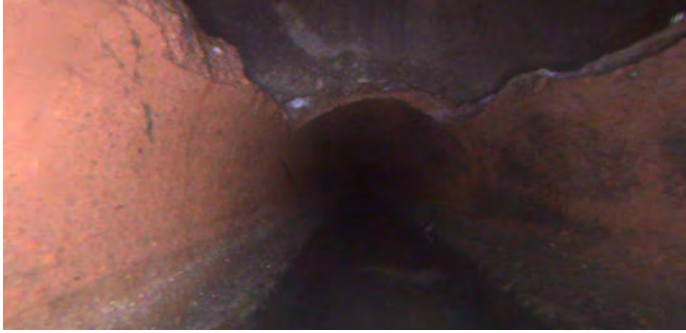
Code: **AMH**
Description: **Manhole**

Distance (ft): **146.2**
Structural Grade: **0**
O&M Grade: **0**
Clock Start/From:
Clock To:
1st Value:
2nd Value:
Value Percent:
Continuous Index:
Within 8" of Joint: **NO**
Remarks: **M-108-015**

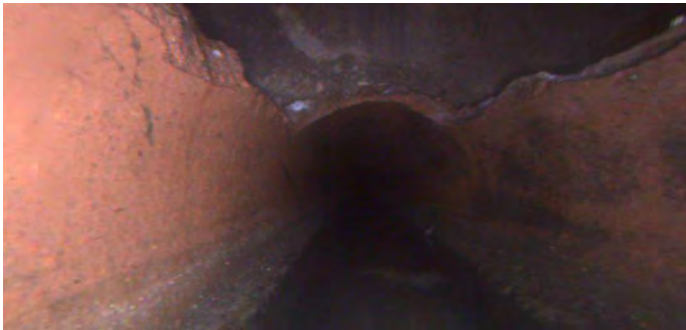
Code: **DAGS**
Description: **Deposits Attached Grease**

Distance (ft): **146.2**
Structural Grade: **0**
O&M Grade: **2**
Clock Start/From: **7**
Clock To: **5**
1st Value:
2nd Value:
Value Percent: **5.000**
Continuous Index: **F01**
Within 8" of Joint: **YES**
Remarks: **WANDER**
