## Profile/Photo Observation Report

Date:	<b>10/23/2021</b>	Weather:		Coding:	<b>PACP 6.0</b>
Pipe Length (ft):		Owner:	<b>Hobart, IN</b>	Pre Clean:	<b>Not Known</b>
P.O.#:	<b>993_1</b>	Surveyor:	<b>M. Pielacha</b>	PSR:	<b>P-108-025-026</b>
Customer:	<b>Hobart, IN</b>	Clean Date:		Shape:	<b>C</b>

Street:	<b>Off Swift Street</b>	Flow Control:	
City:	<b>Hobart, IN</b>	Year Renewed:	
Location:	<b>Yard</b>	Tape/Media #:	<b>993</b>
Purpose:	<b>Routine Assessment</b>	Dia/Height:	<b>10"</b>
Use:	<b>Sanitary</b>	Material:	<b>VCP</b>
Drain Area:		Lining:	
Category:	<b>NA</b>		
Comment:

Location Details:		Direction of Survey:	<b>Upstream</b>
US MH:	<b>M-108-26</b>	DS MH:	<b>M-108-25</b>
		Total Length Surveyed (ft):	<b>231.5</b>

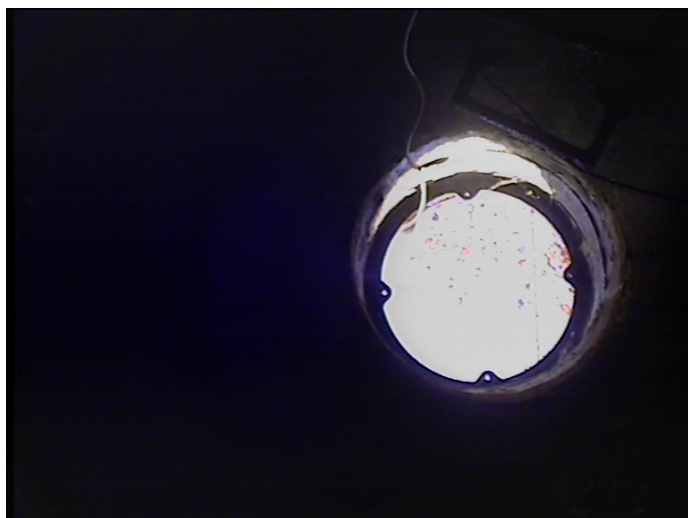
Code: **AMH**  
Description: **Manhole**

Distance (ft): **.0**  
Structural Grade: **0**  
O&M Grade: **0**  
Clock Start/From:  
Clock To:  
1st Value:  
2nd Value:  
Value Percent:  
Continuous Index:  
Within 8" of Joint: **NO**  
Remarks: **M-108-25**

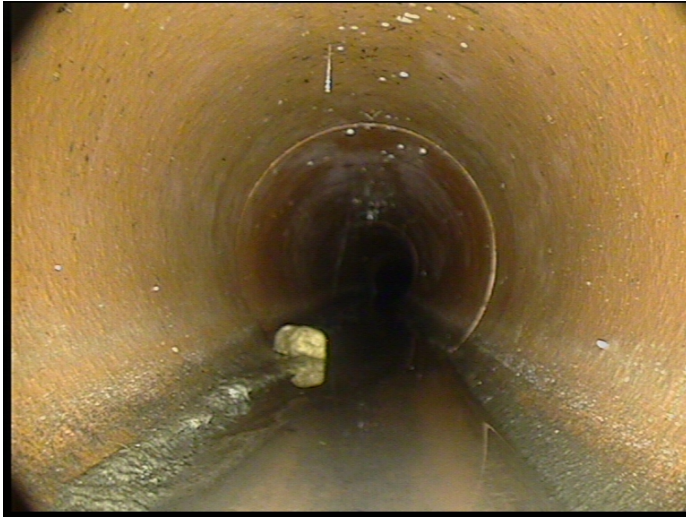
Code: **MWL**  
Description: **Water Level**

Distance (ft): **.0**  
Structural Grade: **0**  
O&M Grade: **0**  
Clock Start/From:  
Clock To:  
1st Value:  
2nd Value:  
Value Percent: **5.000**  
Continuous Index:  
Within 8" of Joint: **NO**  
Remarks:

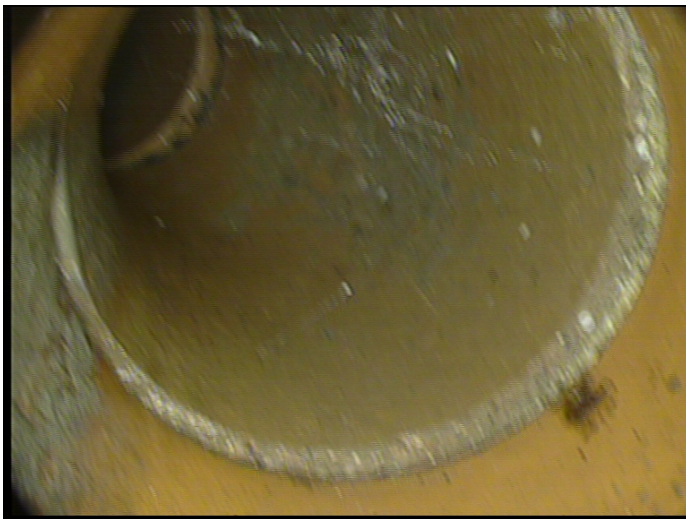
Code: **TF**  
Description: **Tap Factory**

Distance (ft): **16.1**  
Structural Grade: **0**  
O&M Grade: **0**  
Clock Start/From: **10**  
Clock To:  
1st Value: **4.000**  
2nd Value:  
Value Percent:  
Continuous Index:  
Within 8" of Joint: **NO**  
Remarks:

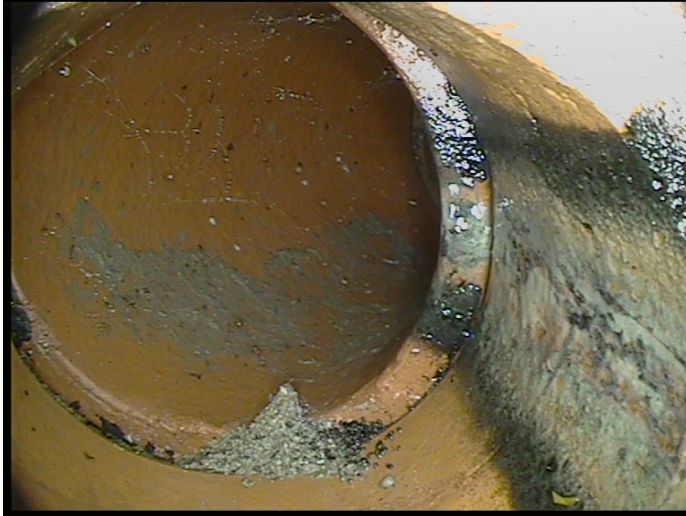
Code: **TF**  
Description: **Tap Factory**

Distance (ft): **17.6**  
Structural Grade: **0**  
O&M Grade: **0**  
Clock Start/From: **2**  
Clock To:  
1st Value: **4.000**  
2nd Value:  
Value Percent:  
Continuous Index:  
Within 8" of Joint: **NO**  
Remarks:

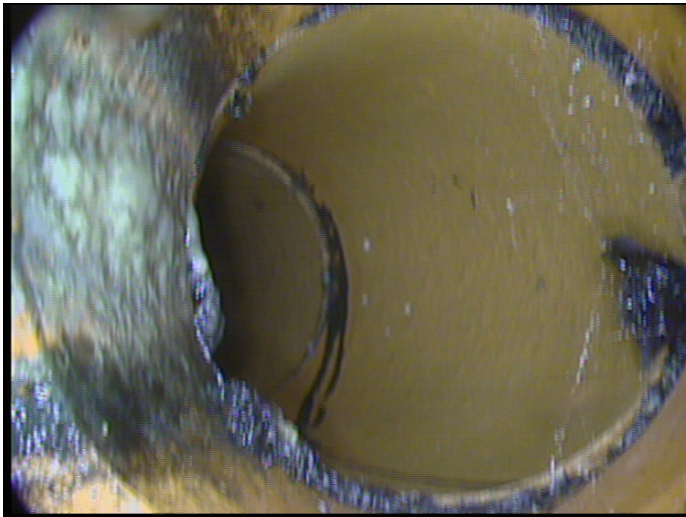
Code: **TF**  
Description: **Tap Factory**

Distance (ft): **100.4**  
Structural Grade: **0**  
O&M Grade: **0**  
Clock Start/From: **10**  
Clock To:  
1st Value: **4.000**  
2nd Value:  
Value Percent:  
Continuous Index:  
Within 8" of Joint: **NO**  
Remarks:

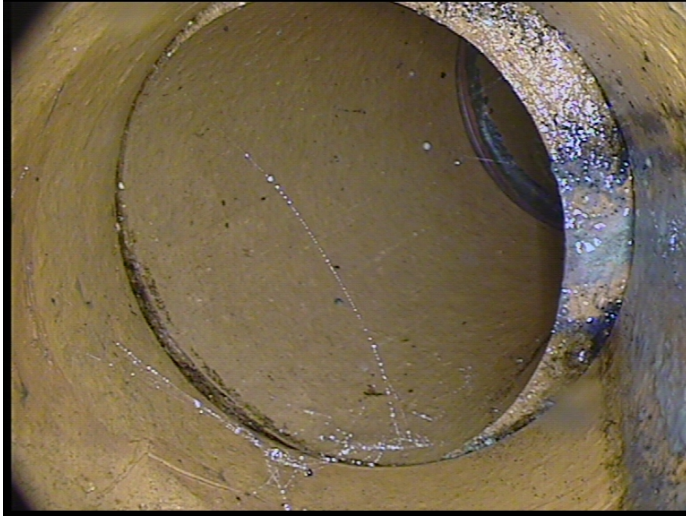
Code: **TF**  
Description: **Tap Factory**

Distance (ft): **102.0**  
Structural Grade: **0**  
O&M Grade: **0**  
Clock Start/From: **2**  
Clock To:  
1st Value: **4.000**  
2nd Value:  
Value Percent:  
Continuous Index:  
Within 8" of Joint: **NO**  
Remarks:

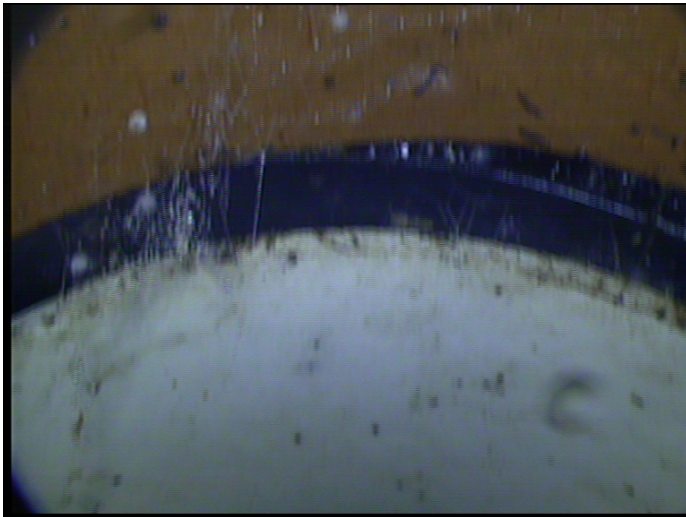
Code: **MMC**  
Description: **Material Change**

Distance (ft): **130.7**  
Structural Grade: **0**  
O&M Grade: **0**  
Clock Start/From:  
Clock To:  
1st Value:  
2nd Value:  
Value Percent:  
Continuous Index:  
Within 8" of Joint: **NO**  
Remarks: **pvc**

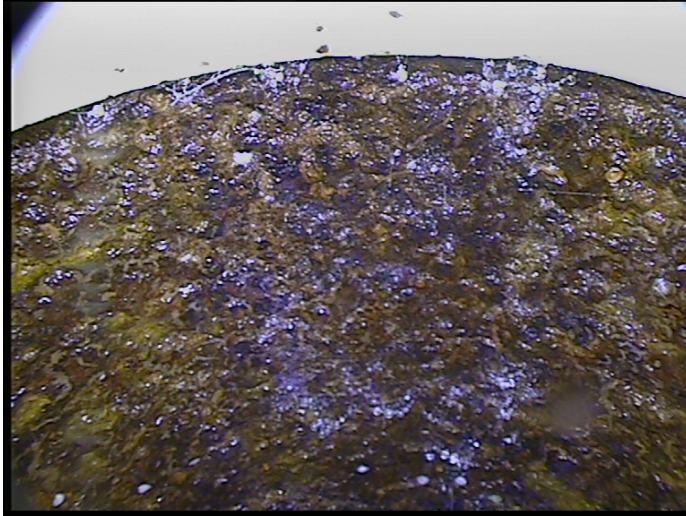
Code: **MMC**  
Description: **Material Change**

Distance (ft): **137.9**  
Structural Grade: **0**  
O&M Grade: **0**  
Clock Start/From:  
Clock To:  
1st Value:  
2nd Value:  
Value Percent:  
Continuous Index:  
Within 8" of Joint: **NO**  
Remarks: **cast iron**

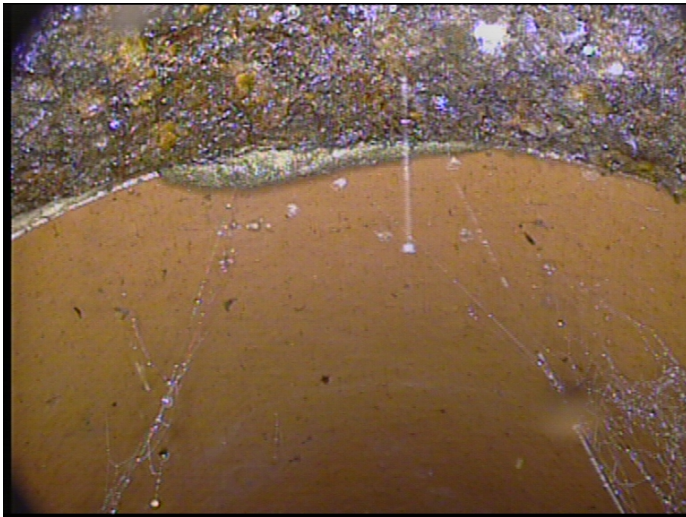
Code: **MMC**  
Description: **Material Change**

Distance (ft): **145.3**  
Structural Grade: **0**  
O&M Grade: **0**  
Clock Start/From:  
Clock To:  
1st Value:  
2nd Value:  
Value Percent:  
Continuous Index:  
Within 8" of Joint: **NO**  
Remarks: **vcp**

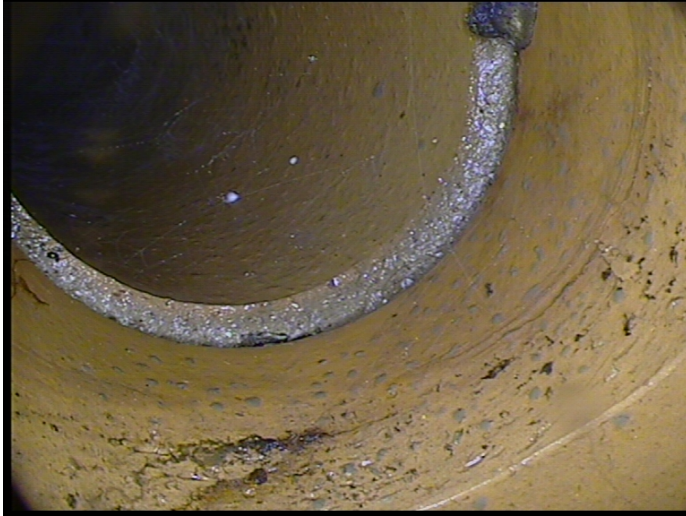
Code: **TF**  
Description: **Tap Factory**

Distance (ft): **167.6**  
Structural Grade: **0**  
O&M Grade: **0**  
Clock Start/From: **10**  
Clock To:  
1st Value: **4.000**  
2nd Value:  
Value Percent:  
Continuous Index:  
Within 8" of Joint: **NO**  
Remarks:

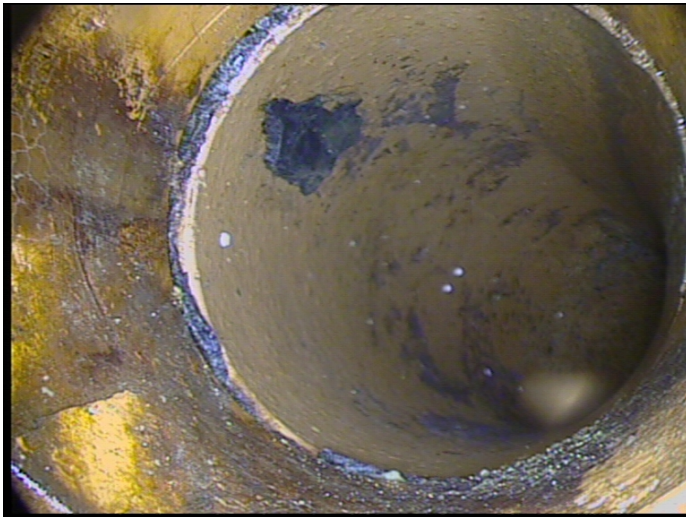
Code: **TF**  
Description: **Tap Factory**

Distance (ft): **171.3**  
Structural Grade: **0**  
O&M Grade: **0**  
Clock Start/From: **3**  
Clock To:  
1st Value: **4.000**  
2nd Value:  
Value Percent:  
Continuous Index:  
Within 8" of Joint: **NO**  
Remarks:

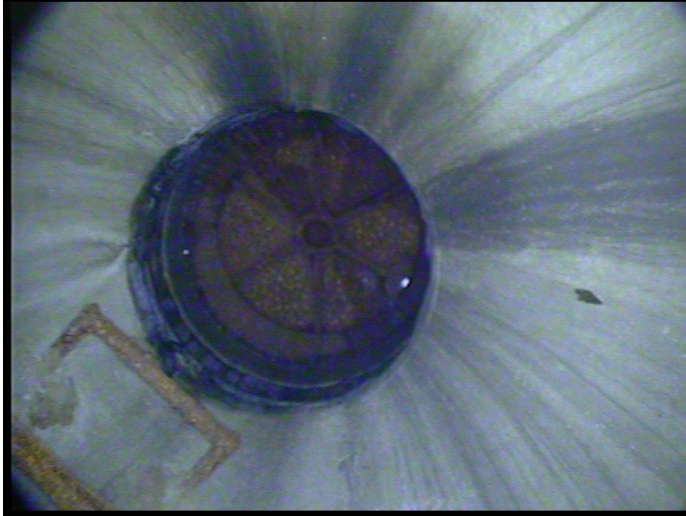
Code:	<b>AMH</b>
Description:	<b>Manhole</b>
Distance (ft):	<b>231.5</b>
Structural Grade:	<b>0</b>
O&M Grade:	<b>0</b>
Clock Start/From:	
Clock To:	
1st Value:	
2nd Value:	
Value Percent:	
Continuous Index:	
Within 8" of Joint:	<b>NO</b>
Remarks:	<b>M-108-26</b>
