Profile/Photo Observation Report

Street:	14TH LN & ALABMA ST	Flow Control:	Not Controlled
City:	Hobart, IN	Year Renewed:	
Location:	Light Highway	Tape/Media #:	
Purpose:	Routine Assessment	Dia/Height:	12"
Use:	Sanitary	Material:	VCP
Drain Area:	NA	Lining:	
Category:	NA		
Comment:	Flow direction wrong

Location Details:		Direction of Survey:	Upstream
US MH:	M-108-027	DS MH:	M-108-017
		Total Length Surveyed (ft):	167.8

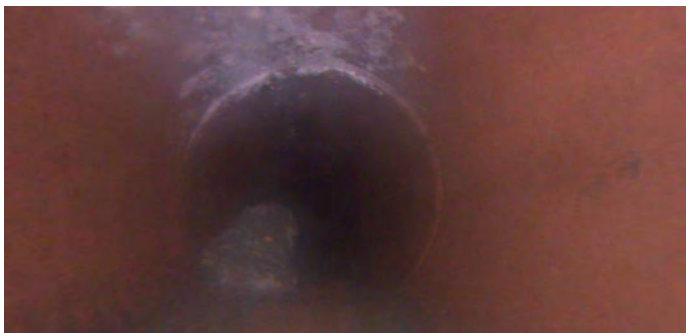
Code: **AMH**
Description: **Manhole**

Distance (ft): **.0**
Structural Grade: **0**
O&M Grade: **0**
Clock Start/From:
Clock To:
1st Value:
2nd Value:
Value Percent:
Continuous Index:
Within 8" of Joint: **NO**
Remarks: **M-108-017**

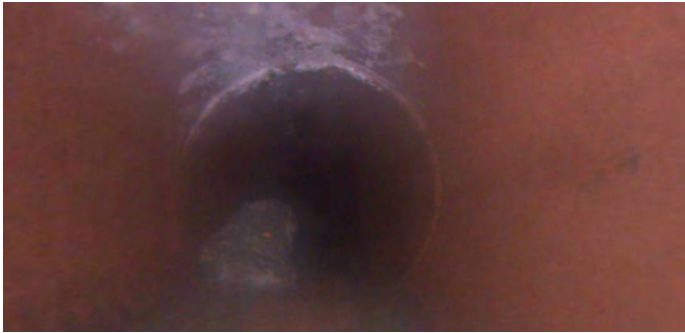
Code:	MWL
Description:	Water Level

Distance (ft):	.0
Structural Grade:	0
O&M Grade:	0
Clock Start/From:	
Clock To:	
1st Value:	
2nd Value:	
Value Percent:	5.000
Continuous Index:	
Within 8" of Joint:	NO
Remarks:

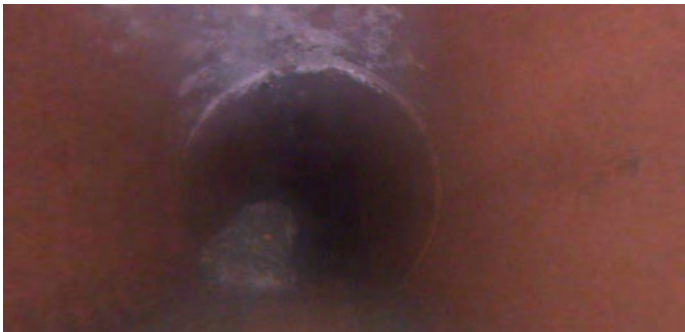
Code:	DAGS
Description:	Deposits Attached Grease

Distance (ft):	.0
Structural Grade:	0
O&M Grade:	2
Clock Start/From:	7
Clock To:	5
1st Value:	
2nd Value:	
Value Percent:	5.000
Continuous Index:	S01
Within 8" of Joint:	YES
Remarks:	WANDER

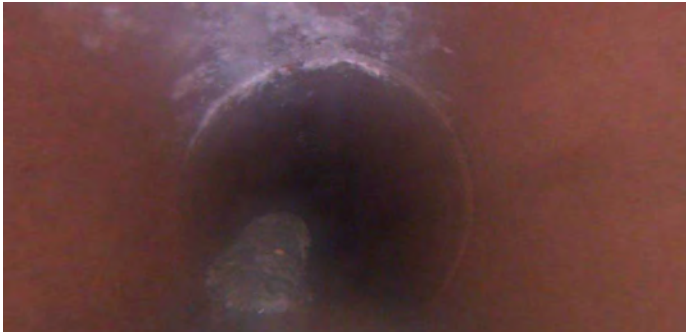
Code: **DSC**
Description: **Deposits Settled Compacted**

Distance (ft): **.3**
Structural Grade: **0**
O&M Grade: **2**
Clock Start/From: **6**
Clock To: **7**
1st Value:
2nd Value:
Value Percent: **5.000**
Continuous Index:
Within 8" of Joint: **YES**
Remarks:

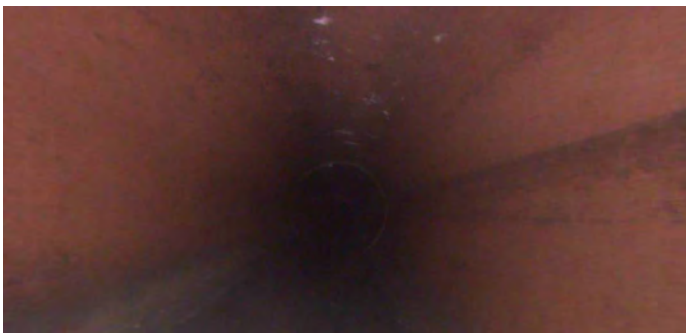
Code: **DAZ**
Description: **Deposits Attached Other**

Distance (ft): **9.1**
Structural Grade: **0**
O&M Grade: **2**
Clock Start/From: **7**
Clock To: **5**
1st Value:
2nd Value:
Value Percent: **5.000**
Continuous Index: **S02**
Within 8" of Joint: **YES**
Remarks: **WANDER**

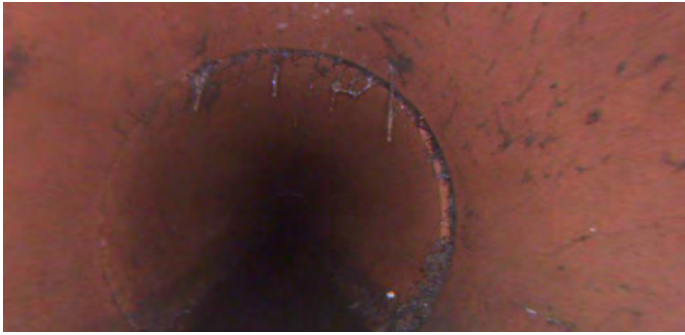
Code: **RFJ**
Description: **Roots Fine Joint**

Distance (ft): **66.0**
Structural Grade: **0**
O&M Grade: **1**
Clock Start/From: **11**
Clock To: **5**
1st Value:
2nd Value:
Value Percent:
Continuous Index:
Within 8" of Joint: **YES**
Remarks:

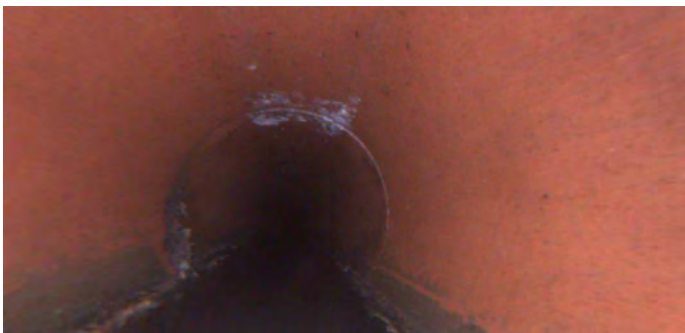
Code: **RFJ**
Description: **Roots Fine Joint**

Distance (ft): **70.6**
Structural Grade: **0**
O&M Grade: **1**
Clock Start/From: **7**
Clock To: **5**
1st Value:
2nd Value:
Value Percent:
Continuous Index: **S03**
Within 8" of Joint: **YES**
Remarks: **WANDER**

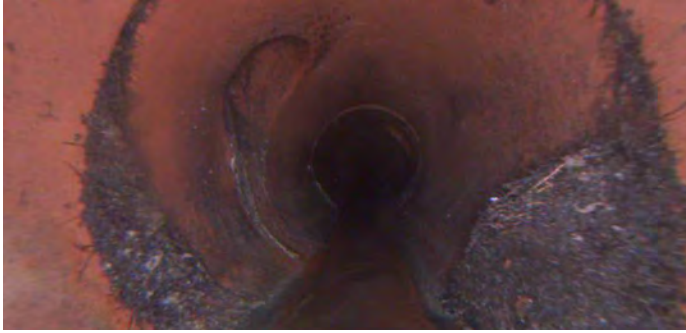
Code: **RMJ**
Description: **Roots Medium Joint**

Distance (ft): **121.6**
Structural Grade: **0**
O&M Grade: **3**
Clock Start/From: **7**
Clock To: **5**
1st Value:
2nd Value:
Value Percent: **15.000**
Continuous Index:
Within 8" of Joint: **YES**
Remarks:

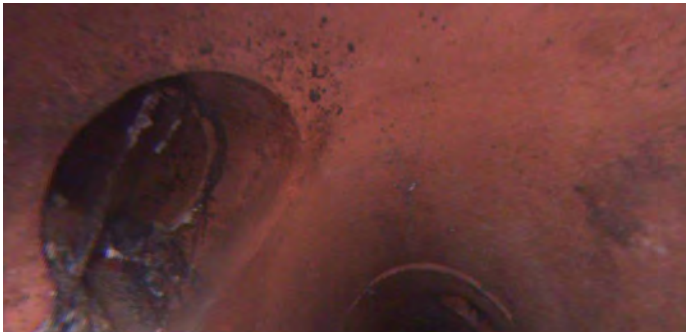
Code: **TF**
Description: **Tap Factory**

Distance (ft): **122.4**
Structural Grade: **0**
O&M Grade: **0**
Clock Start/From: **10**
Clock To:
1st Value: **4.000**
2nd Value:
Value Percent:
Continuous Index:
Within 8" of Joint:
Remarks:

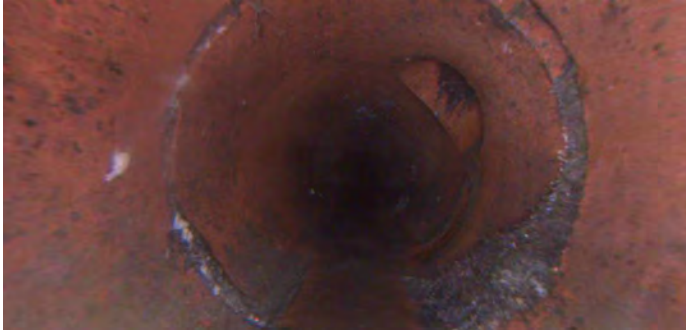
Code: **RMJ**
Description: **Roots Medium Joint**

Distance (ft): **123.5**
Structural Grade: **0**
O&M Grade: **3**
Clock Start/From: **8**
Clock To: **4**
1st Value:
2nd Value:
Value Percent: **5.000**
Continuous Index:
Within 8" of Joint: **YES**
Remarks:

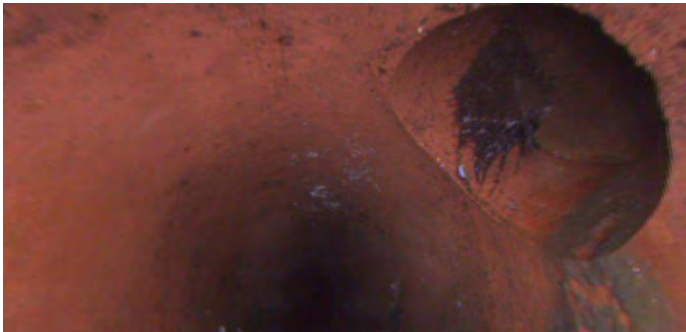
Code: **TF**
Description: **Tap Factory**

Distance (ft): **124.4**
Structural Grade: **0**
O&M Grade: **0**
Clock Start/From: **2**
Clock To:
1st Value: **4.000**
2nd Value:
Value Percent:
Continuous Index:
Within 8" of Joint:
Remarks:

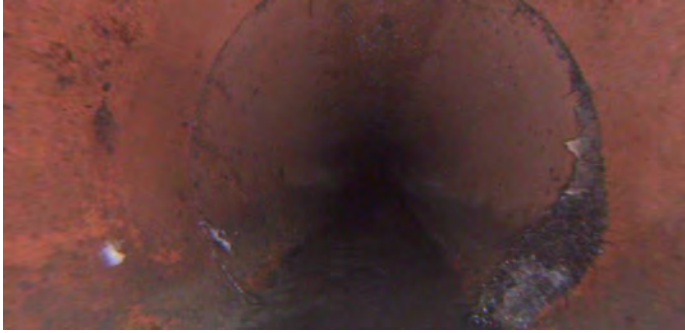
Code: **RMJ**
Description: **Roots Medium Joint**

Distance (ft): **125.6**
Structural Grade: **0**
O&M Grade: **3**
Clock Start/From: **8**
Clock To: **4**
1st Value:
2nd Value:
Value Percent: **5.000**
Continuous Index:
Within 8" of Joint: **YES**
Remarks:

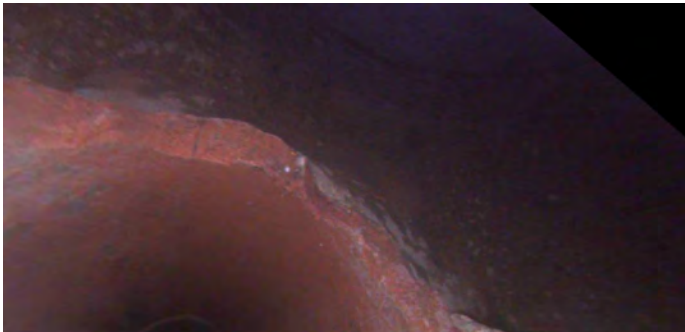
Code: **AMH**
Description: **Manhole**

Distance (ft): **167.8**
Structural Grade: **0**
O&M Grade: **0**
Clock Start/From:
Clock To:
1st Value:
2nd Value:
Value Percent:
Continuous Index:
Within 8" of Joint: **NO**
Remarks: **M-108-027**

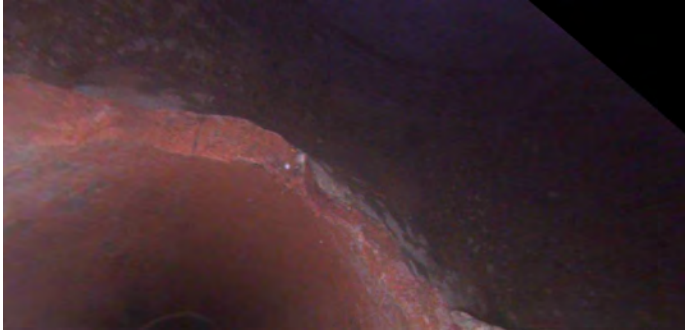
Code: **RFJ**
Description: **Roots Fine Joint**

Distance (ft): **167.8**
Structural Grade: **0**
O&M Grade: **1**
Clock Start/From: **7**
Clock To: **5**
1st Value:
2nd Value:
Value Percent:
Continuous Index: **F03**
Within 8" of Joint: **YES**
Remarks: **WANDER**

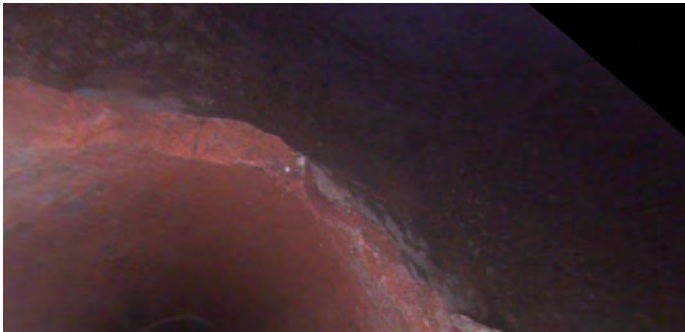
Code: **DAZ**
Description: **Deposits Attached Other**

Distance (ft): **167.8**
Structural Grade: **0**
O&M Grade: **2**
Clock Start/From: **7**
Clock To: **5**
1st Value:
2nd Value:
Value Percent: **5.000**
Continuous Index: **F02**
Within 8" of Joint: **YES**
Remarks: **WANDER**

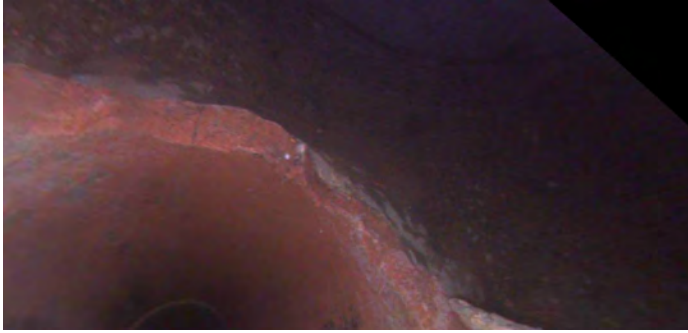
Code:	DAGS
Description:	Deposits Attached Grease
Distance (ft):	167.8
Structural Grade:	0
O&M Grade:	2
Clock Start/From:	7
Clock To:	5
1st Value:	
2nd Value:	
Value Percent:	5.000
Continuous Index:	F01
Within 8" of Joint:	YES
Remarks:	WANDER
