## Profile/Photo Observation Report

Street:	<b>FOXCROFT STREET</b>	Flow Control:	<b>Not Controlled</b>
City:	<b>Hobart, IN</b>	Year Renewed:	
Location:	<b>Light Highway</b>	Tape/Media #:	
Purpose:	<b>Routine Assessment</b>	Dia/Height:	<b>12"</b>
Use:	<b>Sanitary</b>	Material:	<b>VCP</b>
Drain Area:	<b>NA</b>	Lining:	
Category:	<b>NA</b>		
Comment:	<b>Flow direction wrong</b>

Location Details:		Direction of Survey:	<b>Upstream</b>
US MH:	<b>M-108-027</b>	DS MH:	<b>M-108-017</b>
		Total Length Surveyed (ft):	<b>167.8</b>

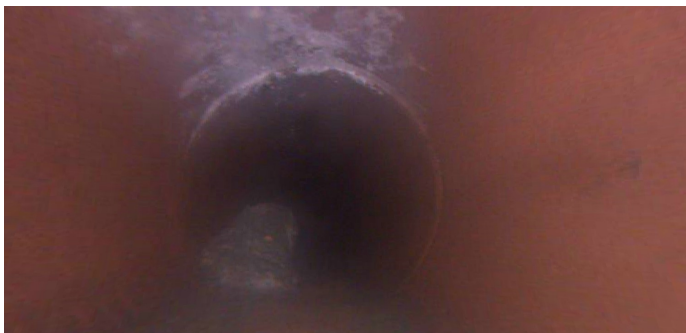
Code: **AMH**  
Description: **Manhole**

Distance (ft): **.0**  
Structural Grade: **0**  
O&M Grade: **0**  
Clock Start/From:  
Clock To:  
1st Value:  
2nd Value:  
Value Percent:  
Continuous Index:  
Within 8" of Joint: **NO**  
Remarks: **M-108-017**

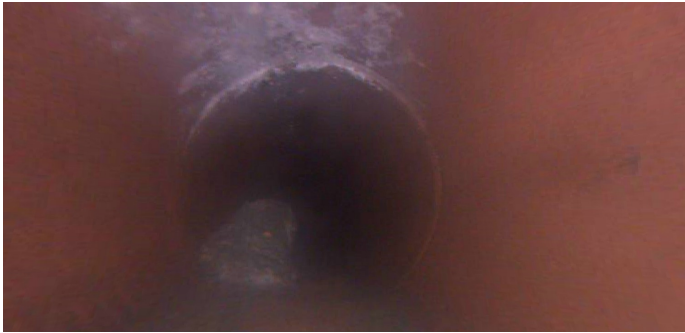
Code:	<b>MWL</b>
Description:	<b>Water Level</b>

Distance (ft):	<b>.0</b>
Structural Grade:	<b>0</b>
O&M Grade:	<b>0</b>
Clock Start/From:	
Clock To:	
1st Value:	
2nd Value:	
Value Percent:	<b>5.000</b>
Continuous Index:	
Within 8" of Joint:	<b>NO</b>
Remarks:

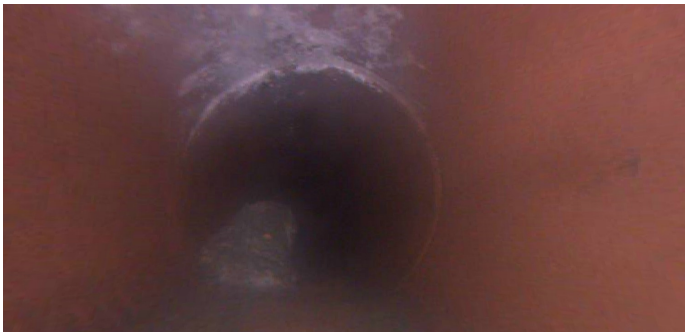
Code:	<b>DAGS</b>
Description:	<b>Deposits Attached Grease</b>

Distance (ft):	<b>.0</b>
Structural Grade:	<b>0</b>
O&M Grade:	<b>2</b>
Clock Start/From:	<b>7</b>
Clock To:	<b>5</b>
1st Value:	
2nd Value:	
Value Percent:	<b>5.000</b>
Continuous Index:	<b>S01</b>
Within 8" of Joint:	<b>YES</b>
Remarks:	<b>WANDER</b>

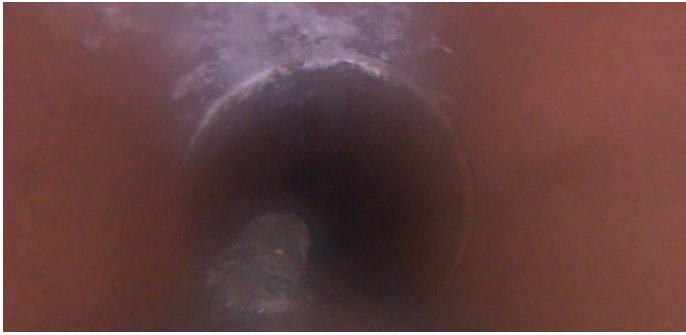
Code: **DSC**  
Description: **Deposits Settled Compacted**

Distance (ft): **.3**  
Structural Grade: **0**  
O&M Grade: **2**  
Clock Start/From: **6**  
Clock To: **7**  
1st Value:  
2nd Value:  
Value Percent: **5.000**  
Continuous Index:  
Within 8" of Joint: **YES**  
Remarks:

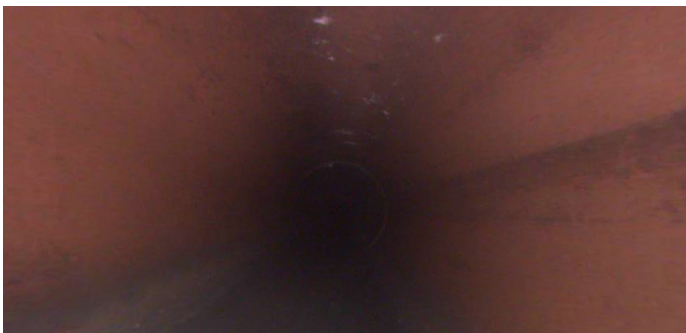
Code: **DAZ**  
Description: **Deposits Attached Other**

Distance (ft): **9.1**  
Structural Grade: **0**  
O&M Grade: **2**  
Clock Start/From: **7**  
Clock To: **5**  
1st Value:  
2nd Value:  
Value Percent: **5.000**  
Continuous Index: **S02**  
Within 8" of Joint: **YES**  
Remarks: **WANDER**

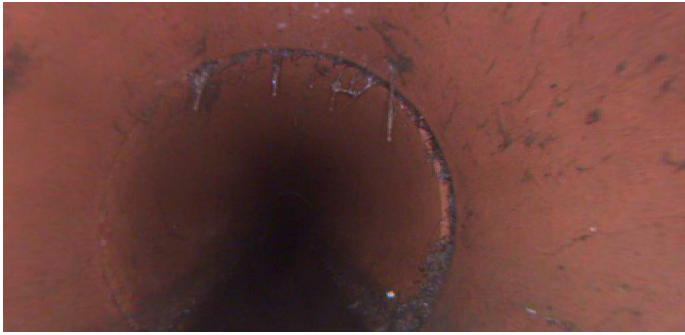
Code: **RFJ**  
Description: **Roots Fine Joint**

Distance (ft): **66.0**  
Structural Grade: **0**  
O&M Grade: **1**  
Clock Start/From: **11**  
Clock To: **5**  
1st Value:  
2nd Value:  
Value Percent:  
Continuous Index:  
Within 8" of Joint: **YES**  
Remarks:

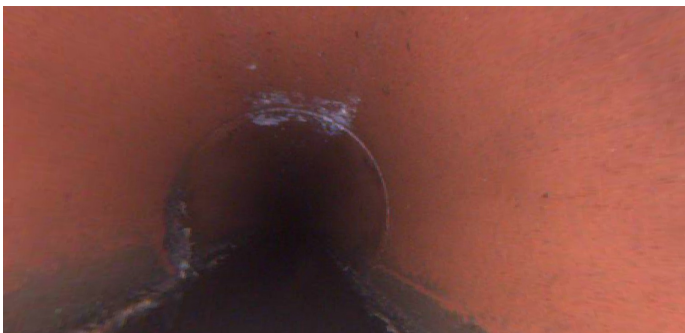
Code: **RFJ**  
Description: **Roots Fine Joint**

Distance (ft): **70.6**  
Structural Grade: **0**  
O&M Grade: **1**  
Clock Start/From: **7**  
Clock To: **5**  
1st Value:  
2nd Value:  
Value Percent:  
Continuous Index: **S03**  
Within 8" of Joint: **YES**  
Remarks: **WANDER**

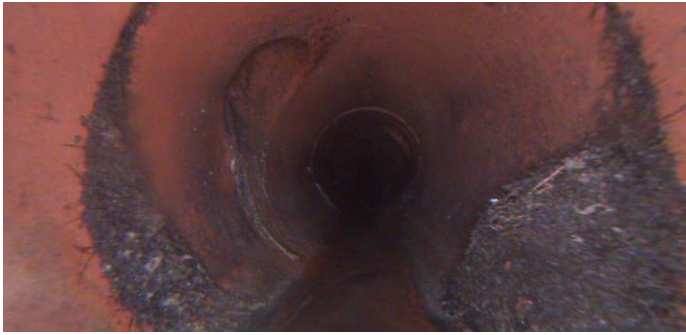
Code: **RMJ**  
Description: **Roots Medium Joint**

Distance (ft): **121.6**  
Structural Grade: **0**  
O&M Grade: **3**  
Clock Start/From: **7**  
Clock To: **5**  
1st Value:  
2nd Value:  
Value Percent: **15.000**  
Continuous Index:  
Within 8" of Joint: **YES**  
Remarks:

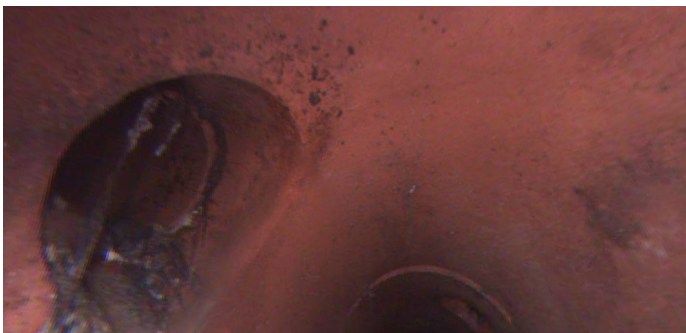
Code: **TF**  
Description: **Tap Factory**

Distance (ft): **122.4**  
Structural Grade: **0**  
O&M Grade: **0**  
Clock Start/From: **10**  
Clock To:  
1st Value: **4.000**  
2nd Value:  
Value Percent:  
Continuous Index:  
Within 8" of Joint:  
Remarks:

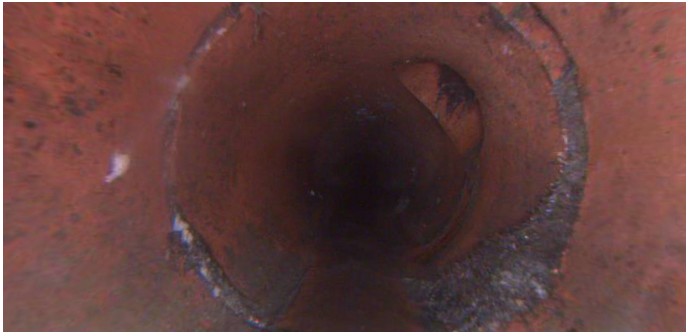
Code: **RMJ**  
Description: **Roots Medium Joint**

Distance (ft): **123.5**  
Structural Grade: **0**  
O&M Grade: **3**  
Clock Start/From: **8**  
Clock To: **4**  
1st Value:  
2nd Value:  
Value Percent: **5.000**  
Continuous Index:  
Within 8" of Joint: **YES**  
Remarks:

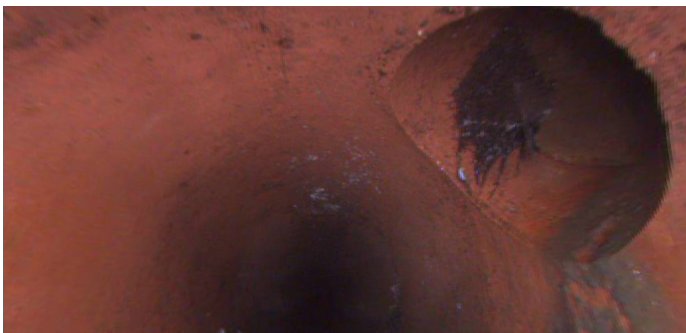
Code: **TF**  
Description: **Tap Factory**

Distance (ft): **124.4**  
Structural Grade: **0**  
O&M Grade: **0**  
Clock Start/From: **2**  
Clock To:  
1st Value: **4.000**  
2nd Value:  
Value Percent:  
Continuous Index:  
Within 8" of Joint:  
Remarks:

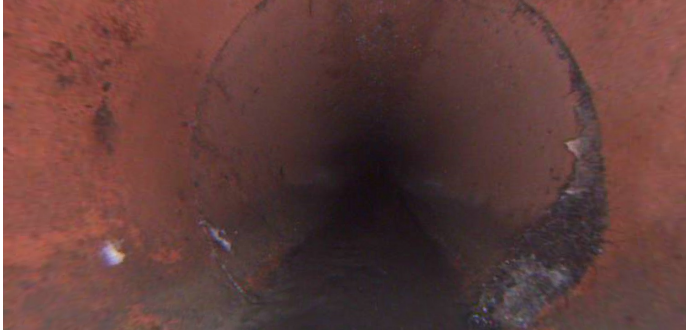
Code: **RMJ**  
Description: **Roots Medium Joint**

Distance (ft): **125.6**  
Structural Grade: **0**  
O&M Grade: **3**  
Clock Start/From: **8**  
Clock To: **4**  
1st Value:  
2nd Value:  
Value Percent: **5.000**  
Continuous Index:  
Within 8" of Joint: **YES**  
Remarks:

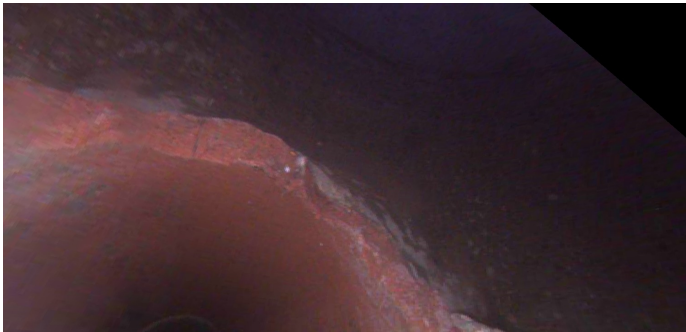
Code: **AMH**  
Description: **Manhole**

Distance (ft): **167.8**  
Structural Grade: **0**  
O&M Grade: **0**  
Clock Start/From:  
Clock To:  
1st Value:  
2nd Value:  
Value Percent:  
Continuous Index:  
Within 8" of Joint: **NO**  
Remarks: **M-108-027**

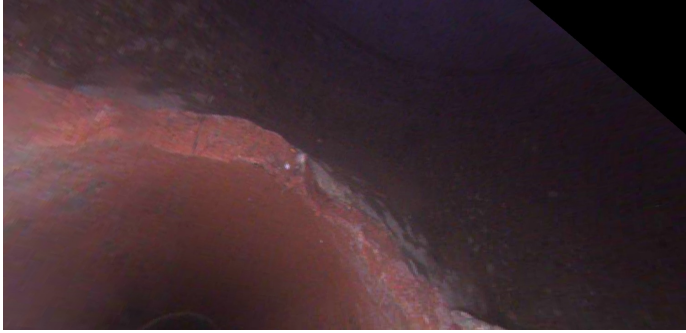
Code: **RFJ**  
Description: **Roots Fine Joint**

Distance (ft): **167.8**  
Structural Grade: **0**  
O&M Grade: **1**  
Clock Start/From: **7**  
Clock To: **5**  
1st Value:  
2nd Value:  
Value Percent:  
Continuous Index: **F03**  
Within 8" of Joint: **YES**  
Remarks: **WANDER**

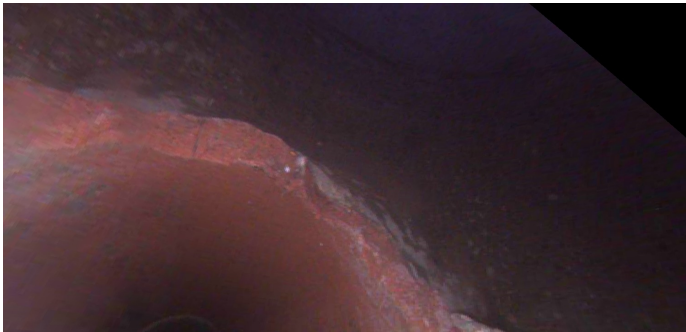
Code: **DAZ**  
Description: **Deposits Attached Other**

Distance (ft): **167.8**  
Structural Grade: **0**  
O&M Grade: **2**  
Clock Start/From: **7**  
Clock To: **5**  
1st Value:  
2nd Value:  
Value Percent: **5.000**  
Continuous Index: **F02**  
Within 8" of Joint: **YES**  
Remarks: **WANDER**

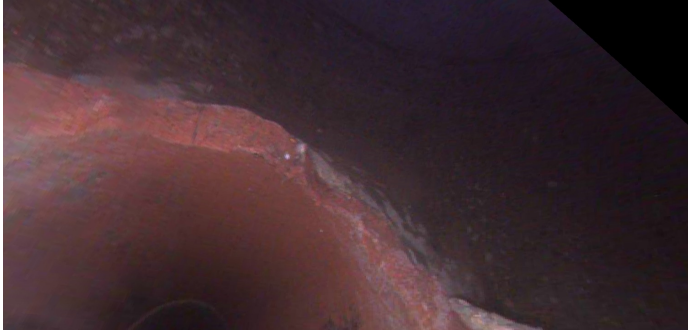
Code:	<b>DAGS</b>
Description:	<b>Deposits Attached Grease</b>
Distance (ft):	<b>167.8</b>
Structural Grade:	<b>0</b>
O&M Grade:	<b>2</b>
Clock Start/From:	<b>7</b>
Clock To:	<b>5</b>
1st Value:	
2nd Value:	
Value Percent:	<b>5.000</b>
Continuous Index:	<b>F01</b>
Within 8" of Joint:	<b>YES</b>
Remarks:	<b>WANDER</b>
