## Profile/Photo Observation Report

Date:	<b>03/24/2018</b>	Weather:		Coding:	<b>PACP 6.0</b>
Pipe Length (ft):	<b>229.1</b>	Owner:	<b>NA</b>	Pre Clean:	<b>No Pre-Cleaning</b>
P.O.#:		Surveyor:	<b>Justin Gonzales</b>	PSR:	<b>P-108-026-027</b>
Customer:		Clean Date:	<b>01/01/1900</b>	Shape:	<b>C</b>

Street:	<b>FOXCROFT STREET</b>	Flow Control:	<b>Not Controlled</b>
City:	<b>Hobart, IN</b>	Year Renewed:	
Location:	<b>Light Highway</b>	Tape/Media #:	
Purpose:	<b>Routine Assessment</b>	Dia/Height:	<b>10"</b>
Use:	<b>Sanitary</b>	Material:	<b>VCP</b>
Drain Area:	<b>NA</b>	Lining:	
Category:	<b>NA</b>		
Comment:	<b>Flow direction wrong</b>		
Location Details:		Direction of Survey:	<b>Downstream</b>
US MH:	<b>M-108-027</b>	DS MH:	<b>M-108-026</b>
		Total Length Surveyed (ft):	<b>241.4</b>

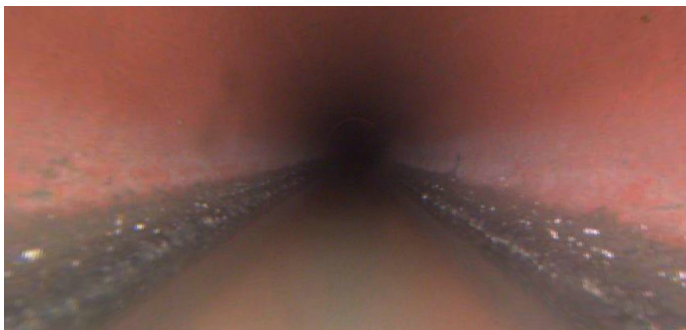
Code: **AMH**  
Description: **Manhole**

Distance (ft): **.0**  
Structural Grade: **0**  
O&M Grade: **0**  
Clock Start/From:  
Clock To:  
1st Value:  
2nd Value:  
Value Percent:  
Continuous Index:  
Within 8" of Joint: **NO**  
Remarks: **M-108-027**

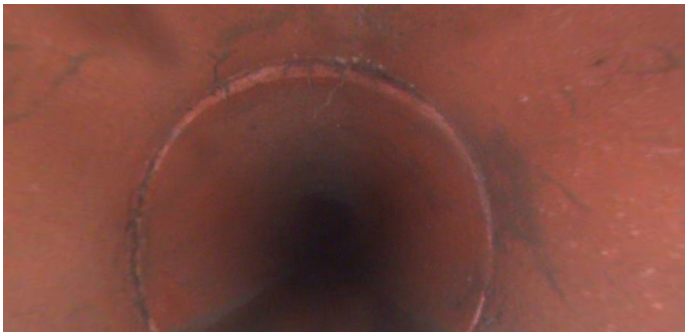
Code:	<b>RFJ</b>
Description:	<b>Roots Fine Joint</b>

Distance (ft):	<b>77.4</b>
Structural Grade:	<b>0</b>
O&M Grade:	<b>1</b>
Clock Start/From:	<b>8</b>
Clock To:	<b>4</b>
1st Value:	
2nd Value:	
Value Percent:	
Continuous Index:	
Within 8" of Joint:	<b>YES</b>
Remarks:

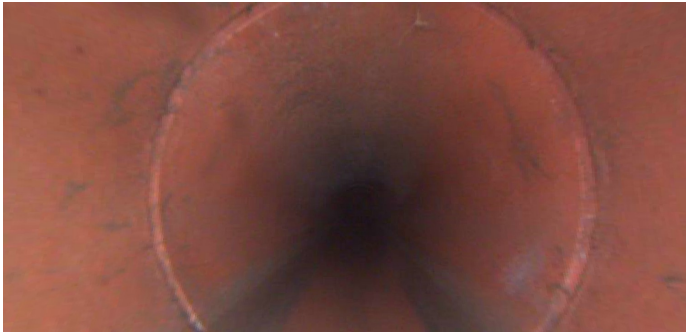
Code: **DAGS**  
Description: **Deposits Attached Grease**

Distance (ft): **82.9**  
Structural Grade: **0**  
O&M Grade: **2**  
Clock Start/From: **10**  
Clock To: **2**  
1st Value:  
2nd Value:  
Value Percent: **5.000**  
Continuous Index:  
Within 8" of Joint: **YES**  
Remarks:

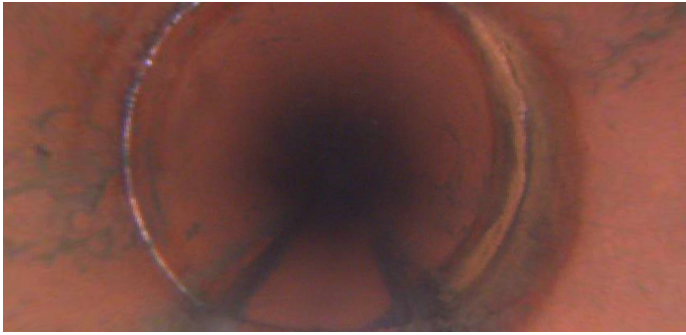
Code: **IS**  
Description: **Infil Stain**

Distance (ft): **140.3**  
Structural Grade: **0**  
O&M Grade: **0**  
Clock Start/From: **9**  
Clock To: **5**  
1st Value:  
2nd Value:  
Value Percent:  
Continuous Index:  
Within 8" of Joint: **YES**  
Remarks:

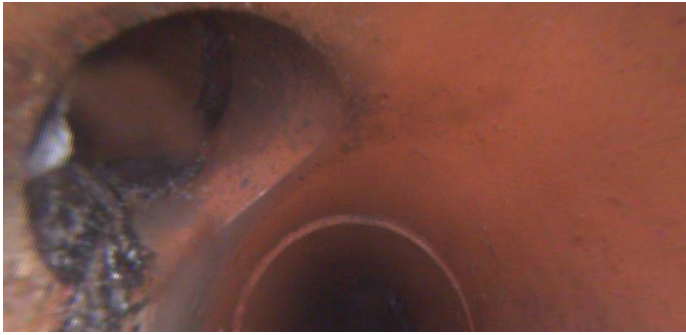
Code: **TF**  
Description: **Tap Factory**

Distance (ft): **163.3**  
Structural Grade: **0**  
O&M Grade: **0**  
Clock Start/From: **10**  
Clock To:  
1st Value: **4.000**  
2nd Value:  
Value Percent:  
Continuous Index:  
Within 8" of Joint:  
Remarks:

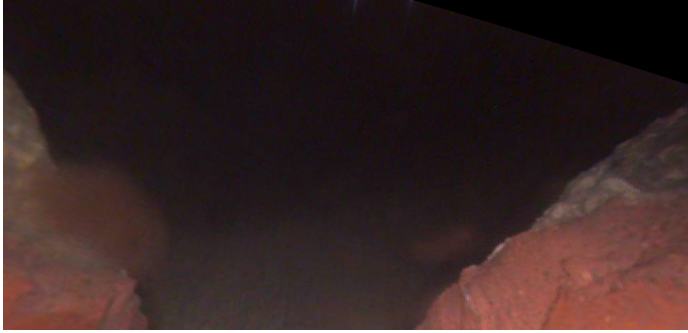
Code:	<b>AMH</b>
Description:	<b>Manhole</b>
Distance (ft):	<b>241.4</b>
Structural Grade:	<b>0</b>
O&M Grade:	<b>0</b>
Clock Start/From:	
Clock To:	
1st Value:	
2nd Value:	
Value Percent:	
Continuous Index:	
Within 8" of Joint:	<b>NO</b>
Remarks:	<b>M-108-026</b>
