Profile/Photo Observation Report

Street:	ALLEY BETWEEN SWIFT ST & MISSIS	Flow Control:	Not Controlled
City:	Hobart, IN	Year Renewed:	
Location:	Light Highway	Tape/Media #:	
Purpose:	Routine Assessment	Dia/Height:	10"
Use:	Sanitary	Material:	VCP
Drain Area:	NA	Lining:	
Category:	NA		
Comment:	R_M at 99 ft debris .Flow direction wrong		
Location Details:		Direction of Survey:	Downstream
US MH:	M-108-029	DS MH:	M-108-031
		Total Length Surveyed (ft):	100.5

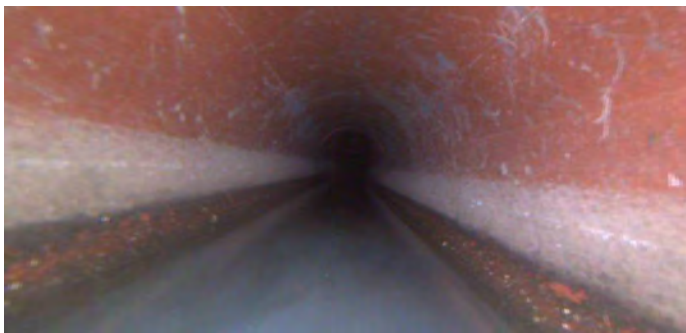
Code: **AMH**
Description: **Manhole**

Distance (ft): **.0**
Structural Grade: **0**
O&M Grade: **0**
Clock Start/From:
Clock To:
1st Value:
2nd Value:
Value Percent:
Continuous Index:
Within 8" of Joint: **NO**
Remarks: **M-108-029**

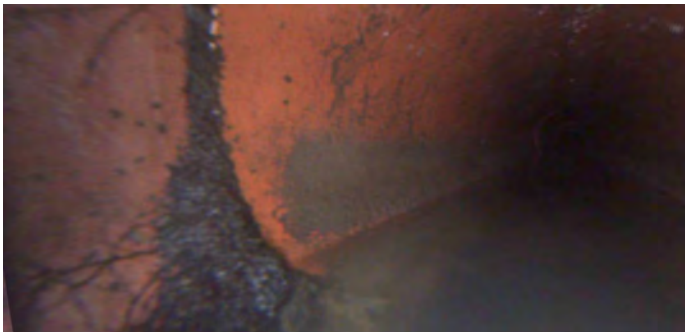
Code:	RFJ
Description:	Roots Fine Joint

Distance (ft):	9.2
Structural Grade:	0
O&M Grade:	1
Clock Start/From:	7
Clock To:	9
1st Value:	
2nd Value:	
Value Percent:	
Continuous Index:	
Within 8" of Joint:	YES
Remarks:

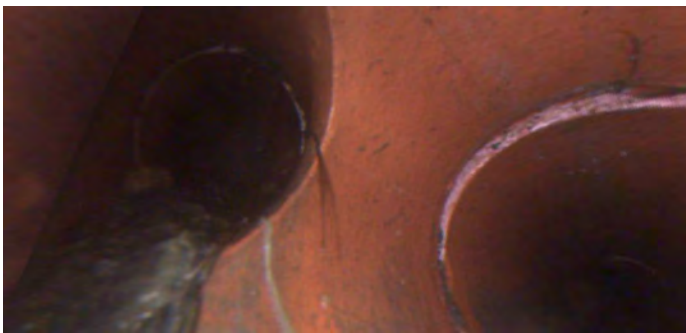
Code: **TF**
Description: **Tap Factory**

Distance (ft): **25.7**
Structural Grade: **0**
O&M Grade: **0**
Clock Start/From: **10**
Clock To:
1st Value: **4.000**
2nd Value:
Value Percent:
Continuous Index:
Within 8" of Joint: **YES**
Remarks:

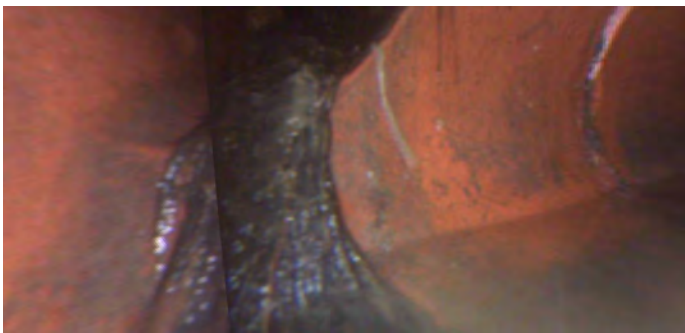
Code: **RML**
Description: **Roots Medium Lateral**

Distance (ft): **25.7**
Structural Grade: **0**
O&M Grade: **3**
Clock Start/From: **8**
Clock To:
1st Value:
2nd Value:
Value Percent: **5.000**
Continuous Index:
Within 8" of Joint: **NO**
Remarks:

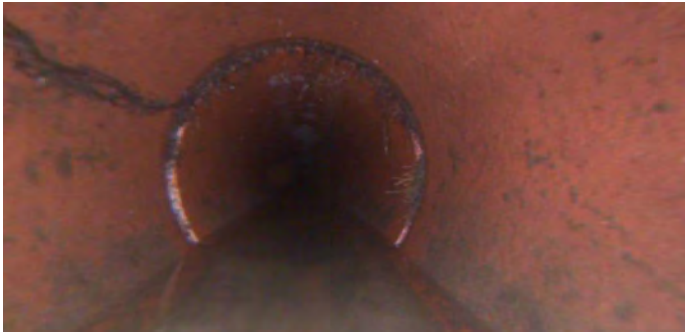
Code: **RFJ**
Description: **Roots Fine Joint**

Distance (ft): **56.2**
Structural Grade: **0**
O&M Grade: **1**
Clock Start/From: **9**
Clock To: **3**
1st Value:
2nd Value:
Value Percent:
Continuous Index: **S01**
Within 8" of Joint: **YES**
Remarks: **wandering**

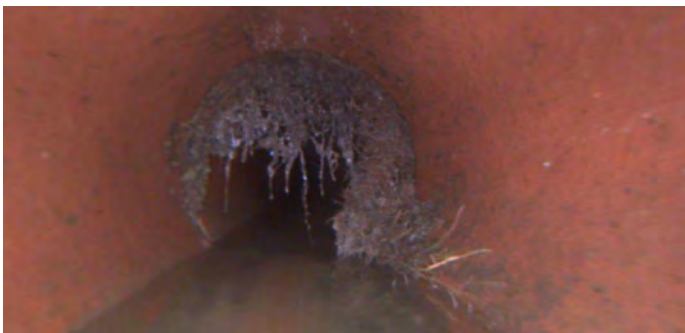
Code: **RMJ**
Description: **Roots Medium Joint**

Distance (ft): **71.8**
Structural Grade: **0**
O&M Grade: **3**
Clock Start/From: **9**
Clock To: **5**
1st Value:
2nd Value:
Value Percent: **10.000**
Continuous Index:
Within 8" of Joint: **YES**
Remarks:

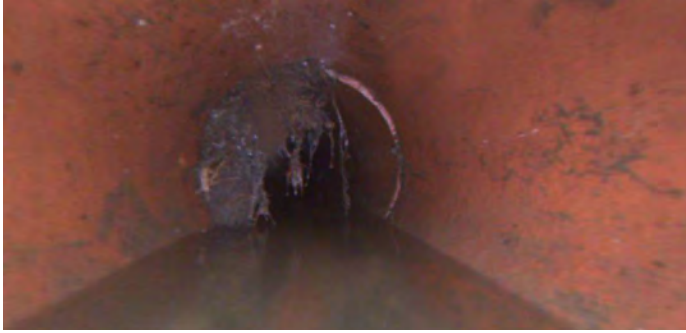
Code: **RMJ**
Description: **Roots Medium Joint**

Distance (ft): **82.0**
Structural Grade: **0**
O&M Grade: **3**
Clock Start/From: **7**
Clock To: **1**
1st Value:
2nd Value:
Value Percent: **10.000**
Continuous Index: **S02**
Within 8" of Joint: **YES**
Remarks: **wandering**

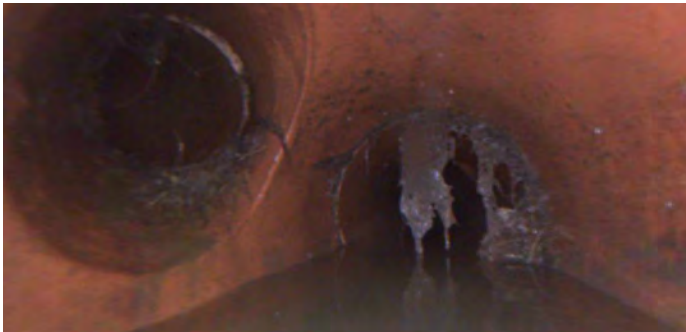
Code: **TF**
Description: **Tap Factory**

Distance (ft): **89.3**
Structural Grade: **0**
O&M Grade: **0**
Clock Start/From: **10**
Clock To:
1st Value: **4.000**
2nd Value:
Value Percent:
Continuous Index:
Within 8" of Joint: **YES**
Remarks:

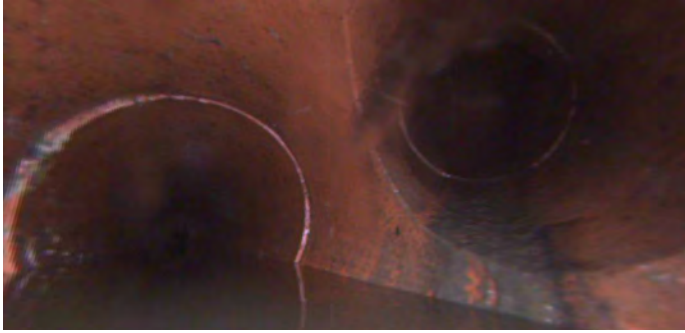
Code: **TF**
Description: **Tap Factory**

Distance (ft): **91.7**
Structural Grade: **0**
O&M Grade: **0**
Clock Start/From: **2**
Clock To:
1st Value: **4.000**
2nd Value:
Value Percent:
Continuous Index:
Within 8" of Joint: **YES**
Remarks:

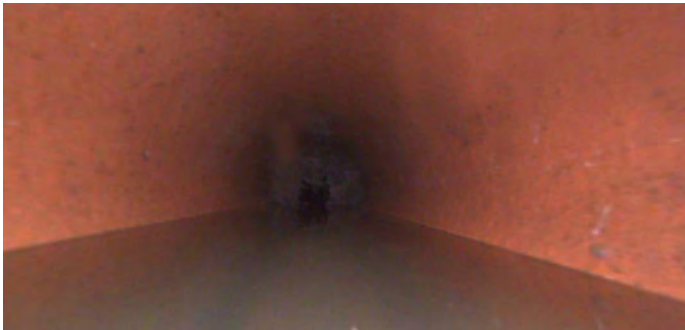
Code: **MWL**
Description: **Water Level**

Distance (ft): **95.0**
Structural Grade: **0**
O&M Grade: **0**
Clock Start/From:
Clock To:
1st Value:
2nd Value:
Value Percent: **25.000**
Continuous Index:
Within 8" of Joint: **NO**
Remarks:

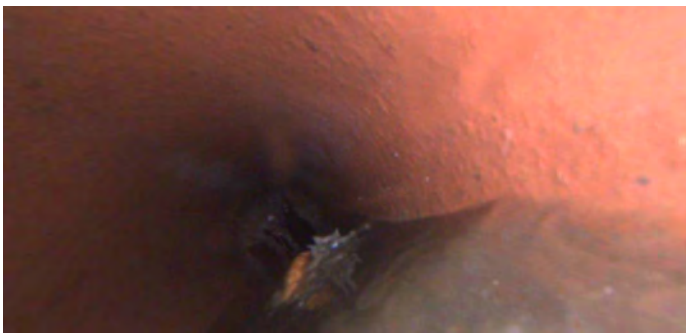
Code: **RFJ**
Description: **Roots Fine Joint**

Distance (ft): **100.5**
Structural Grade: **0**
O&M Grade: **1**
Clock Start/From: **9**
Clock To: **3**
1st Value:
2nd Value:
Value Percent:
Continuous Index: **F01**
Within 8" of Joint: **YES**
Remarks: **wandering**

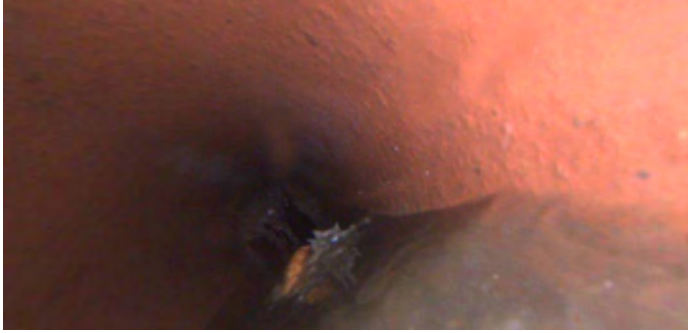
Code:	RMJ
Description:	Roots Medium Joint
Distance (ft):	100.5
Structural Grade:	0
O&M Grade:	3
Clock Start/From:	7
Clock To:	1
1st Value:	
2nd Value:	
Value Percent:	10.000
Continuous Index:	F02
Within 8" of Joint:	YES
Remarks:	wandering
