## Profile/Photo Observation Report

Date:	<b>03/24/2018</b>	Weather:		Coding:	<b>PACP 6.0</b>
Pipe Length (ft):	<b>235.3</b>	Owner:	<b>NA</b>	Pre Clean:	<b>No Pre-Cleaning</b>
P.O.#:		Surveyor:	<b>Justin Gonzales</b>	PSR:	<b>P-108-031-029</b>
Customer:		Clean Date:	<b>01/01/1900</b>	Shape:	<b>C</b>

Street:	<b>ALLEY BETWEEN SWIFT ST &amp; MISSIS</b>	Flow Control:	<b>Not Controlled</b>
City:	<b>Hobart, IN</b>	Year Renewed:	
Location:	<b>Light Highway</b>	Tape/Media #:	
Purpose:	<b>Routine Assessment</b>	Dia/Height:	<b>10"</b>
Use:	<b>Sanitary</b>	Material:	<b>VCP</b>
Drain Area:	<b>NA</b>	Lining:	
Category:	<b>NA</b>		
Comment:	<b>R_M at 143 ft debris. Flow direction wrong</b>		
Location Details:		Direction of Survey:	<b>Upstream</b>
US MH:	<b>M-108-029</b>	DS MH:	<b>M-108-031</b>
		Total Length Surveyed (ft):	<b>145.1</b>

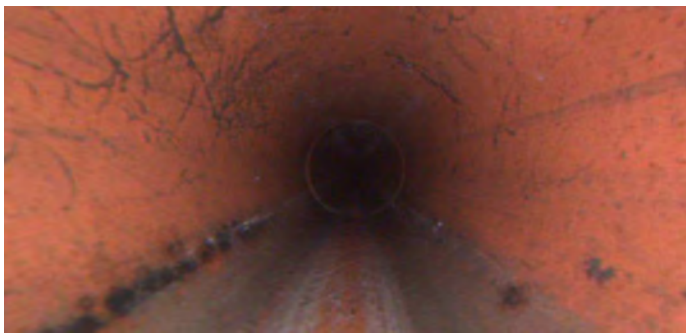
Code: **AMH**  
Description: **Manhole**

Distance (ft): **.0**  
Structural Grade: **0**  
O&M Grade: **0**  
Clock Start/From:  
Clock To:  
1st Value:  
2nd Value:  
Value Percent:  
Continuous Index:  
Within 8" of Joint: **NO**  
Remarks: **M-108-031**

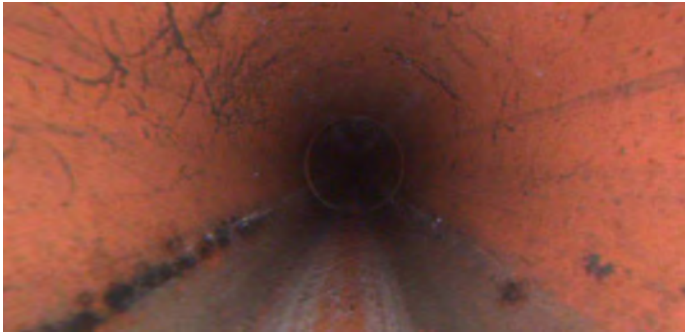
Code:	<b>MWL</b>
Description:	<b>Water Level</b>

Distance (ft):	<b>.0</b>
Structural Grade:	<b>0</b>
O&M Grade:	<b>0</b>
Clock Start/From:	
Clock To:	
1st Value:	
2nd Value:	
Value Percent:	<b>5.000</b>
Continuous Index:	
Within 8" of Joint:	<b>NO</b>
Remarks:

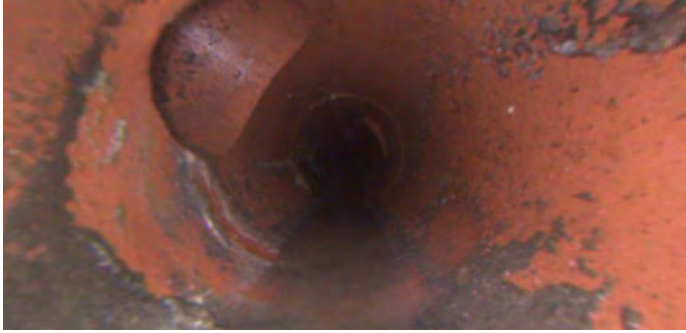
Code: **TF**  
Description: **Tap Factory**

Distance (ft): **14.0**  
Structural Grade: **0**  
O&M Grade: **0**  
Clock Start/From: **10**  
Clock To:  
1st Value: **4.000**  
2nd Value:  
Value Percent:  
Continuous Index:  
Within 8" of Joint:  
Remarks:

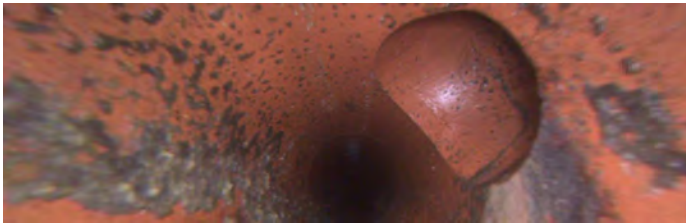
Code: **TF**  
Description: **Tap Factory**

Distance (ft): **16.4**  
Structural Grade: **0**  
O&M Grade: **0**  
Clock Start/From: **2**  
Clock To:  
1st Value: **4.000**  
2nd Value:  
Value Percent:  
Continuous Index:  
Within 8" of Joint:  
Remarks:

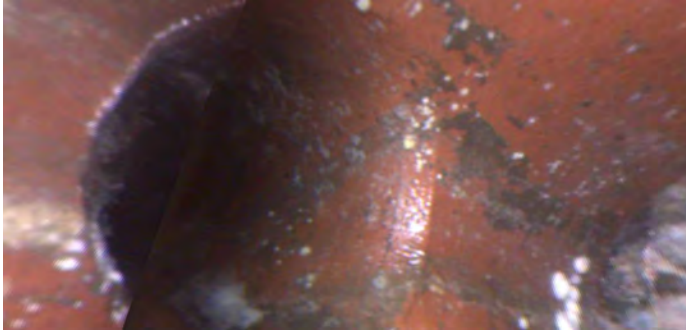
Code: **TF**  
Description: **Tap Factory**

Distance (ft): **81.9**  
Structural Grade: **0**  
O&M Grade: **0**  
Clock Start/From: **10**  
Clock To:  
1st Value: **4.000**  
2nd Value:  
Value Percent:  
Continuous Index:  
Within 8" of Joint:  
Remarks:

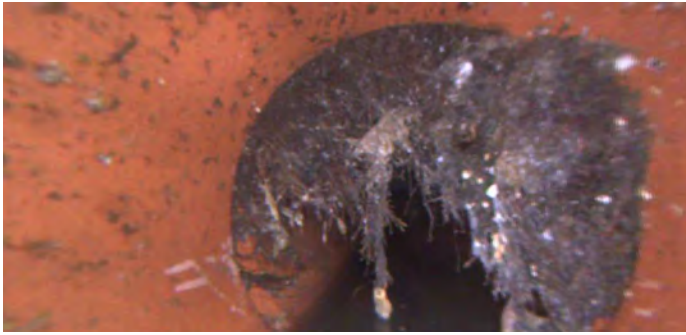
Code: **RBJ**  
Description: **Roots Ball Joint**

Distance (ft): **84.5**  
Structural Grade: **0**  
O&M Grade: **4**  
Clock Start/From: **8**  
Clock To: **4**  
1st Value:  
2nd Value:  
Value Percent: **60.000**  
Continuous Index:  
Within 8" of Joint: **YES**  
Remarks:

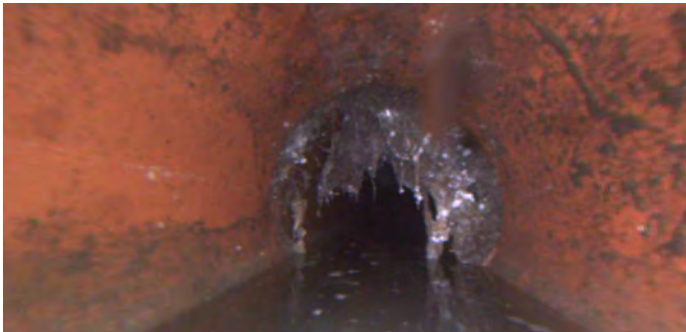
Code: **RMJ**  
Description: **Roots Medium Joint**

Distance (ft): **89.4**  
Structural Grade: **0**  
O&M Grade: **3**  
Clock Start/From: **7**  
Clock To: **5**  
1st Value:  
2nd Value:  
Value Percent: **35.000**  
Continuous Index:  
Within 8" of Joint: **YES**  
Remarks:

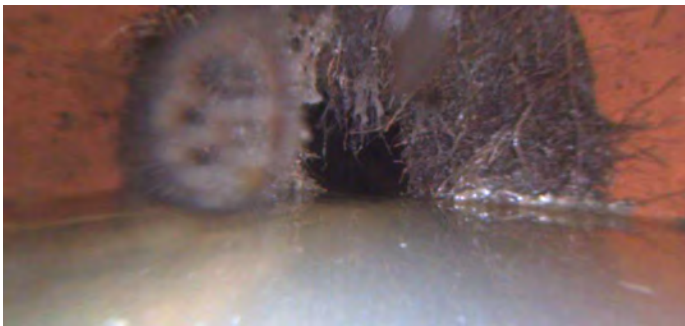
Code: **RBJ**  
Description: **Roots Ball Joint**

Distance (ft): **141.8**  
Structural Grade: **0**  
O&M Grade: **4**  
Clock Start/From: **8**  
Clock To: **4**  
1st Value:  
2nd Value:  
Value Percent: **80.000**  
Continuous Index:  
Within 8" of Joint: **YES**  
Remarks:

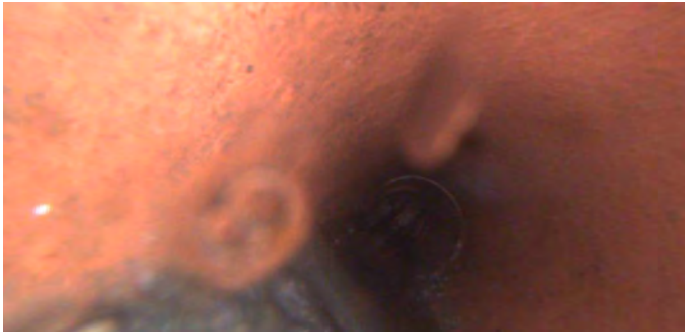
Code: **MSA**  
Description: **Abandoned Survey**

Distance (ft): **145.1**  
Structural Grade: **0**  
O&M Grade: **0**  
Clock Start/From:  
Clock To:  
1st Value:  
2nd Value:  
Value Percent:  
Continuous Index:  
Within 8" of Joint: **NO**  
Remarks: **ROBOT HAS TURNED OVER**

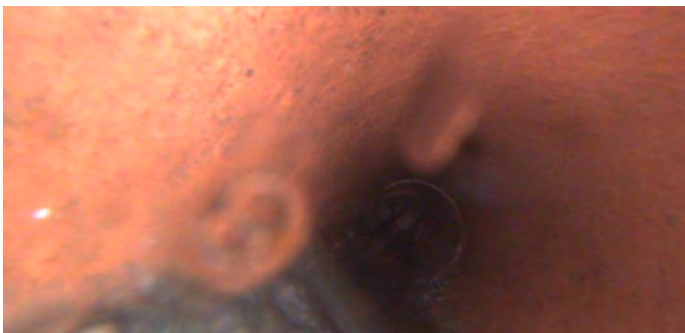
Code: **RMJ**  
Description: **Roots Medium Joint**

Distance (ft): **145.1**  
Structural Grade: **0**  
O&M Grade: **3**  
Clock Start/From: **7**  
Clock To: **5**  
1st Value:  
2nd Value:  
Value Percent: **50.000**  
Continuous Index: **F02**  
Within 8" of Joint: **YES**  
Remarks: **WANDER**

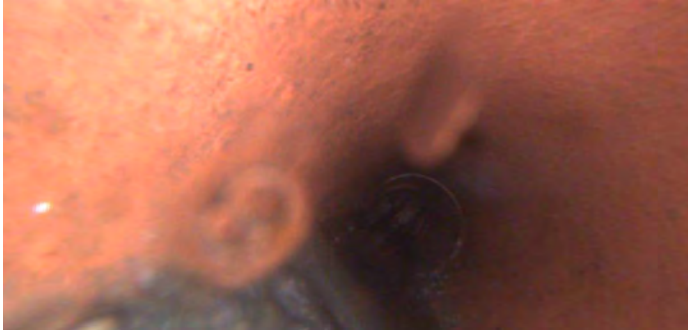
Code:	<b>DAGS</b>
Description:	<b>Deposits Attached Grease</b>
Distance (ft):	<b>145.1</b>
Structural Grade:	<b>0</b>
O&M Grade:	<b>2</b>
Clock Start/From:	<b>7</b>
Clock To:	<b>5</b>
1st Value:	
2nd Value:	
Value Percent:	<b>5.000</b>
Continuous Index:	<b>F01</b>
Within 8" of Joint:	<b>YES</b>
Remarks:	<b>WANDER</b>
