## Profile/Photo Observation Report

| Street: | <b>ALLEY BETWEEN SWIFT ST &amp; MISSIS</b> | Flow Control: | <b>Not Controlled</b> |
| City: | <b>Hobart, IN</b> | Year Renewed: | |
| US MH: | <b>M-108-031</b> | DS MH: | <b>M-108-032</b> |

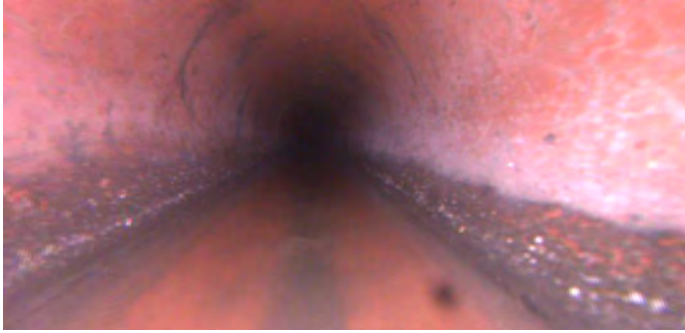
Code: **AMH**  
Description: **Manhole**

Distance (ft): **.0**  
Structural Grade: **0**  
O&M Grade: **0**  
Clock Start/From:  
Clock To:  
1st Value:  
2nd Value:  
Value Percent:  
Continuous Index:  
Within 8" of Joint: **NO**  
Remarks: **M-108-031**

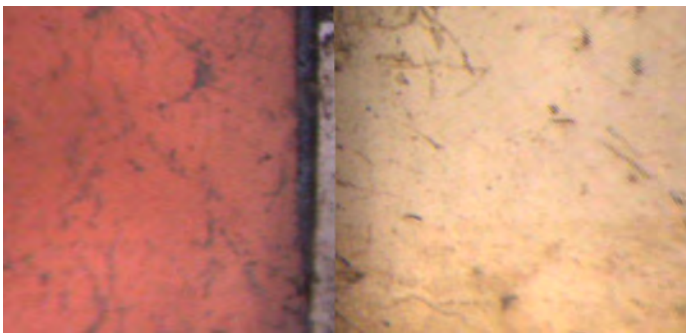
Code: **MMC**  
Description: **Material Change**

Distance (ft): **22.7**  
Structural Grade: **0**  
O&M Grade: **0**  
Clock Start/From:  
Clock To:  
1st Value:  
2nd Value:  
Value Percent:  
Continuous Index:  
Within 8" of Joint: **NO**  
Remarks: **vcp**

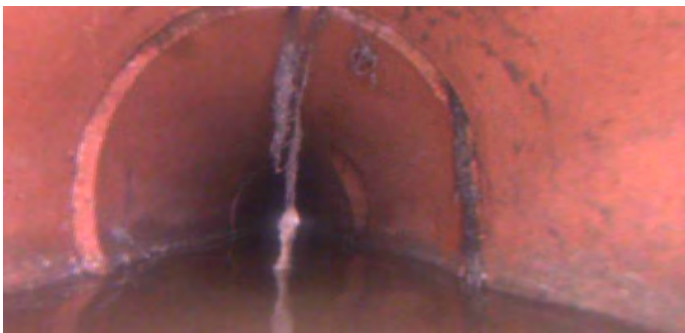
Code: **RFJ**  
Description: **Roots Fine Joint**

Distance (ft): **25.7**  
Structural Grade: **0**  
O&M Grade: **1**  
Clock Start/From: **12**  
Clock To: **5**  
1st Value:  
2nd Value:  
Value Percent:  
Continuous Index:  
Within 8" of Joint: **YES**  
Remarks:

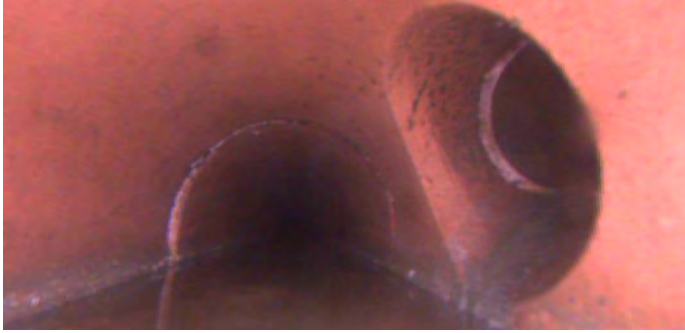
Code: **TF**  
Description: **Tap Factory**

Distance (ft): **27.1**  
Structural Grade: **0**  
O&M Grade: **0**  
Clock Start/From: **2**  
Clock To:  
1st Value: **4.000**  
2nd Value:  
Value Percent:  
Continuous Index:  
Within 8" of Joint: **YES**  
Remarks:

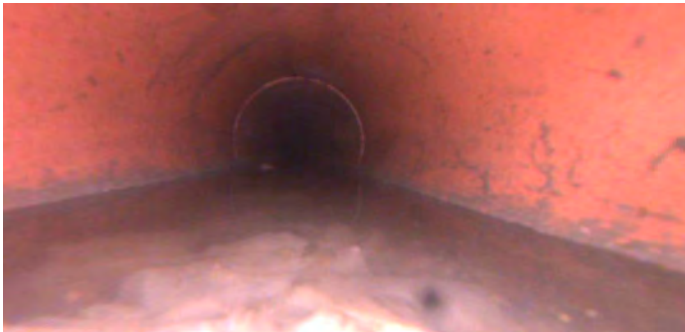
Code: **DSZ**  
Description: **Deposits Settled Other**

Distance (ft): **46.6**  
Structural Grade: **0**  
O&M Grade: **2**  
Clock Start/From: **6**  
Clock To:  
1st Value:  
2nd Value:  
Value Percent: **10.000**  
Continuous Index:  
Within 8" of Joint: **NO**  
Remarks: **tissue**

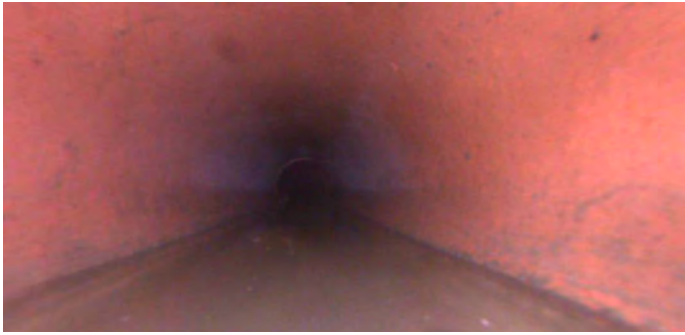
Code: **DSZ**  
Description: **Deposits Settled Other**

Distance (ft): **86.0**  
Structural Grade: **0**  
O&M Grade: **2**  
Clock Start/From: **6**  
Clock To:  
1st Value:  
2nd Value:  
Value Percent: **5.000**  
Continuous Index: **F01**  
Within 8" of Joint: **NO**  
Remarks: **tissue**

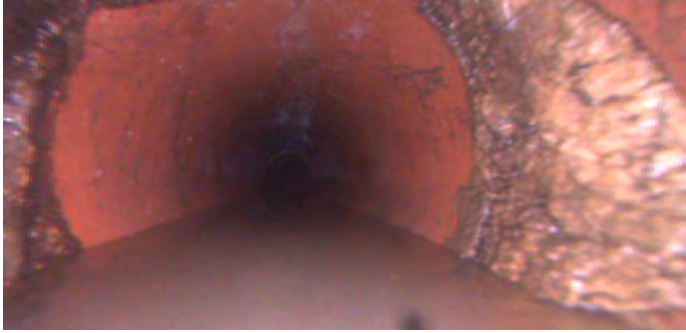
Code: **DAZ**  
Description: **Deposits Attached Other**

Distance (ft): **140.9**  
Structural Grade: **0**  
O&M Grade: **2**  
Clock Start/From: **8**  
Clock To: **4**  
1st Value:  
2nd Value:  
Value Percent: **5.000**  
Continuous Index:  
Within 8" of Joint: **YES**  
Remarks:

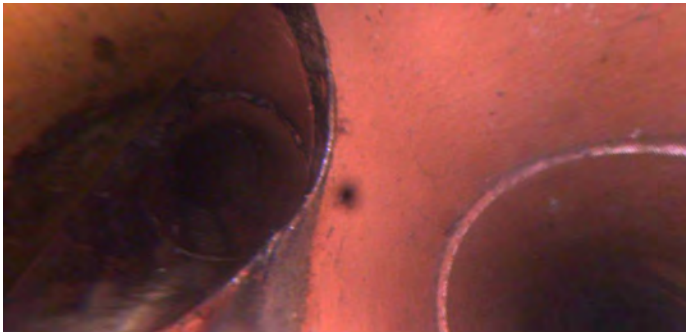
Code: **TF**  
Description: **Tap Factory**

Distance (ft): **147.5**  
Structural Grade: **0**  
O&M Grade: **0**  
Clock Start/From: **10**  
Clock To:  
1st Value: **4.000**  
2nd Value:  
Value Percent:  
Continuous Index:  
Within 8" of Joint: **YES**  
Remarks:

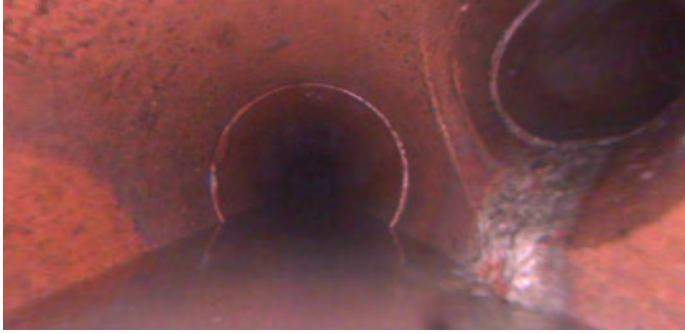
Code: **TF**  
Description: **Tap Factory**

Distance (ft): **149.2**  
Structural Grade: **0**  
O&M Grade: **0**  
Clock Start/From: **2**  
Clock To:  
1st Value: **4.000**  
2nd Value:  
Value Percent:  
Continuous Index:  
Within 8" of Joint: **YES**  
Remarks:

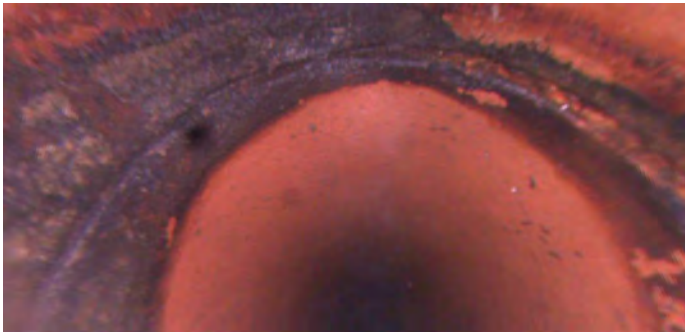
Code: **IS**  
Description: **Infil Stain**

Distance (ft): **159.8**  
Structural Grade: **0**  
O&M Grade: **0**  
Clock Start/From: **8**  
Clock To: **4**  
1st Value:  
2nd Value:  
Value Percent:  
Continuous Index:  
Within 8" of Joint: **YES**  
Remarks:

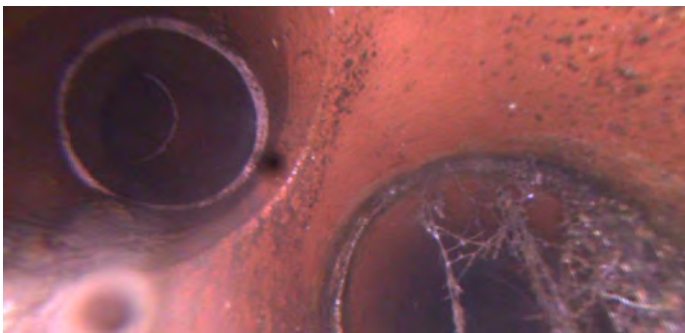
Code: **TF**  
Description: **Tap Factory**

Distance (ft): **205.8**  
Structural Grade: **0**  
O&M Grade: **0**  
Clock Start/From: **10**  
Clock To:  
1st Value: **4.000**  
2nd Value:  
Value Percent:  
Continuous Index:  
Within 8" of Joint: **YES**  
Remarks:

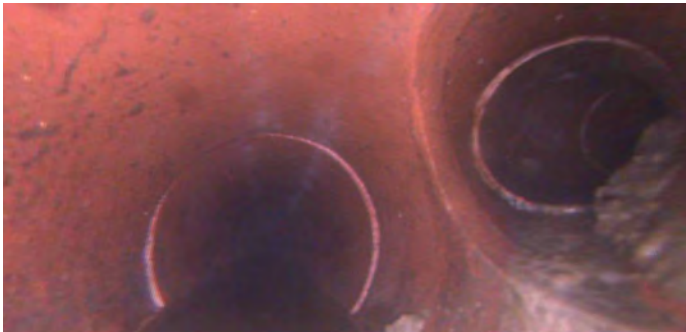
Code: **TF**  
Description: **Tap Factory**

Distance (ft): **207.5**  
Structural Grade: **0**  
O&M Grade: **0**  
Clock Start/From: **2**  
Clock To:  
1st Value: **4.000**  
2nd Value:  
Value Percent:  
Continuous Index:  
Within 8" of Joint: **YES**  
Remarks:

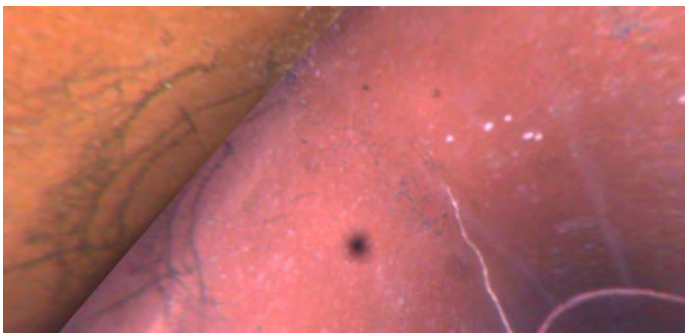
Code: **RFB**  
Description: **Roots Fine Barrel**

Distance (ft): **221.8**  
Structural Grade: **0**  
O&M Grade: **2**  
Clock Start/From: **7**  
Clock To: **11**  
1st Value:  
2nd Value:  
Value Percent:  
Continuous Index:  
Within 8" of Joint: **NO**  
Remarks:

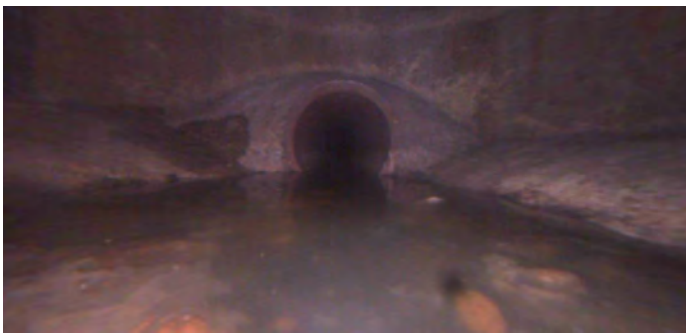
Code: **AMH**  
Description: **Manhole**

Distance (ft): **231.7**  
Structural Grade: **0**  
O&M Grade: **0**  
Clock Start/From:  
Clock To:  
1st Value:  
2nd Value:  
Value Percent:  
Continuous Index:  
Within 8" of Joint: **NO**  
Remarks: **M-108-032**
