## Profile/Photo Observation Report

Street:	<b>FOXCROFT STREET</b>	Flow Control:	<b>Not Controlled</b>
City:	<b>Hobart, IN</b>	Year Renewed:	
Location:	<b>Light Highway</b>	Tape/Media #:	
Purpose:	<b>Routine Assessment</b>	Dia/Height:	<b>10"</b>
Use:	<b>Sanitary</b>	Material:	<b>VCP</b>
Drain Area:	<b>NA</b>	Lining:	
Category:	<b>NA</b>		
Comment:	<b>Flow direction wrong</b>

Location Details:		Direction of Survey:	<b>Downstream</b>
US MH:	<b>M-108-031</b>	DS MH:	<b>M-108-032</b>
		Total Length Surveyed (ft):	<b>231.7</b>

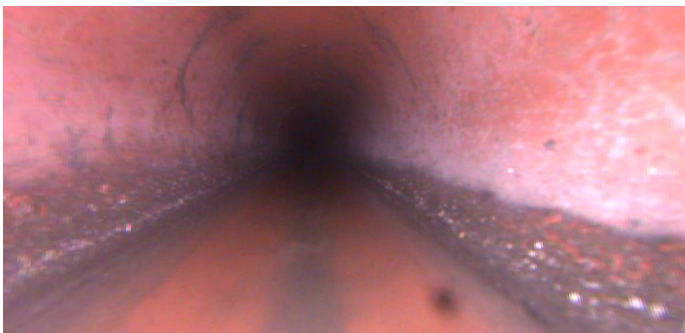
Code: **MWL**  
Description: **Water Level**

Distance (ft): **.0**  
Structural Grade: **0**  
O&M Grade: **0**  
Clock Start/From:  
Clock To:  
1st Value:  
2nd Value:  
Value Percent: **5.000**  
Continuous Index:  
Within 8" of Joint: **NO**  
Remarks:

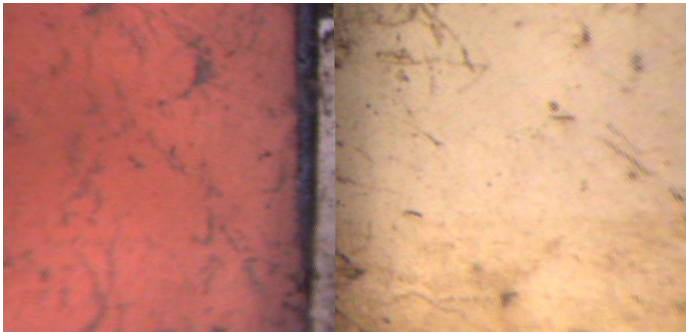
Code: **MMC**  
Description: **Material Change**

Distance (ft): **22.7**  
Structural Grade: **0**  
O&M Grade: **0**  
Clock Start/From:  
Clock To:  
1st Value:  
2nd Value:  
Value Percent:  
Continuous Index:  
Within 8" of Joint: **NO**  
Remarks: **vcp**

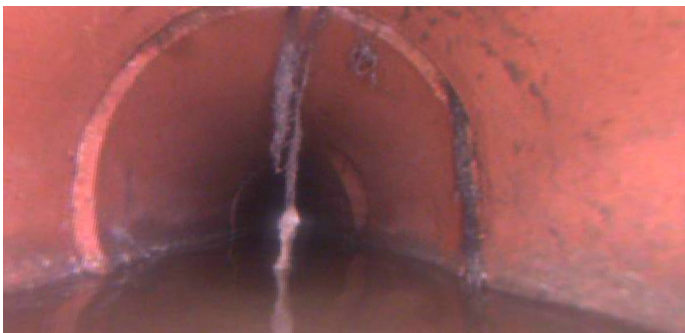
Code: **RFJ**  
Description: **Roots Fine Joint**

Distance (ft): **25.7**  
Structural Grade: **0**  
O&M Grade: **1**  
Clock Start/From: **12**  
Clock To: **5**  
1st Value:  
2nd Value:  
Value Percent:  
Continuous Index:  
Within 8" of Joint: **YES**  
Remarks:

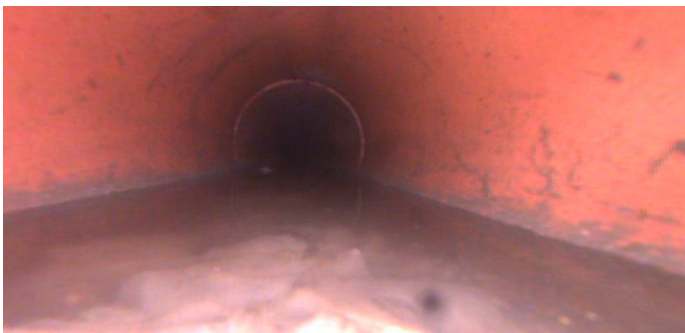
Code: **DSZ**  
Description: **Deposits Settled Other**

Distance (ft): **46.6**  
Structural Grade: **0**  
O&M Grade: **2**  
Clock Start/From: **6**  
Clock To:  
1st Value:  
2nd Value:  
Value Percent: **10.000**  
Continuous Index:  
Within 8" of Joint: **NO**  
Remarks: **tissue**

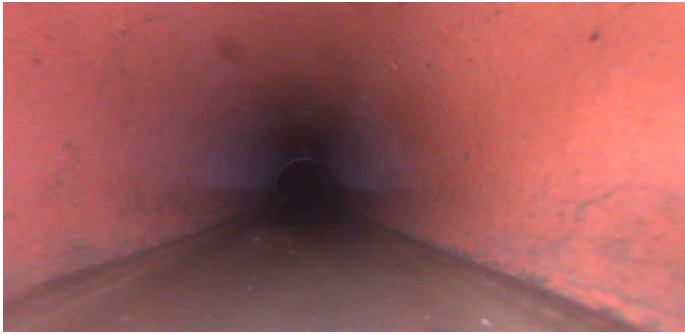
Code: **DSZ**  
Description: **Deposits Settled Other**

Distance (ft): **86.0**  
Structural Grade: **0**  
O&M Grade: **2**  
Clock Start/From: **6**  
Clock To:  
1st Value:  
2nd Value:  
Value Percent: **5.000**  
Continuous Index: **F01**  
Within 8" of Joint: **NO**  
Remarks: **tissue**

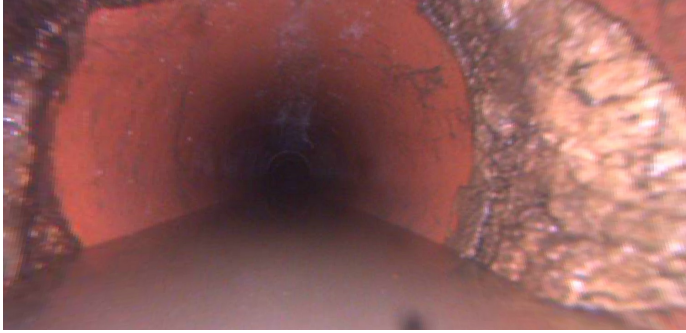
Code: **DAZ**  
Description: **Deposits Attached Other**

Distance (ft): **140.9**  
Structural Grade: **0**  
O&M Grade: **2**  
Clock Start/From: **8**  
Clock To: **4**  
1st Value:  
2nd Value:  
Value Percent: **5.000**  
Continuous Index:  
Within 8" of Joint: **YES**  
Remarks:

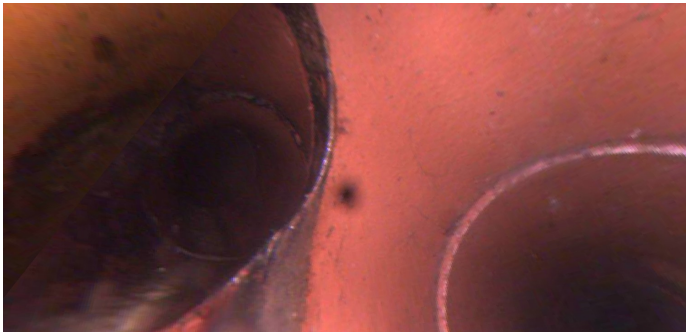
Code: **TF**  
Description: **Tap Factory**

Distance (ft): **147.5**  
Structural Grade: **0**  
O&M Grade: **0**  
Clock Start/From: **10**  
Clock To:  
1st Value: **4.000**  
2nd Value:  
Value Percent:  
Continuous Index:  
Within 8" of Joint: **YES**  
Remarks:

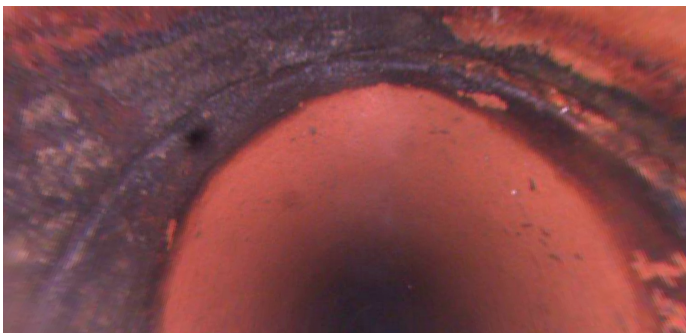
Code: **IS**  
Description: **Infil Stain**

Distance (ft): **159.8**  
Structural Grade: **0**  
O&M Grade: **0**  
Clock Start/From: **8**  
Clock To: **4**  
1st Value:  
2nd Value:  
Value Percent:  
Continuous Index:  
Within 8" of Joint: **YES**  
Remarks:

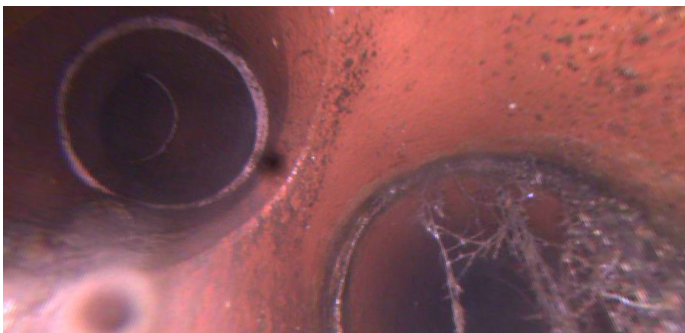
Code: **TF**  
Description: **Tap Factory**

Distance (ft): **205.8**  
Structural Grade: **0**  
O&M Grade: **0**  
Clock Start/From: **10**  
Clock To:  
1st Value: **4.000**  
2nd Value:  
Value Percent:  
Continuous Index:  
Within 8" of Joint: **YES**  
Remarks:

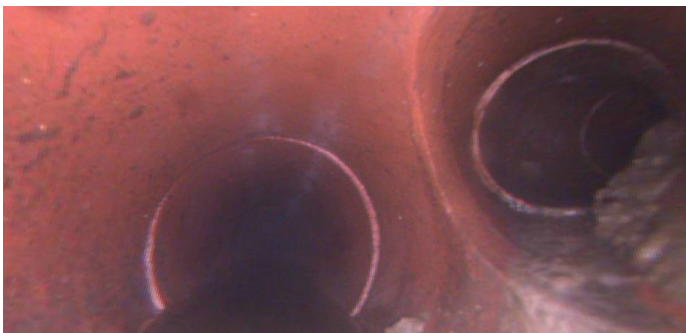
Code: **TF**  
Description: **Tap Factory**

Distance (ft): **207.5**  
Structural Grade: **0**  
O&M Grade: **0**  
Clock Start/From: **2**  
Clock To:  
1st Value: **4.000**  
2nd Value:  
Value Percent:  
Continuous Index:  
Within 8" of Joint: **YES**  
Remarks:

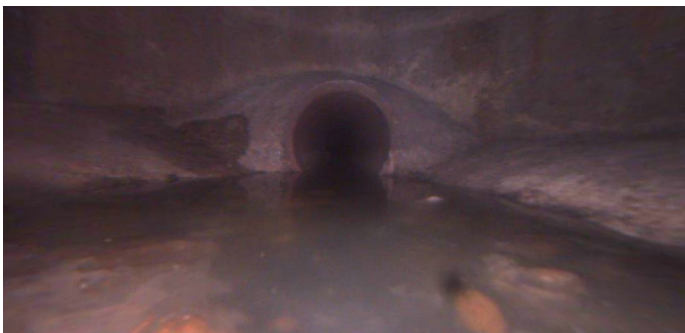
Code: **AMH**  
Description: **Manhole**

Distance (ft): **231.7**  
Structural Grade: **0**  
O&M Grade: **0**  
Clock Start/From:  
Clock To:  
1st Value:  
2nd Value:  
Value Percent:  
Continuous Index:  
Within 8" of Joint: **NO**  
Remarks: **M-108-032**
