## Profile/Photo Observation Report

Date:	<b>03/25/2018</b>	Weather:		Coding:	<b>PACP 6.0</b>
Pipe Length (ft):	<b>231.7</b>	Owner:	<b>NA</b>	Pre Clean:	<b>No Pre-Cleaning</b>
P.O.#:		Surveyor:	<b>Byrd Fitzgerald</b>	PSR:	<b>P-108-033-032</b>
Customer:		Clean Date:	<b>01/01/1900</b>	Shape:	<b>C</b>

Street:	<b>ALLEY BETWEEN SWIFT ST &amp; MISSIS</b>	Flow Control:	<b>Not Controlled</b>
City:	<b>Hobart, IN</b>	Year Renewed:	
Location:	<b>Light Highway</b>	Tape/Media #:	
Purpose:	<b>Routine Assessment</b>	Dia/Height:	<b>10"</b>
Use:	<b>Sanitary</b>	Material:	<b>VCP</b>
Drain Area:	<b>NA</b>	Lining:	
Category:	<b>NA</b>		
Comment:	<b>Flow direction wrong</b>		
Location Details:		Direction of Survey:	<b>Upstream</b>
US MH:	<b>M-108-032</b>	DS MH:	<b>M-108-033</b>
		Total Length Surveyed (ft):	<b>239.2</b>

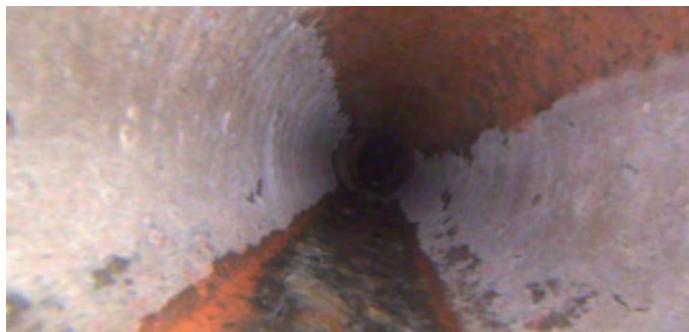
Code: **AMH**  
 Description: **Manhole**  
 Distance (ft): **.0**  
 Structural Grade: **0**  
 O&M Grade: **0**  
 Clock Start/From:  
 Clock To:  
 1st Value:  
 2nd Value:  
 Value Percent:  
 Continuous Index:  
 Within 8" of Joint: **NO**  
 Remarks: **M-108-033**

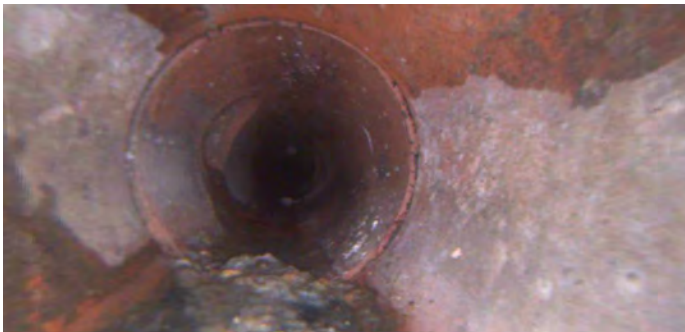
Code:	<b>DSZ</b>
Description:	<b>Deposits Settled Other</b>

Distance (ft):	<b>3.5</b>
Structural Grade:	<b>0</b>
O&M Grade:	<b>2</b>
Clock Start/From:	<b>6</b>
Clock To:	
1st Value:	
2nd Value:	
Value Percent:	<b>5.000</b>
Continuous Index:	
Within 8" of Joint:	<b>NO</b>
Remarks:	<b>tissue/debris</b>

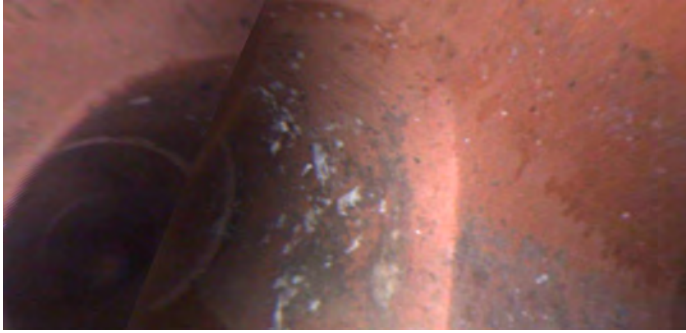
Code: **TF**  
Description: **Tap Factory**

Distance (ft): **5.1**  
Structural Grade: **0**  
O&M Grade: **0**  
Clock Start/From: **10**  
Clock To:  
1st Value: **4.000**  
2nd Value:  
Value Percent:  
Continuous Index:  
Within 8" of Joint:  
Remarks:

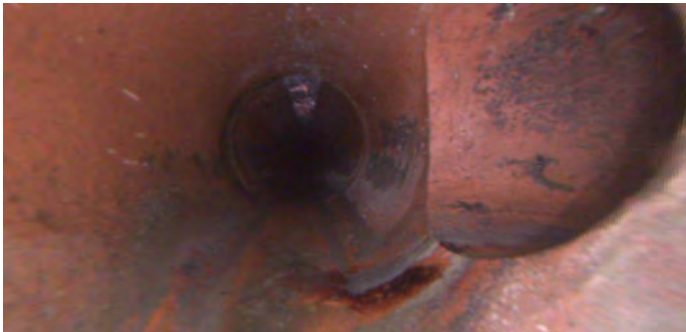
Code: **TF**  
Description: **Tap Factory**

Distance (ft): **6.7**  
Structural Grade: **0**  
O&M Grade: **0**  
Clock Start/From: **3**  
Clock To:  
1st Value: **4.000**  
2nd Value:  
Value Percent:  
Continuous Index:  
Within 8" of Joint:  
Remarks:

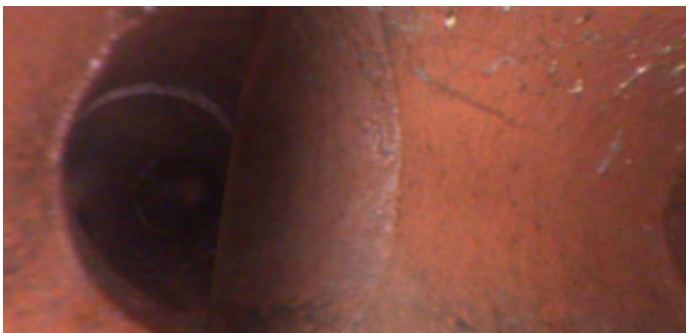
Code: **TF**  
Description: **Tap Factory**

Distance (ft): **61.5**  
Structural Grade: **0**  
O&M Grade: **0**  
Clock Start/From: **9**  
Clock To:  
1st Value: **4.000**  
2nd Value:  
Value Percent:  
Continuous Index:  
Within 8" of Joint:  
Remarks:

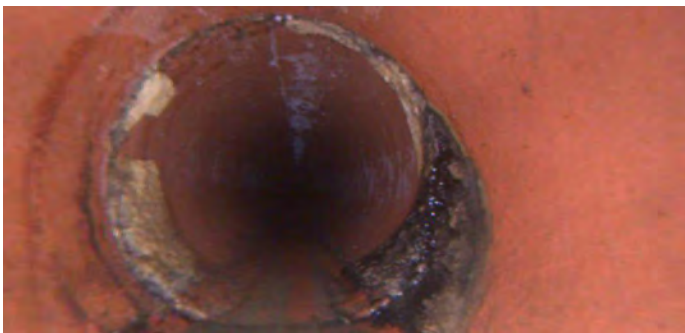
Code: **DAZ**  
Description: **Deposits Attached Other**

Distance (ft): **74.5**  
Structural Grade: **0**  
O&M Grade: **2**  
Clock Start/From: **7**  
Clock To: **5**  
1st Value:  
2nd Value:  
Value Percent: **5.000**  
Continuous Index:  
Within 8" of Joint: **YES**  
Remarks:

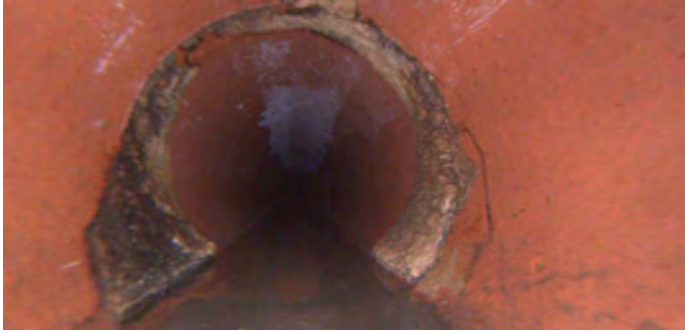
Code: **DAZ**  
Description: **Deposits Attached Other**

Distance (ft): **116.2**  
Structural Grade: **0**  
O&M Grade: **2**  
Clock Start/From: **7**  
Clock To: **5**  
1st Value:  
2nd Value:  
Value Percent: **5.000**  
Continuous Index: **S02**  
Within 8" of Joint: **YES**  
Remarks: **wandering**

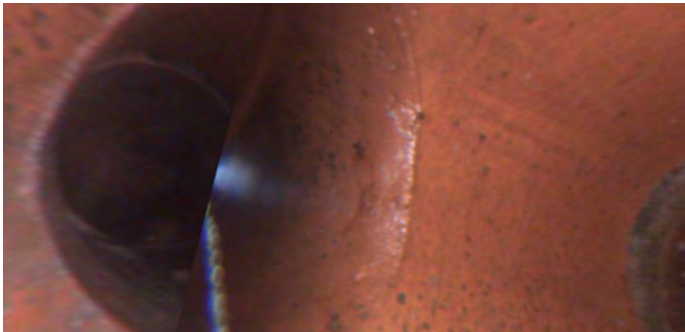
Code: **TF**  
Description: **Tap Factory**

Distance (ft): **128.3**  
Structural Grade: **0**  
O&M Grade: **0**  
Clock Start/From: **10**  
Clock To:  
1st Value: **4.000**  
2nd Value:  
Value Percent:  
Continuous Index:  
Within 8" of Joint: **YES**  
Remarks:

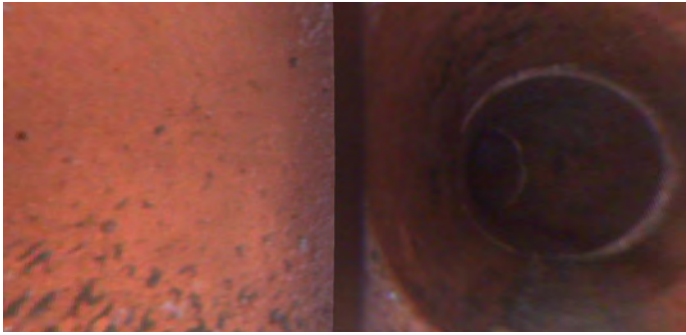
Code: **TF**  
Description: **Tap Factory**

Distance (ft): **130.8**  
Structural Grade: **0**  
O&M Grade: **0**  
Clock Start/From: **3**  
Clock To:  
1st Value: **4.000**  
2nd Value:  
Value Percent:  
Continuous Index:  
Within 8" of Joint: **YES**  
Remarks:

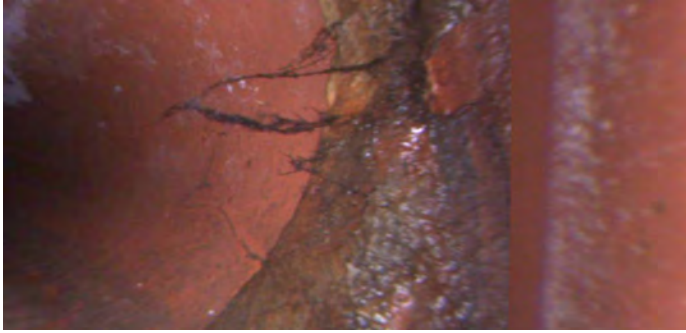
Code: **DAE**  
Description: **Deposits Attached Encrustation**

Distance (ft): **178.4**  
Structural Grade: **0**  
O&M Grade: **2**  
Clock Start/From: **7**  
Clock To: **5**  
1st Value:  
2nd Value:  
Value Percent: **5.000**  
Continuous Index:  
Within 8" of Joint: **YES**  
Remarks:

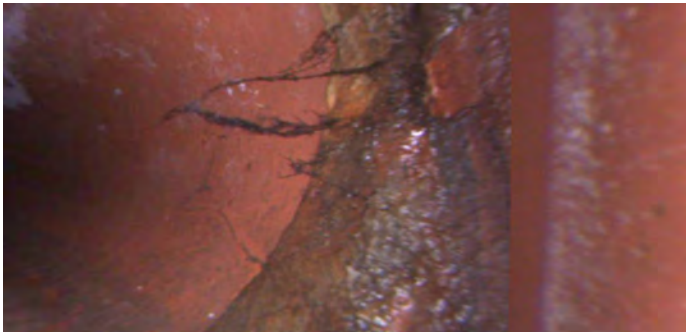
Code: **RFJ**  
Description: **Roots Fine Joint**

Distance (ft): **178.4**  
Structural Grade: **0**  
O&M Grade: **1**  
Clock Start/From: **3**  
Clock To:  
1st Value:  
2nd Value:  
Value Percent:  
Continuous Index:  
Within 8" of Joint: **YES**  
Remarks:

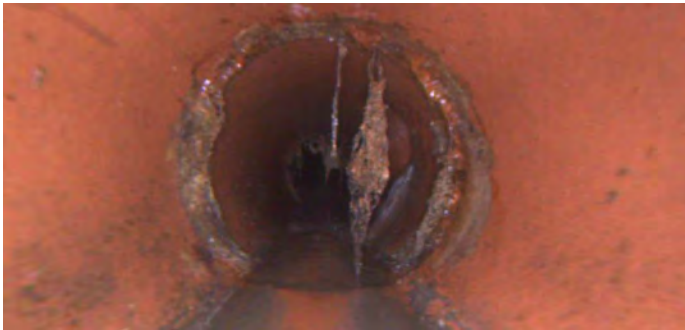
Code: **RMJ**  
Description: **Roots Medium Joint**

Distance (ft): **200.5**  
Structural Grade: **0**  
O&M Grade: **3**  
Clock Start/From: **1**  
Clock To:  
1st Value:  
2nd Value:  
Value Percent: **5.000**  
Continuous Index: **S03**  
Within 8" of Joint: **YES**  
Remarks: **wandering**

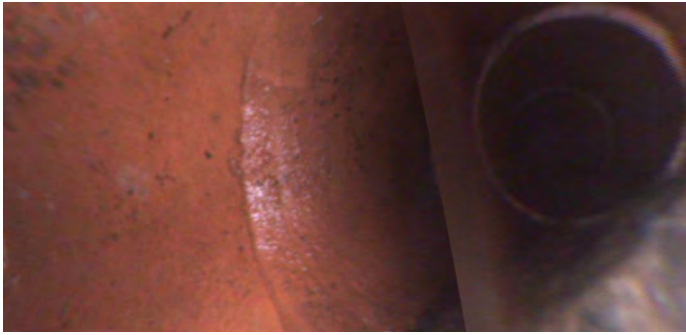
Code: **TF**  
Description: **Tap Factory**

Distance (ft): **202.1**  
Structural Grade: **0**  
O&M Grade: **0**  
Clock Start/From: **2**  
Clock To:  
1st Value: **4.000**  
2nd Value:  
Value Percent:  
Continuous Index:  
Within 8" of Joint: **YES**  
Remarks:

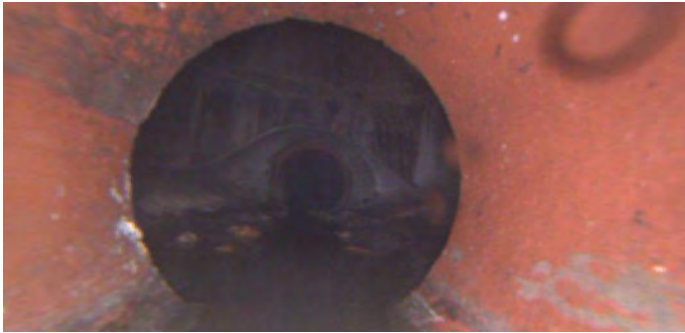
Code: **IW**  
Description: **Infil Weeper**

Distance (ft): **237.8**  
Structural Grade: **0**  
O&M Grade: **2**  
Clock Start/From: **10**  
Clock To:  
1st Value:  
2nd Value:  
Value Percent:  
Continuous Index: **F01**  
Within 8" of Joint: **YES**  
Remarks: **wandering**

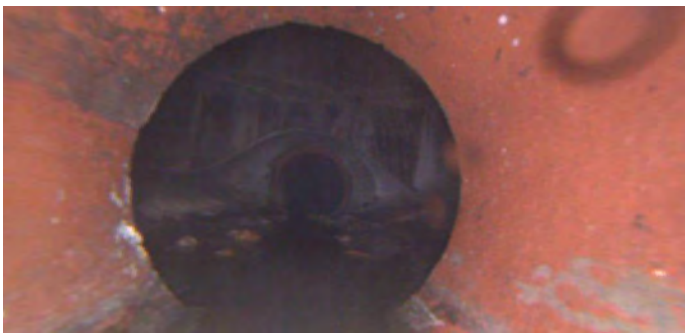
Code: **RMJ**  
Description: **Roots Medium Joint**

Distance (ft): **237.8**  
Structural Grade: **0**  
O&M Grade: **3**  
Clock Start/From: **1**  
Clock To:  
1st Value:  
2nd Value:  
Value Percent: **5.000**  
Continuous Index: **F03**  
Within 8" of Joint: **YES**  
Remarks: **wandering**

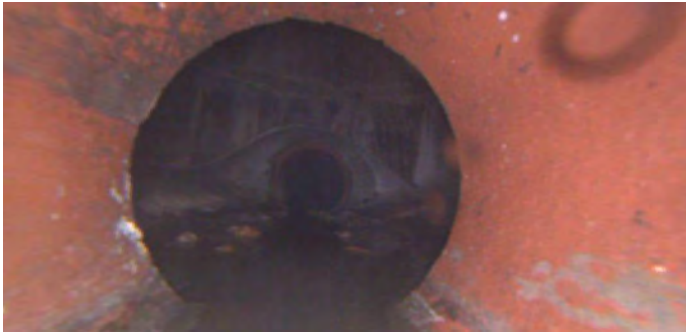
Code: **DAZ**  
Description: **Deposits Attached Other**

Distance (ft): **237.8**  
Structural Grade: **0**  
O&M Grade: **2**  
Clock Start/From: **7**  
Clock To: **5**  
1st Value:  
2nd Value:  
Value Percent: **5.000**  
Continuous Index: **F02**  
Within 8" of Joint: **YES**  
Remarks: **wandering**

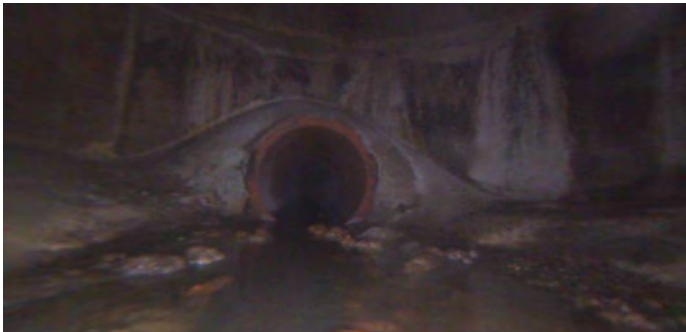
Code: **AMH**  
Description: **Manhole**

Distance (ft): **239.2**  
Structural Grade: **0**  
O&M Grade: **0**  
Clock Start/From:  
Clock To:  
1st Value:  
2nd Value:  
Value Percent:  
Continuous Index:  
Within 8" of Joint: **NO**  
Remarks: **M-108-032**
