Profile/Photo Observation Report

Date:	03/25/2018	Weather:		Coding:	PACP 6.0
Pipe Length (ft):	239.6	Owner:	NA	Pre Clean:	No Pre-Cleaning
P.O.#:		Surveyor:	Byrd Fitzgerald	PSR:	P-108-040-041
Customer:		Clean Date:	01/01/1900	Shape:	C

Street:	FOXCROFT STREET	Flow Control:	Not Controlled
City:	Hobart, IN	Year Renewed:	
Location:	Light Highway	Tape/Media #:	
Purpose:	Routine Assessment	Dia/Height:	10"
Use:	Sanitary	Material:	VCP
Drain Area:	NA	Lining:	
Category:	NA		
Comment:	Flow direction wrong		
Location Details:		Direction of Survey:	Downstream
US MH:	M-108-041	DS MH:	M-108-040
		Total Length Surveyed (ft):	249.1

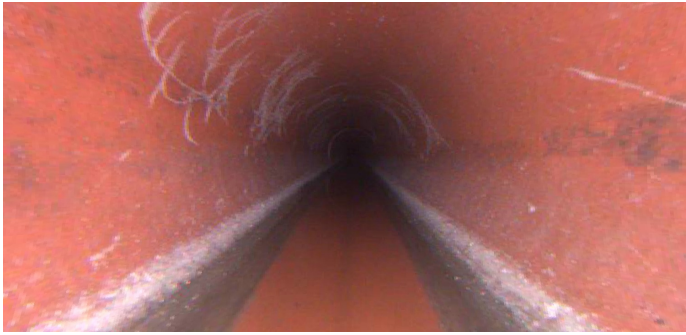
Code: **AMH**
Description: **Manhole**

Distance (ft): **.0**
Structural Grade: **0**
O&M Grade: **0**
Clock Start/From:
Clock To:
1st Value:
2nd Value:
Value Percent:
Continuous Index:
Within 8" of Joint: **NO**
Remarks: **M-108-041**

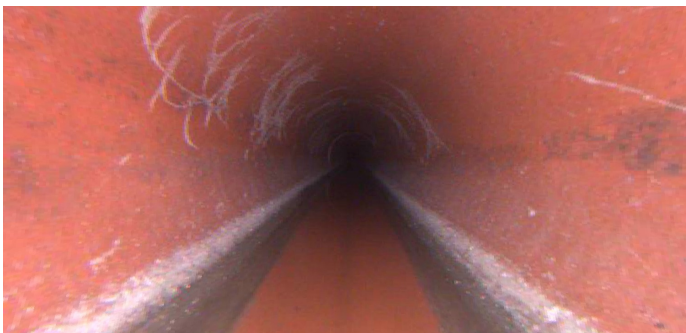
Code: **MWL**
Description: **Water Level**

Distance (ft): **.0**
Structural Grade: **0**
O&M Grade: **0**
Clock Start/From:
Clock To:
1st Value:
2nd Value:
Value Percent: **5.000**
Continuous Index:
Within 8" of Joint: **NO**
Remarks:

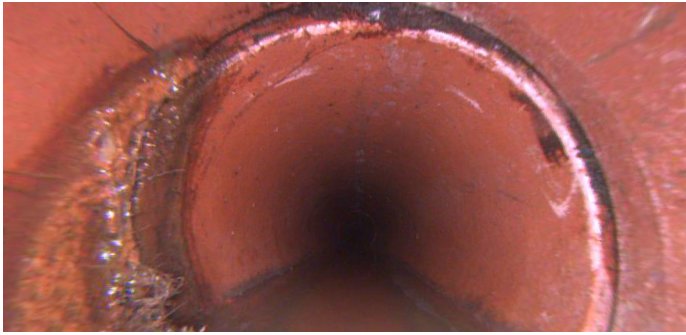
Code: **IW**
Description: **Infil Weeper**

Distance (ft): **15.2**
Structural Grade: **0**
O&M Grade: **2**
Clock Start/From: **8**
Clock To: **11**
1st Value:
2nd Value:
Value Percent:
Continuous Index:
Within 8" of Joint: **YES**
Remarks:

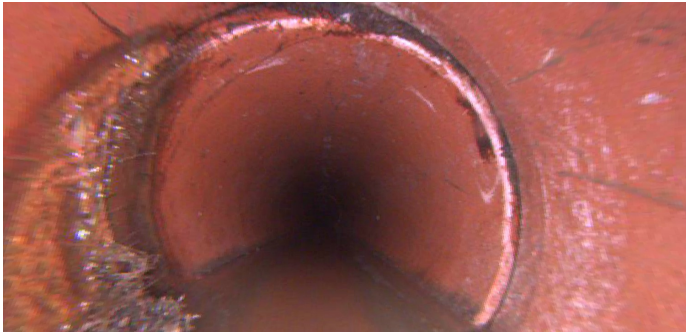
Code: **RFJ**
Description: **Roots Fine Joint**

Distance (ft): **15.2**
Structural Grade: **0**
O&M Grade: **1**
Clock Start/From: **7**
Clock To: **10**
1st Value:
2nd Value:
Value Percent:
Continuous Index:
Within 8" of Joint: **YES**
Remarks:

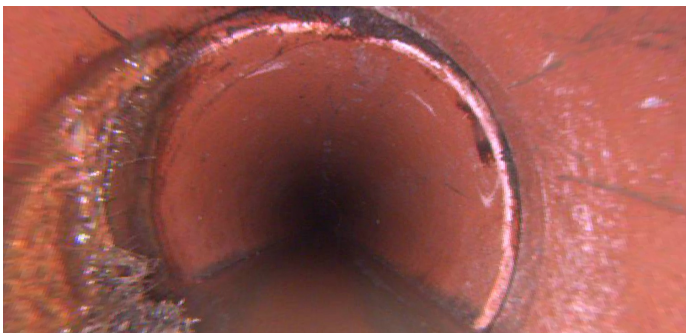
Code: **DAE**
Description: **Deposits Attached Encrustation**

Distance (ft): **15.2**
Structural Grade: **0**
O&M Grade: **2**
Clock Start/From: **7**
Clock To: **11**
1st Value:
2nd Value:
Value Percent: **5.000**
Continuous Index:
Within 8" of Joint: **YES**
Remarks:

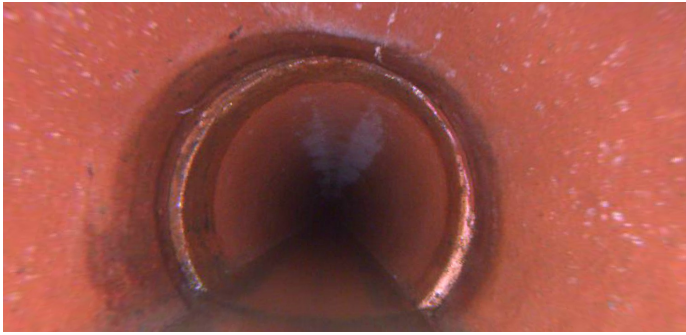
Code: **IW**
Description: **Infil Weeper**

Distance (ft): **24.9**
Structural Grade: **0**
O&M Grade: **2**
Clock Start/From: **8**
Clock To: **4**
1st Value:
2nd Value:
Value Percent:
Continuous Index:
Within 8" of Joint: **YES**
Remarks:

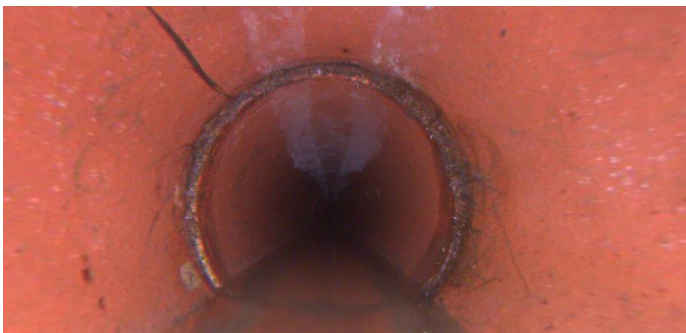
Code: **IW**
Description: **Infil Weeper**

Distance (ft): **29.7**
Structural Grade: **0**
O&M Grade: **2**
Clock Start/From: **8**
Clock To: **4**
1st Value:
2nd Value:
Value Percent:
Continuous Index:
Within 8" of Joint: **YES**
Remarks:

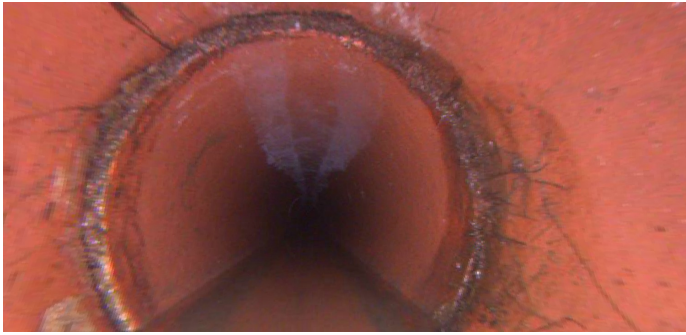
Code: **RFJ**
Description: **Roots Fine Joint**

Distance (ft): **30.0**
Structural Grade: **0**
O&M Grade: **1**
Clock Start/From: **7**
Clock To: **5**
1st Value:
2nd Value:
Value Percent:
Continuous Index: **S01**
Within 8" of Joint: **YES**
Remarks: **wandering**

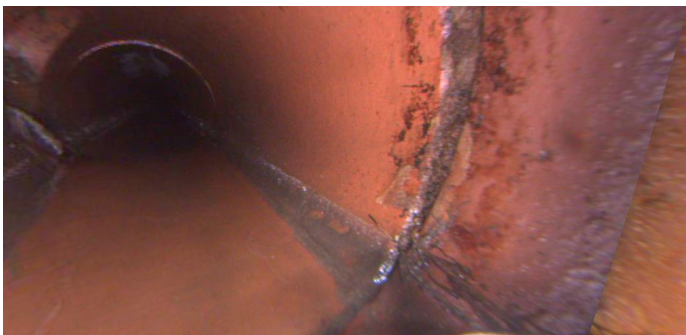
Code: **RFJ**
Description: **Roots Fine Joint**

Distance (ft): **55.0**
Structural Grade: **0**
O&M Grade: **1**
Clock Start/From: **4**
Clock To:
1st Value:
2nd Value:
Value Percent:
Continuous Index:
Within 8" of Joint: **YES**
Remarks:

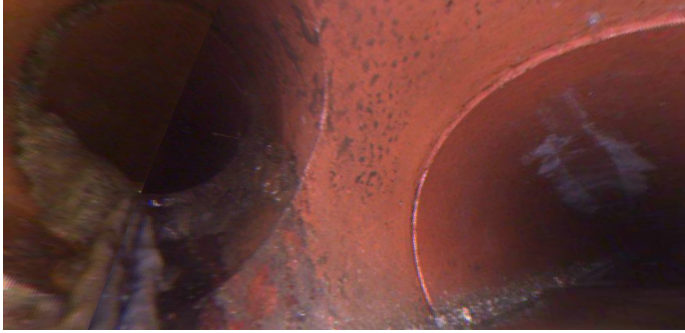
Code: **TF**
Description: **Tap Factory**

Distance (ft): **56.7**
Structural Grade: **0**
O&M Grade: **0**
Clock Start/From: **10**
Clock To:
1st Value: **4.000**
2nd Value:
Value Percent:
Continuous Index:
Within 8" of Joint: **YES**
Remarks:

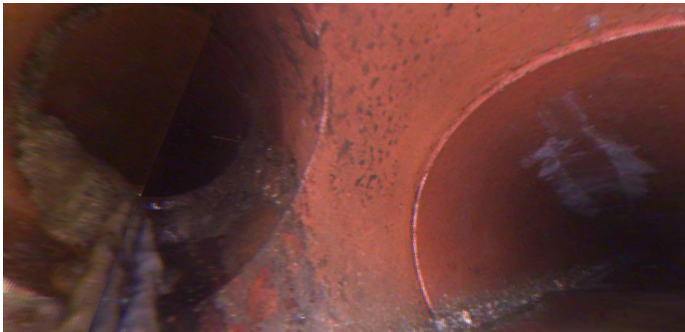
Code: **DAZ**
Description: **Deposits Attached Other**

Distance (ft): **56.7**
Structural Grade: **0**
O&M Grade: **2**
Clock Start/From: **3**
Clock To: **9**
1st Value:
2nd Value:
Value Percent: **5.000**
Continuous Index:
Within 8" of Joint: **NO**
Remarks: **inside tap**

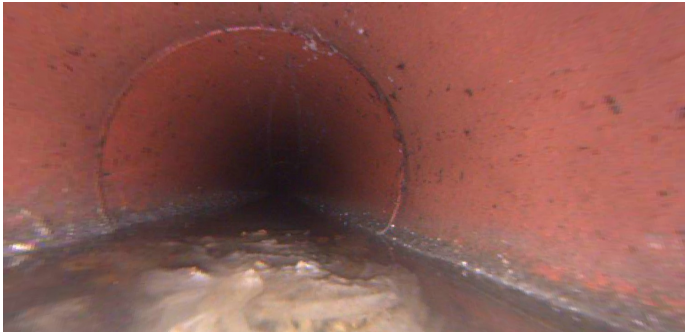
Code: **DSZ**
Description: **Deposits Settled Other**

Distance (ft): **61.6**
Structural Grade: **0**
O&M Grade: **2**
Clock Start/From: **6**
Clock To:
1st Value:
2nd Value:
Value Percent: **5.000**
Continuous Index:
Within 8" of Joint: **NO**
Remarks: **tissue**

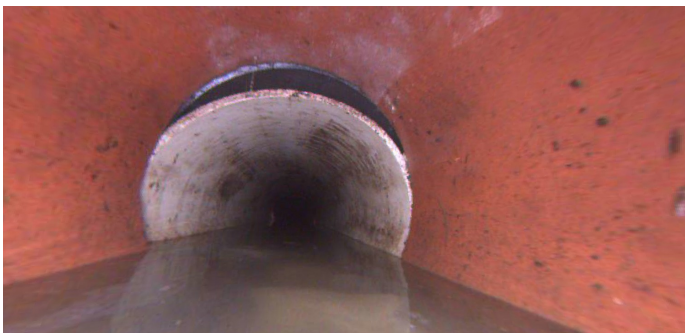
Code: **JOL**
Description: **Joint Offset Large**

Distance (ft): **95.0**
Structural Grade: **2**
O&M Grade: **0**
Clock Start/From:
Clock To:
1st Value:
2nd Value:
Value Percent:
Continuous Index:
Within 8" of Joint: **NO**
Remarks:

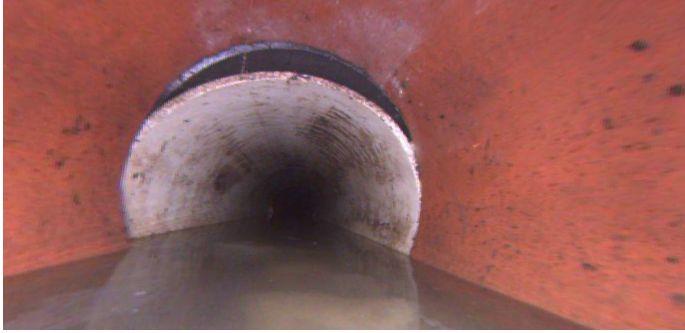
Code: **MMC**
Description: **Material Change**

Distance (ft): **95.0**
Structural Grade: **0**
O&M Grade: **0**
Clock Start/From:
Clock To:
1st Value:
2nd Value:
Value Percent:
Continuous Index:
Within 8" of Joint: **NO**
Remarks: **pvc**

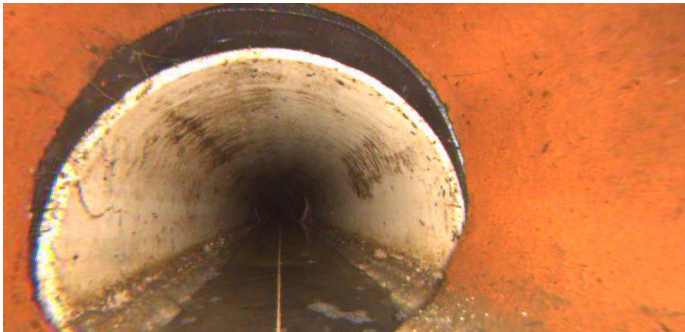
Code: **JOL**
Description: **Joint Offset Large**

Distance (ft): **100.7**
Structural Grade: **2**
O&M Grade: **0**
Clock Start/From:
Clock To:
1st Value:
2nd Value:
Value Percent:
Continuous Index:
Within 8" of Joint: **NO**
Remarks:

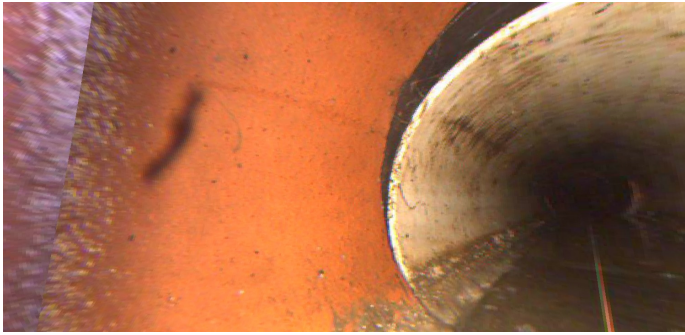
Code: **MMC**
Description: **Material Change**

Distance (ft): **100.7**
Structural Grade: **0**
O&M Grade: **0**
Clock Start/From:
Clock To:
1st Value:
2nd Value:
Value Percent:
Continuous Index:
Within 8" of Joint: **NO**
Remarks: **vcp**

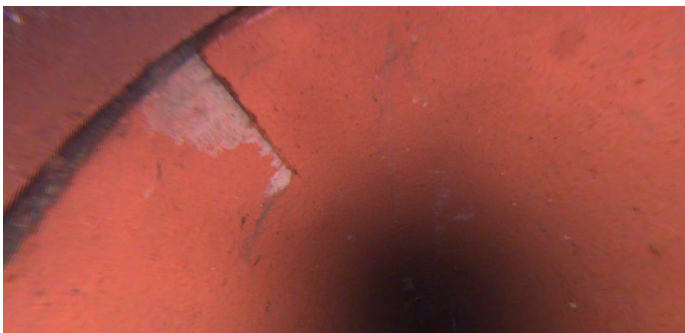
Code: **CL**
Description: **Crack Longitudinal**

Distance (ft): **118.1**
Structural Grade: **2**
O&M Grade: **0**
Clock Start/From: **11**
Clock To:
1st Value:
2nd Value:
Value Percent:
Continuous Index:
Within 8" of Joint: **YES**
Remarks:

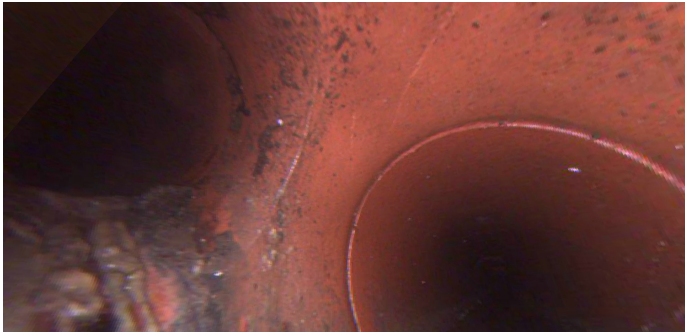
Code: **TFD**
Description: **Tap Factory Defective**

Distance (ft): **134.6**
Structural Grade: **0**
O&M Grade: **2**
Clock Start/From: **10**
Clock To:
1st Value: **4.000**
2nd Value:
Value Percent:
Continuous Index:
Within 8" of Joint: **YES**
Remarks: **ROOTS**

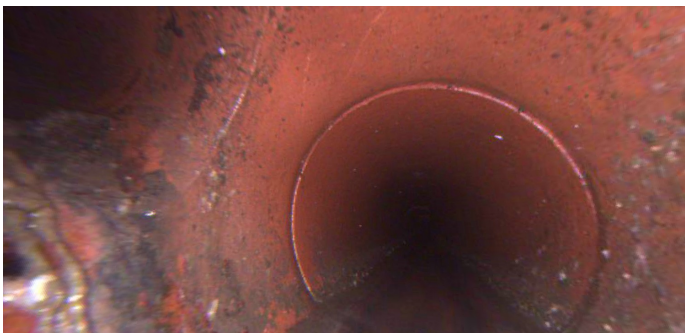
Code: **RFL**
Description: **Roots Fine Lateral**

Distance (ft): **134.6**
Structural Grade: **0**
O&M Grade: **1**
Clock Start/From: **9**
Clock To:
1st Value:
2nd Value:
Value Percent:
Continuous Index:
Within 8" of Joint: **NO**
Remarks:

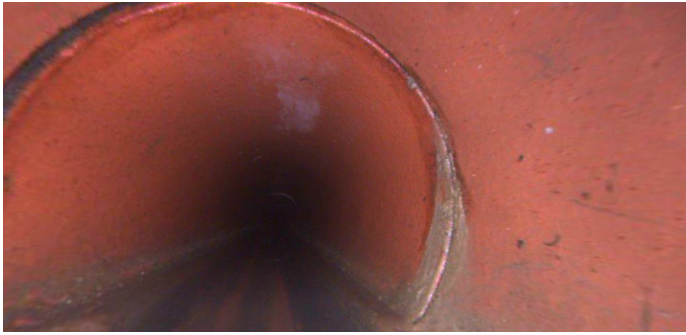
Code: **IW**
Description: **Infil Weeper**

Distance (ft): **139.9**
Structural Grade: **0**
O&M Grade: **2**
Clock Start/From: **2**
Clock To: **4**
1st Value:
2nd Value:
Value Percent:
Continuous Index:
Within 8" of Joint: **YES**
Remarks:

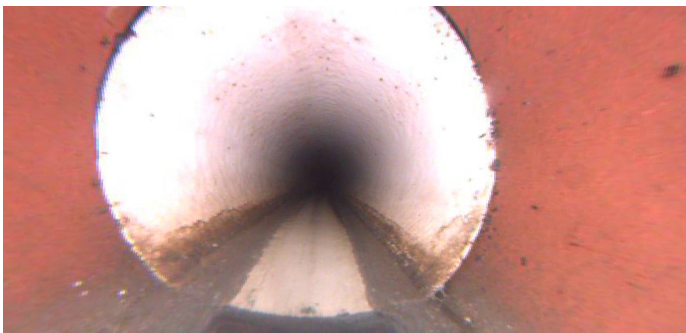
Code: **MMC**
Description: **Material Change**

Distance (ft): **193.1**
Structural Grade: **0**
O&M Grade: **0**
Clock Start/From:
Clock To:
1st Value:
2nd Value:
Value Percent:
Continuous Index:
Within 8" of Joint: **NO**
Remarks: **pvc**

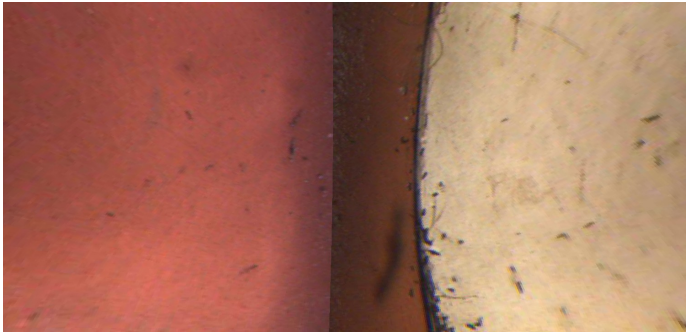
Code: **MMC**
Description: **Material Change**

Distance (ft): **201.4**
Structural Grade: **0**
O&M Grade: **0**
Clock Start/From:
Clock To:
1st Value:
2nd Value:
Value Percent:
Continuous Index:
Within 8" of Joint: **NO**
Remarks: **vcp**

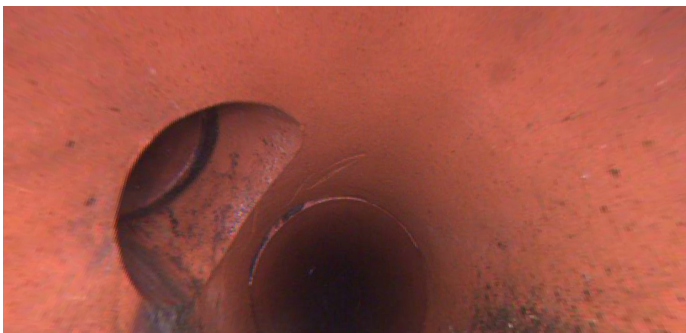
Code: **TF**
Description: **Tap Factory**

Distance (ft): **207.2**
Structural Grade: **0**
O&M Grade: **0**
Clock Start/From: **10**
Clock To:
1st Value: **4.000**
2nd Value:
Value Percent:
Continuous Index:
Within 8" of Joint:
Remarks:

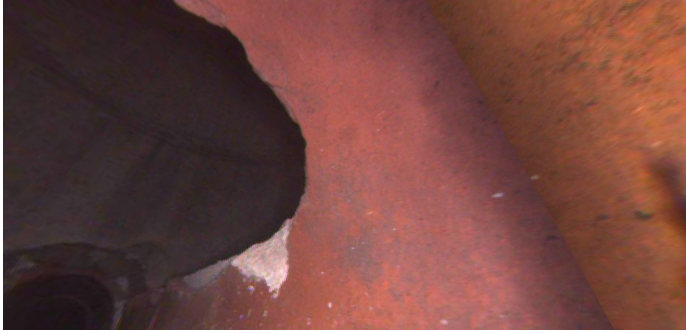
Code: **RFJ**
Description: **Roots Fine Joint**

Distance (ft): **247.0**
Structural Grade: **0**
O&M Grade: **1**
Clock Start/From: **7**
Clock To: **5**
1st Value:
2nd Value:
Value Percent:
Continuous Index: **F01**
Within 8" of Joint: **YES**
Remarks: **wandering**

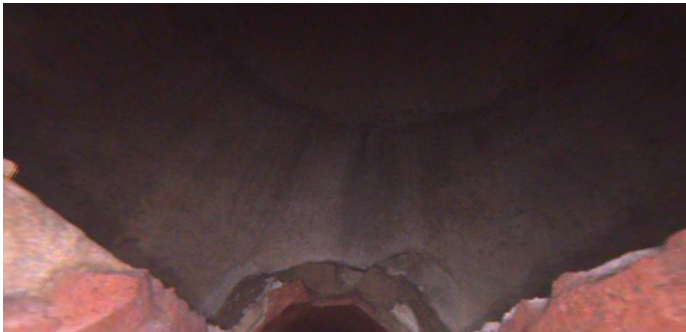
Code: **AMH**
Description: **Manhole**

Distance (ft): **249.1**
Structural Grade: **0**
O&M Grade: **0**
Clock Start/From:
Clock To:
1st Value:
2nd Value:
Value Percent:
Continuous Index:
Within 8" of Joint: **NO**
Remarks: **M-108-040**
