Profile/Photo Observation Report

Date:	03/25/2018	Weather:		Coding:	PACP 6.0
Pipe Length (ft):	272.5	Owner:	NA	Pre Clean:	No Pre-Cleaning
P.O.#:		Surveyor:	Byrd Fitzgerald	PSR:	P-108-041-042
Customer:		Clean Date:	01/01/1900	Shape:	C

Street:	FOXCROFT STREET	Flow Control:	Not Controlled
City:	Hobart, IN	Year Renewed:	
Location:	Light Highway	Tape/Media #:	
Purpose:	Routine Assessment	Dia/Height:	10"
Use:	Sanitary	Material:	VCP
Drain Area:	NA	Lining:	
Category:	NA		
Comment:	Flow direction wrong		
Location Details:		Direction of Survey:	Upstream
US MH:	M-108-042	DS MH:	M-108-041
		Total Length Surveyed (ft):	266.3

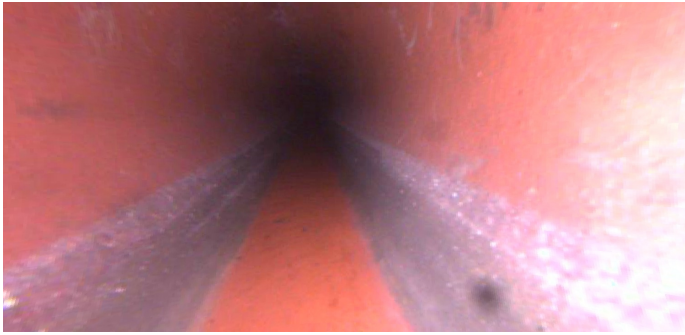
Code: **AMH**
Description: **Manhole**

Distance (ft): **.0**
Structural Grade: **0**
O&M Grade: **0**
Clock Start/From:
Clock To:
1st Value:
2nd Value:
Value Percent:
Continuous Index:
Within 8" of Joint: **NO**
Remarks: **M-108-041**

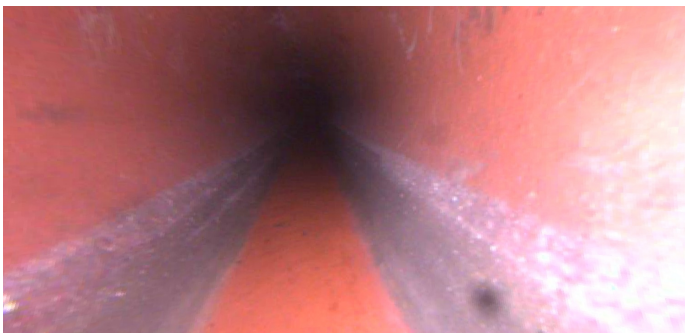
Code: **MWL**
Description: **Water Level**

Distance (ft): **.0**
Structural Grade: **0**
O&M Grade: **0**
Clock Start/From:
Clock To:
1st Value:
2nd Value:
Value Percent: **5.000**
Continuous Index:
Within 8" of Joint: **NO**
Remarks:

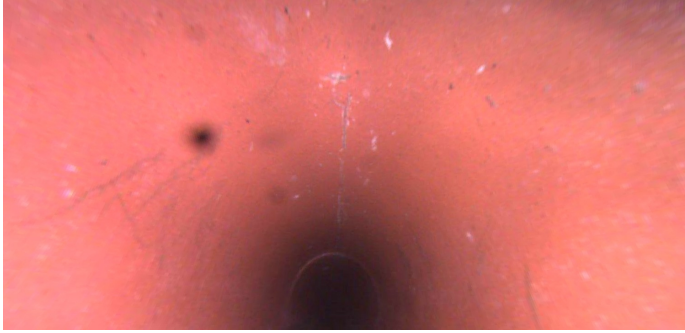
Code: **CL**
Description: **Crack Longitudinal**

Distance (ft): **7.4**
Structural Grade: **2**
O&M Grade: **0**
Clock Start/From: **12**
Clock To:
1st Value:
2nd Value:
Value Percent:
Continuous Index: **S01**
Within 8" of Joint: **YES**
Remarks:

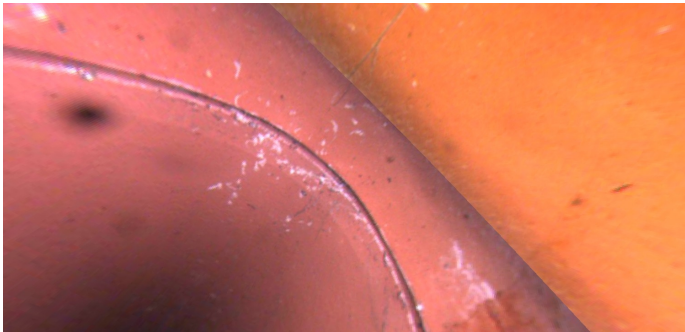
Code: **CM**
Description: **Crack Multiple**

Distance (ft): **14.4**
Structural Grade: **3**
O&M Grade: **0**
Clock Start/From: **12**
Clock To: **2**
1st Value:
2nd Value:
Value Percent:
Continuous Index: **S02**
Within 8" of Joint: **YES**
Remarks: **wandering**

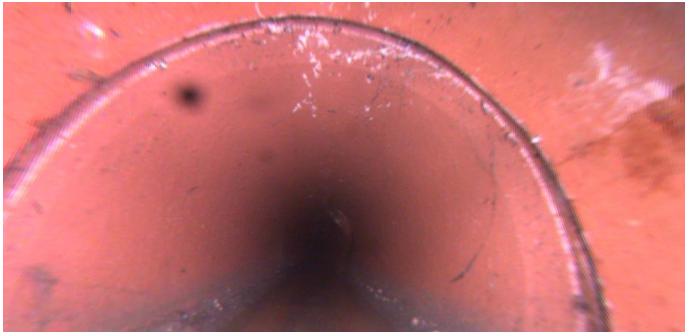
Code: **CL**
Description: **Crack Longitudinal**

Distance (ft): **14.4**
Structural Grade: **2**
O&M Grade: **0**
Clock Start/From: **12**
Clock To:
1st Value:
2nd Value:
Value Percent:
Continuous Index: **F01**
Within 8" of Joint: **YES**
Remarks:

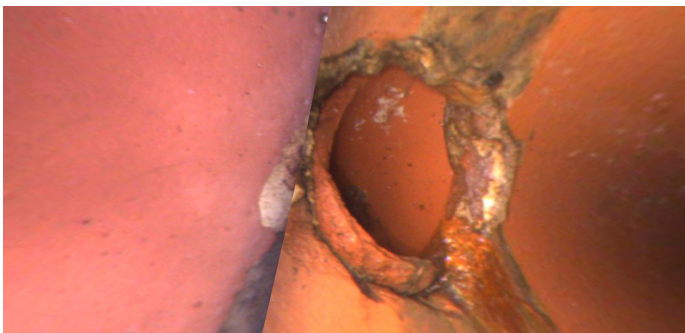
Code: **TB**
Description: **Tap Break-in**

Distance (ft): **17.4**
Structural Grade: **0**
O&M Grade: **0**
Clock Start/From: **2**
Clock To:
1st Value: **4.000**
2nd Value:
Value Percent:
Continuous Index:
Within 8" of Joint:
Remarks:

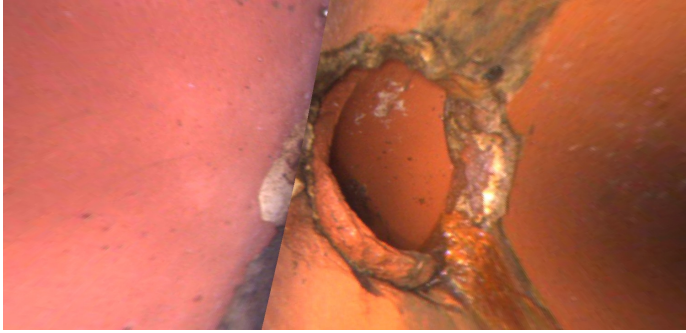
Code: **DAE**
Description: **Deposits Attached Encrustation**

Distance (ft): **17.4**
Structural Grade: **0**
O&M Grade: **2**
Clock Start/From: **9**
Clock To: **5**
1st Value:
2nd Value:
Value Percent: **5.000**
Continuous Index:
Within 8" of Joint: **NO**
Remarks: **around tap**

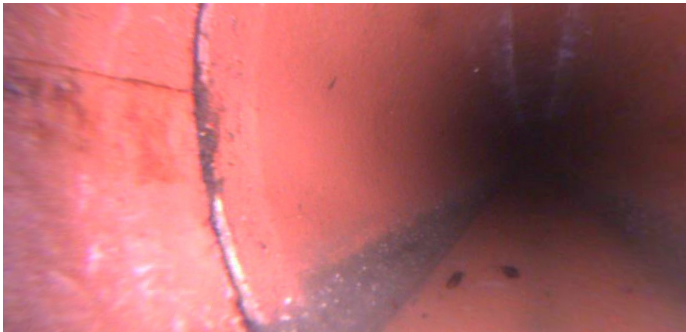
Code: **FL**
Description: **Fracture Longitudinal**

Distance (ft): **19.4**
Structural Grade: **3**
O&M Grade: **0**
Clock Start/From: **9**
Clock To:
1st Value:
2nd Value:
Value Percent:
Continuous Index:
Within 8" of Joint: **YES**
Remarks:

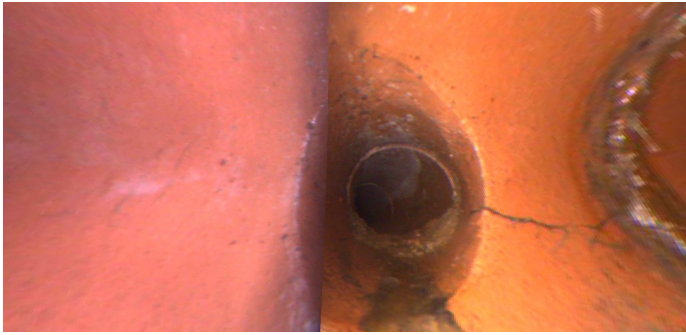
Code: **TF**
Description: **Tap Factory**

Distance (ft): **30.5**
Structural Grade: **0**
O&M Grade: **0**
Clock Start/From: **2**
Clock To:
1st Value: **4.000**
2nd Value:
Value Percent:
Continuous Index:
Within 8" of Joint: **YES**
Remarks:

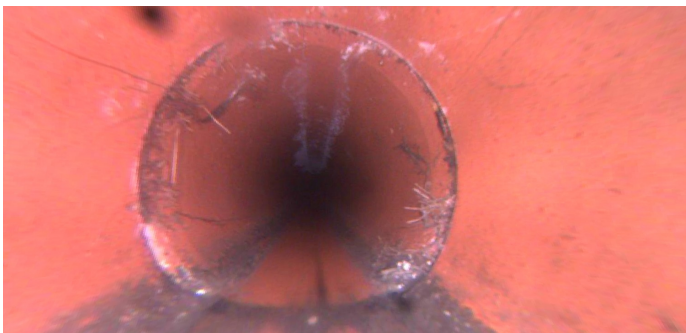
Code: **RFJ**
Description: **Roots Fine Joint**

Distance (ft): **56.0**
Structural Grade: **0**
O&M Grade: **1**
Clock Start/From: **7**
Clock To: **5**
1st Value:
2nd Value:
Value Percent:
Continuous Index:
Within 8" of Joint: **YES**
Remarks:

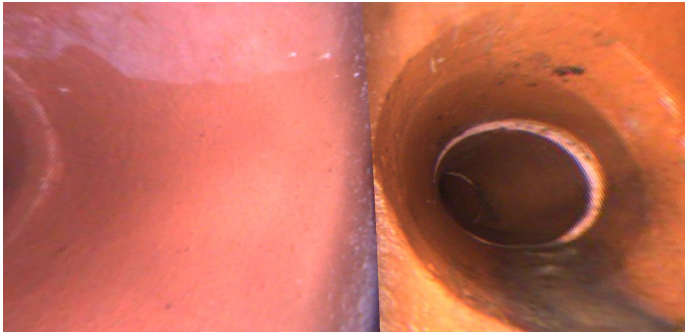
Code: **TF**
Description: **Tap Factory**

Distance (ft): **87.4**
Structural Grade: **0**
O&M Grade: **0**
Clock Start/From: **2**
Clock To:
1st Value: **4.000**
2nd Value:
Value Percent:
Continuous Index:
Within 8" of Joint: **YES**
Remarks:

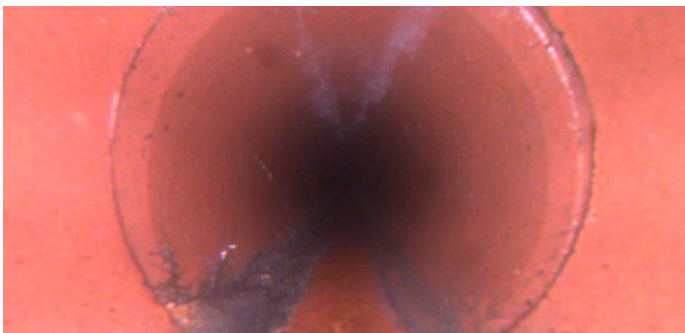
Code: **RFJ**
Description: **Roots Fine Joint**

Distance (ft): **88.0**
Structural Grade: **0**
O&M Grade: **1**
Clock Start/From: **7**
Clock To: **8**
1st Value:
2nd Value:
Value Percent:
Continuous Index:
Within 8" of Joint: **YES**
Remarks:

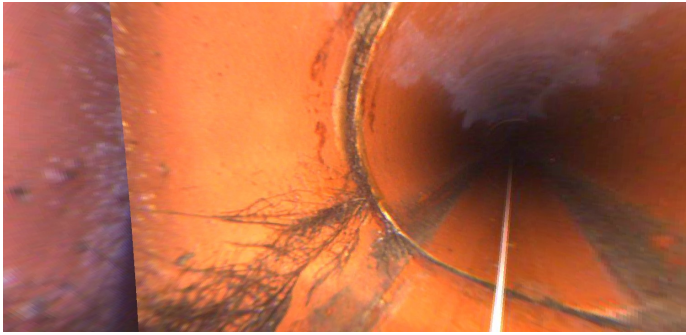
Code: **RFJ**
Description: **Roots Fine Joint**

Distance (ft): **108.8**
Structural Grade: **0**
O&M Grade: **1**
Clock Start/From: **4**
Clock To:
1st Value:
2nd Value:
Value Percent:
Continuous Index:
Within 8" of Joint: **YES**
Remarks: **into barrel**

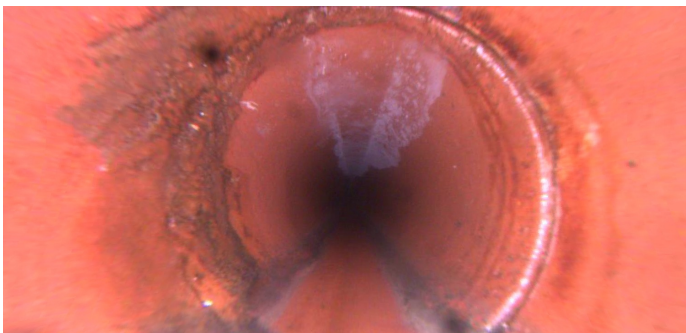
Code: **IW**
Description: **Infil Weeper**

Distance (ft): **117.9**
Structural Grade: **0**
O&M Grade: **2**
Clock Start/From: **8**
Clock To: **4**
1st Value:
2nd Value:
Value Percent:
Continuous Index:
Within 8" of Joint: **YES**
Remarks:

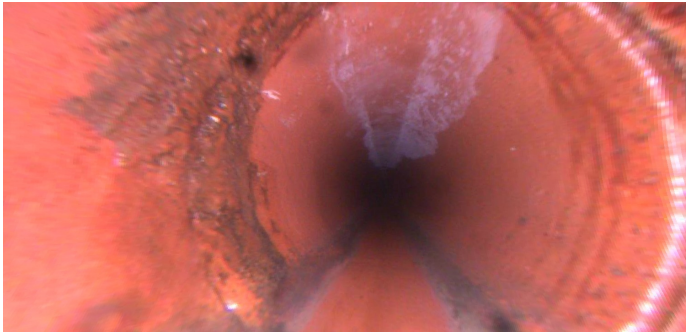
Code: **DAE**
Description: **Deposits Attached Encrustation**

Distance (ft): **117.9**
Structural Grade: **0**
O&M Grade: **2**
Clock Start/From: **7**
Clock To: **12**
1st Value:
2nd Value:
Value Percent: **5.000**
Continuous Index:
Within 8" of Joint: **YES**
Remarks:

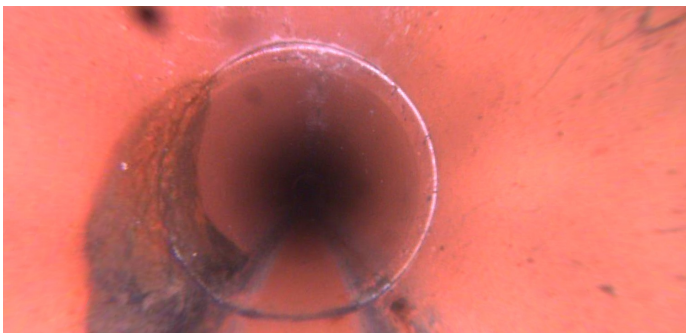
Code: **IW**
Description: **Infil Weeper**

Distance (ft): **147.6**
Structural Grade: **0**
O&M Grade: **2**
Clock Start/From: **8**
Clock To: **12**
1st Value:
2nd Value:
Value Percent:
Continuous Index:
Within 8" of Joint: **YES**
Remarks:

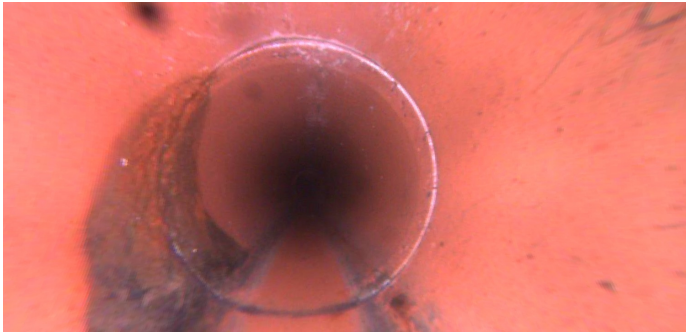
Code: **DAE**
Description: **Deposits Attached Encrustation**

Distance (ft): **147.6**
Structural Grade: **0**
O&M Grade: **2**
Clock Start/From: **7**
Clock To: **11**
1st Value:
2nd Value:
Value Percent: **5.000**
Continuous Index: **S03**
Within 8" of Joint: **YES**
Remarks: **wandering**

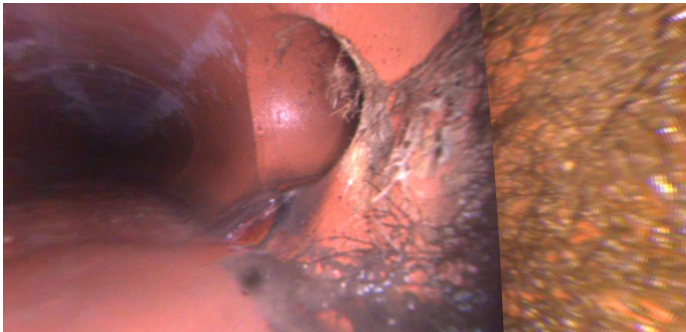
Code: **RFJ**
Description: **Roots Fine Joint**

Distance (ft): **188.0**
Structural Grade: **0**
O&M Grade: **1**
Clock Start/From: **7**
Clock To: **5**
1st Value:
2nd Value:
Value Percent:
Continuous Index:
Within 8" of Joint: **YES**
Remarks:

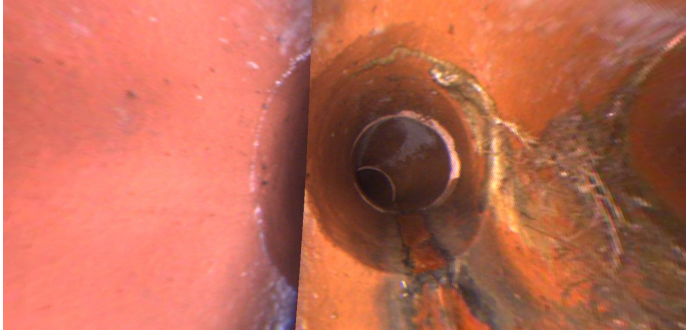
Code: **TF**
Description: **Tap Factory**

Distance (ft): **188.8**
Structural Grade: **0**
O&M Grade: **0**
Clock Start/From: **2**
Clock To:
1st Value: **4.000**
2nd Value:
Value Percent:
Continuous Index:
Within 8" of Joint: **YES**
Remarks:

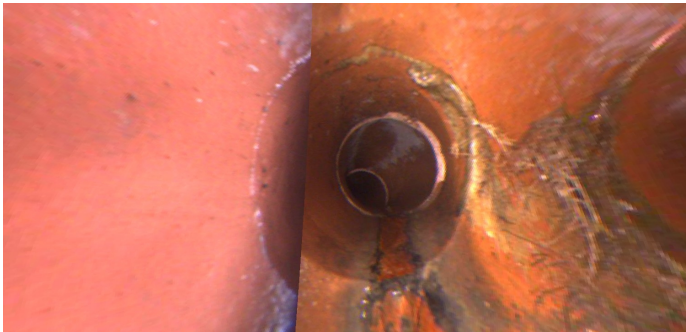
Code: **RFC**
Description: **Roots Fine Connection**

Distance (ft): **188.8**
Structural Grade: **0**
O&M Grade: **1**
Clock Start/From: **2**
Clock To:
1st Value:
2nd Value:
Value Percent:
Continuous Index:
Within 8" of Joint: **NO**
Remarks:

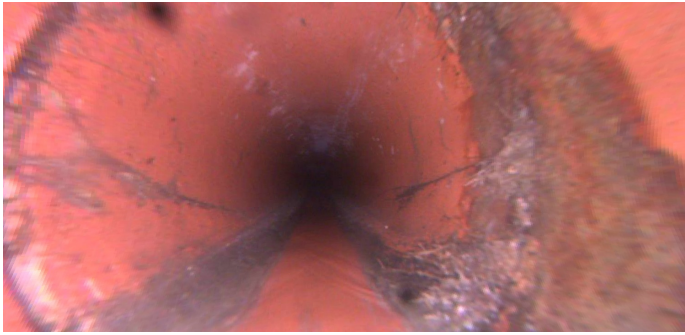
Code: **RFJ**
Description: **Roots Fine Joint**

Distance (ft): **224.3**
Structural Grade: **0**
O&M Grade: **1**
Clock Start/From: **7**
Clock To: **5**
1st Value:
2nd Value:
Value Percent:
Continuous Index: **S04**
Within 8" of Joint: **YES**
Remarks: **wandering**

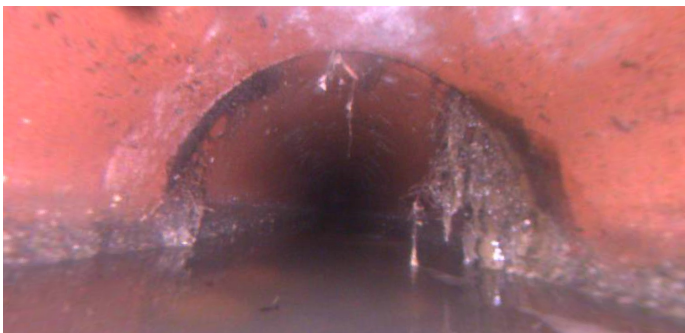
Code: **RMJ**
Description: **Roots Medium Joint**

Distance (ft): **258.7**
Structural Grade: **0**
O&M Grade: **3**
Clock Start/From: **8**
Clock To: **4**
1st Value:
2nd Value:
Value Percent: **15.000**
Continuous Index:
Within 8" of Joint: **YES**
Remarks:

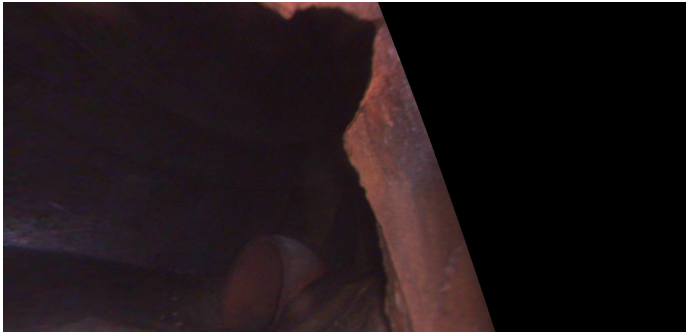
Code: **RFJ**
Description: **Roots Fine Joint**

Distance (ft): **265.4**
Structural Grade: **0**
O&M Grade: **1**
Clock Start/From: **7**
Clock To: **5**
1st Value:
2nd Value:
Value Percent:
Continuous Index: **F04**
Within 8" of Joint: **YES**
Remarks: **wandering**

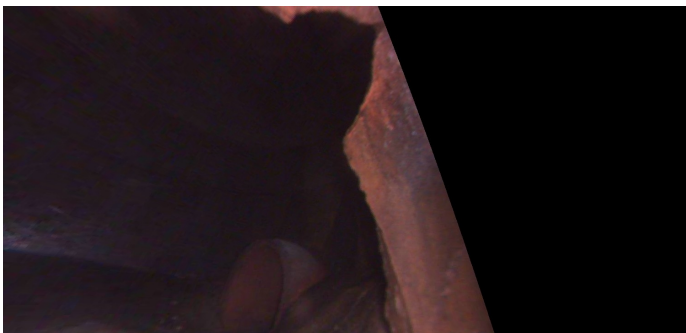
Code: **DAE**
Description: **Deposits Attached Encrustation**

Distance (ft): **265.4**
Structural Grade: **0**
O&M Grade: **2**
Clock Start/From: **7**
Clock To: **11**
1st Value:
2nd Value:
Value Percent: **5.000**
Continuous Index: **F03**
Within 8" of Joint: **YES**
Remarks: **wandering**

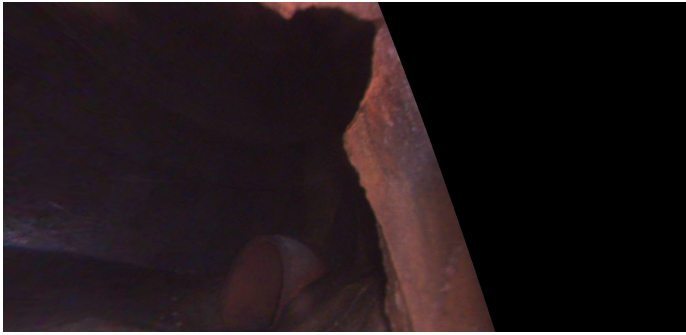
Code: **CM**
Description: **Crack Multiple**

Distance (ft): **265.4**
Structural Grade: **3**
O&M Grade: **0**
Clock Start/From: **12**
Clock To: **2**
1st Value:
2nd Value:
Value Percent:
Continuous Index: **F02**
Within 8" of Joint: **YES**
Remarks: **wandering**

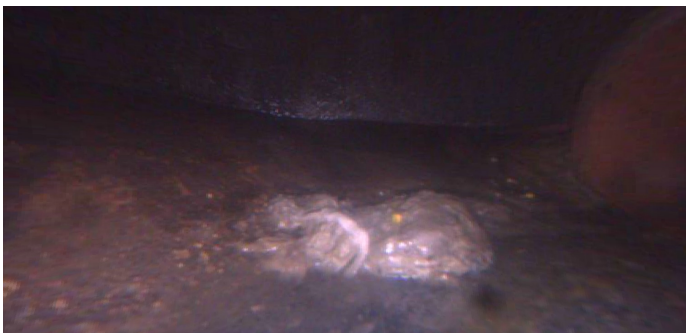
Code: **AMH**
Description: **Manhole**

Distance (ft): **266.3**
Structural Grade: **0**
O&M Grade: **0**
Clock Start/From:
Clock To:
1st Value:
2nd Value:
Value Percent:
Continuous Index:
Within 8" of Joint: **NO**
Remarks: **M-108-042**
