## Profile/Photo Observation Report

Street:	<b>OFF MISSISSIPPI PL</b>	Flow Control:	<b>Not Controlled</b>
City:	<b>Hobart, IN</b>	Year Renewed:	
Location:	<b>Light Highway</b>	Tape/Media #:	
Purpose:	<b>Routine Assessment</b>	Dia/Height:	<b>10"</b>
Use:	<b>Sanitary</b>	Material:	<b>VCP</b>
Drain Area:	<b>NA</b>	Lining:	
Category:	<b>NA</b>		
Comment:	<b>Flow direction wrong</b>

Location Details:		Direction of Survey:	<b>Downstream</b>
US MH:	<b>M-108-043</b>	DS MH:	<b>M-108-042</b>
		Total Length Surveyed (ft):	<b>240.7</b>

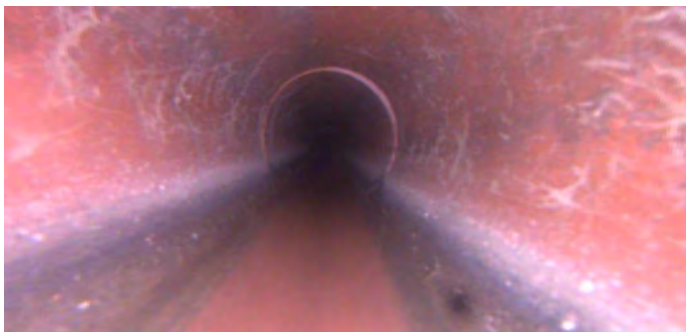
Code: **AMH**  
Description: **Manhole**

Distance (ft): **.0**  
Structural Grade: **0**  
O&M Grade: **0**  
Clock Start/From:  
Clock To:  
1st Value:  
2nd Value:  
Value Percent:  
Continuous Index:  
Within 8" of Joint: **NO**  
Remarks: **M-108-043**

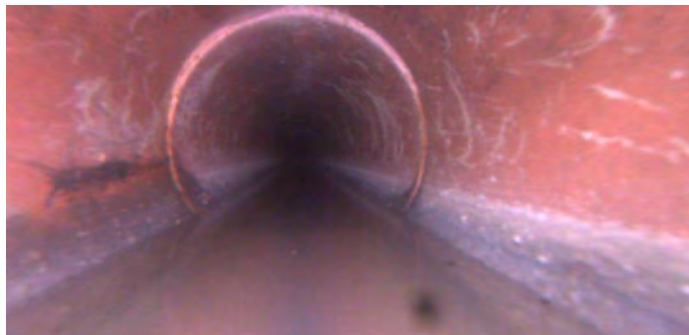
Code: **RFJ**  
Description: **Roots Fine Joint**

Distance (ft): **6.7**  
Structural Grade: **0**  
O&M Grade: **1**  
Clock Start/From: **9**  
Clock To:  
1st Value:  
2nd Value:  
Value Percent:  
Continuous Index:  
Within 8" of Joint: **YES**  
Remarks:

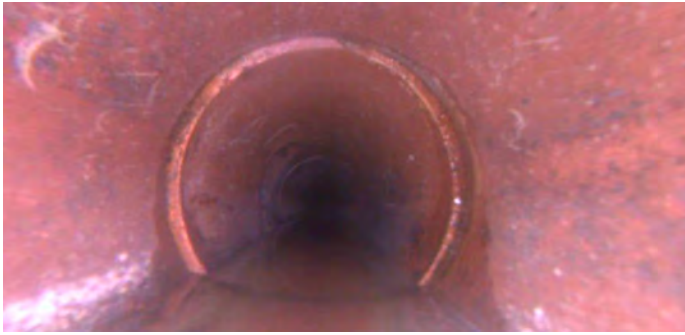
Code: **IW**  
Description: **Infil Weeper**

Distance (ft): **26.5**  
Structural Grade: **0**  
O&M Grade: **2**  
Clock Start/From: **8**  
Clock To: **4**  
1st Value:  
2nd Value:  
Value Percent:  
Continuous Index:  
Within 8" of Joint: **YES**  
Remarks:

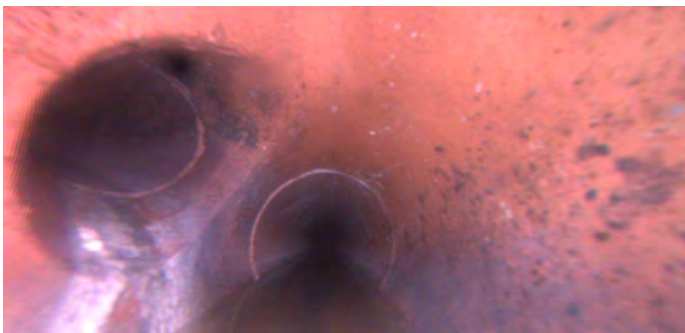
Code: **TF**  
Description: **Tap Factory**

Distance (ft): **28.0**  
Structural Grade: **0**  
O&M Grade: **0**  
Clock Start/From: **10**  
Clock To:  
1st Value: **4.000**  
2nd Value:  
Value Percent:  
Continuous Index:  
Within 8" of Joint:  
Remarks:

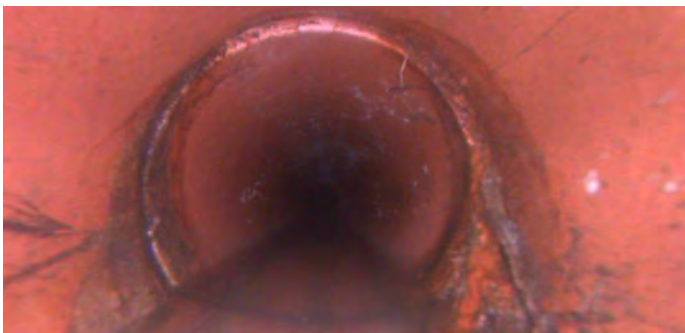
Code: **IW**  
Description: **Infil Weeper**

Distance (ft): **58.3**  
Structural Grade: **0**  
O&M Grade: **2**  
Clock Start/From: **8**  
Clock To: **4**  
1st Value:  
2nd Value:  
Value Percent:  
Continuous Index:  
Within 8" of Joint: **YES**  
Remarks:

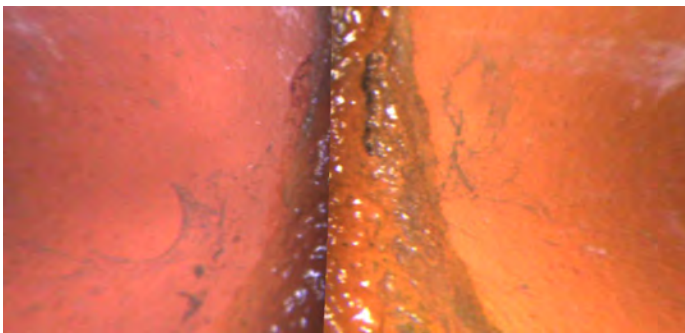
Code: **DAE**  
Description: **Deposits Attached Encrustation**

Distance (ft): **83.7**  
Structural Grade: **0**  
O&M Grade: **2**  
Clock Start/From: **7**  
Clock To: **5**  
1st Value:  
2nd Value:  
Value Percent: **5.000**  
Continuous Index: **S02**  
Within 8" of Joint: **YES**  
Remarks: **wandering**

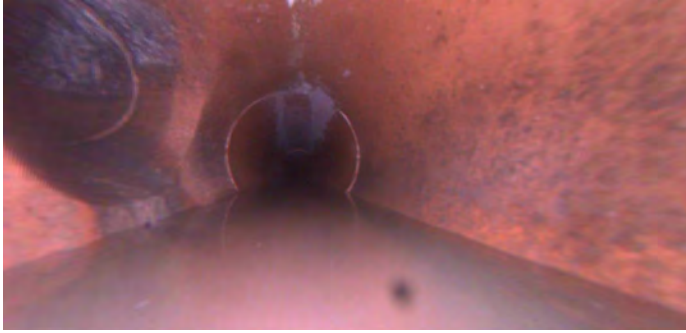
Code: **TF**  
Description: **Tap Factory**

Distance (ft): **89.2**  
Structural Grade: **0**  
O&M Grade: **0**  
Clock Start/From: **10**  
Clock To:  
1st Value: **4.000**  
2nd Value:  
Value Percent:  
Continuous Index:  
Within 8" of Joint: **YES**  
Remarks:

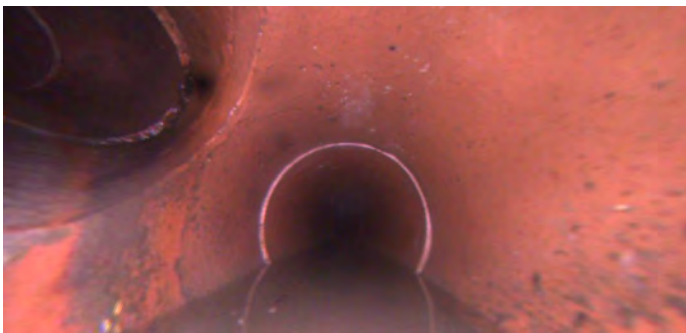
Code: **TF**  
Description: **Tap Factory**

Distance (ft): **165.8**  
Structural Grade: **0**  
O&M Grade: **0**  
Clock Start/From: **10**  
Clock To:  
1st Value: **4.000**  
2nd Value:  
Value Percent:  
Continuous Index:  
Within 8" of Joint: **YES**  
Remarks:

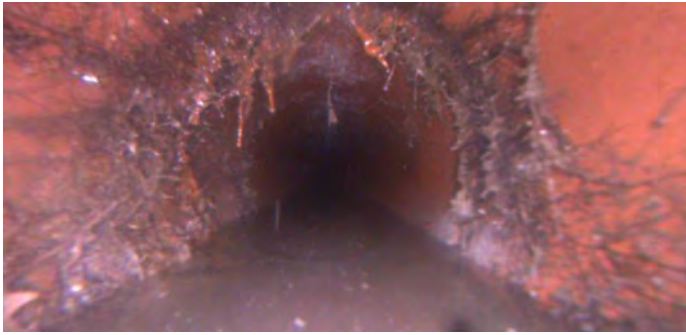
Code: **RMJ**  
Description: **Roots Medium Joint**

Distance (ft): **190.9**  
Structural Grade: **0**  
O&M Grade: **3**  
Clock Start/From: **8**  
Clock To: **4**  
1st Value:  
2nd Value:  
Value Percent: **10.000**  
Continuous Index:  
Within 8" of Joint: **YES**  
Remarks:

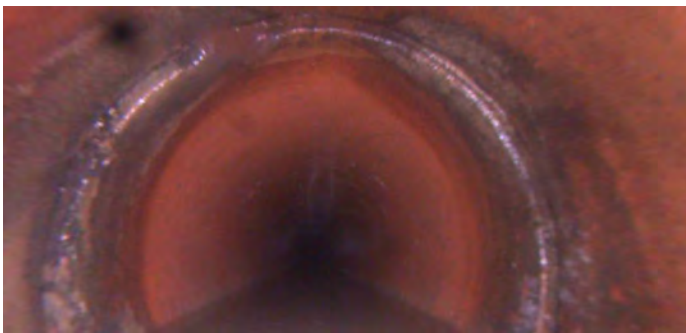
Code: **IW**  
Description: **Infil Weeper**

Distance (ft): **220.7**  
Structural Grade: **0**  
O&M Grade: **2**  
Clock Start/From: **8**  
Clock To: **4**  
1st Value:  
2nd Value:  
Value Percent:  
Continuous Index:  
Within 8" of Joint: **YES**  
Remarks:

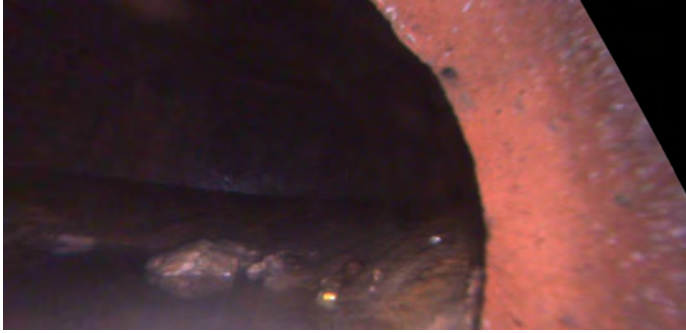
Code: **DAE**  
Description: **Deposits Attached Encrustation**

Distance (ft): **239.8**  
Structural Grade: **0**  
O&M Grade: **2**  
Clock Start/From: **7**  
Clock To: **5**  
1st Value:  
2nd Value:  
Value Percent: **5.000**  
Continuous Index: **F02**  
Within 8" of Joint: **YES**  
Remarks: **wandering**

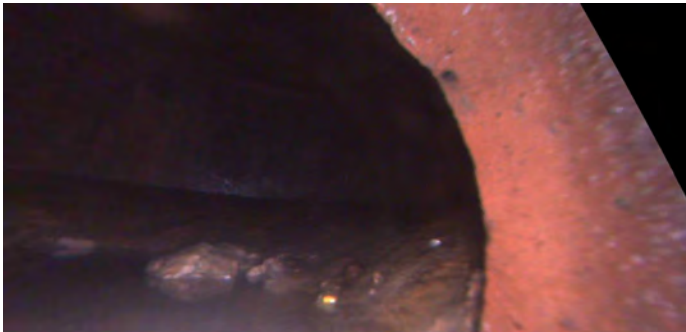
Code: **RFJ**  
Description: **Roots Fine Joint**

Distance (ft): **239.8**  
Structural Grade: **0**  
O&M Grade: **1**  
Clock Start/From: **7**  
Clock To: **5**  
1st Value:  
2nd Value:  
Value Percent:  
Continuous Index: **F01**  
Within 8" of Joint: **YES**  
Remarks: **wandering**
