## Profile/Photo Observation Report

Street:	<b>FOXCROFT STREET</b>	Flow Control:	<b>Not Controlled</b>
City:	<b>Hobart, IN</b>	Year Renewed:	
Location:	<b>Light Highway</b>	Tape/Media #:	
Purpose:	<b>Routine Assessment</b>	Dia/Height:	<b>10"</b>
Use:	<b>Sanitary</b>	Material:	<b>VCP</b>
Drain Area:	<b>NA</b>	Lining:	
Category:	<b>NA</b>		
Comment:	<b>Flow direction wrong</b>

Location Details:		Direction of Survey:	<b>Downstream</b>
US MH:	<b>M-108-043</b>	DS MH:	<b>M-108-042</b>
		Total Length Surveyed (ft):	<b>240.7</b>

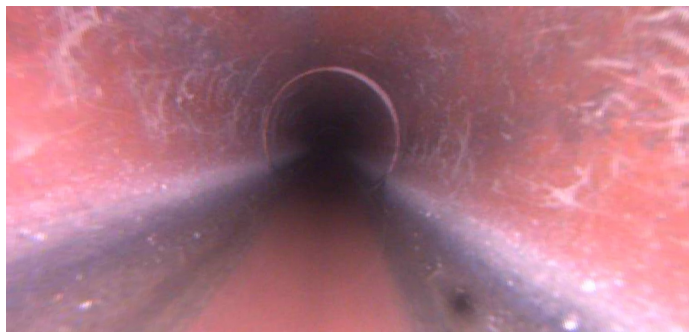
Code: **AMH**  
 Description: **Manhole**  
 Distance (ft): **.0**  
 Structural Grade: **0**  
 O&M Grade: **0**  
 Clock Start/From:  
 Clock To:  
 1st Value:  
 2nd Value:  
 Value Percent:  
 Continuous Index:  
 Within 8" of Joint: **NO**  
 Remarks: **M-108-043**

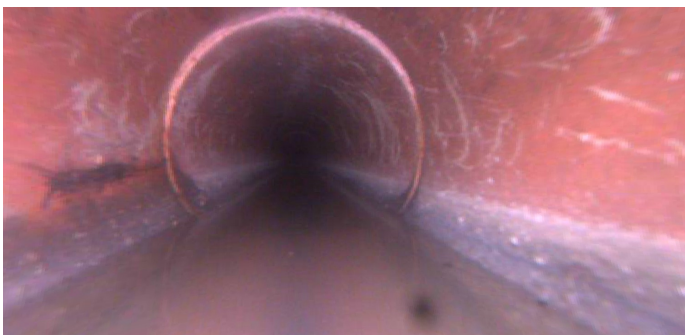
Code:	<b>RFJ</b>
Description:	<b>Roots Fine Joint</b>

Distance (ft):	<b>6.7</b>
Structural Grade:	<b>0</b>
O&M Grade:	<b>1</b>
Clock Start/From:	<b>9</b>
Clock To:	
1st Value:	
2nd Value:	
Value Percent:	
Continuous Index:	
Within 8" of Joint:	<b>YES</b>
Remarks:

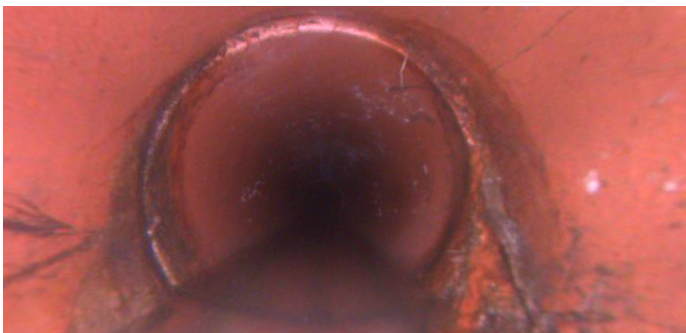
Code: **IW**  
Description: **Infil Weeper**

Distance (ft): **58.3**  
Structural Grade: **0**  
O&M Grade: **2**  
Clock Start/From: **8**  
Clock To: **4**  
1st Value:  
2nd Value:  
Value Percent:  
Continuous Index:  
Within 8" of Joint: **YES**  
Remarks:

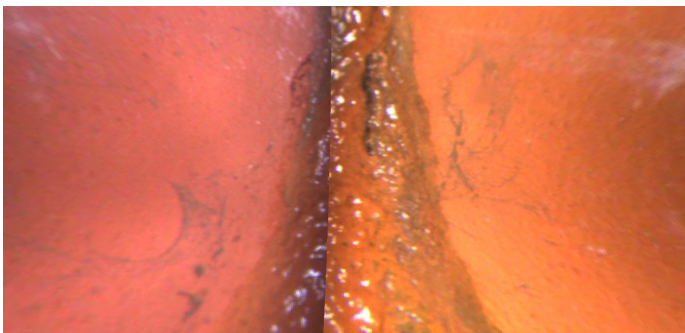
Code: **DAE**  
Description: **Deposits Attached Encrustation**

Distance (ft): **83.7**  
Structural Grade: **0**  
O&M Grade: **2**  
Clock Start/From: **7**  
Clock To: **5**  
1st Value:  
2nd Value:  
Value Percent: **5.000**  
Continuous Index: **S02**  
Within 8" of Joint: **YES**  
Remarks: **wandering**

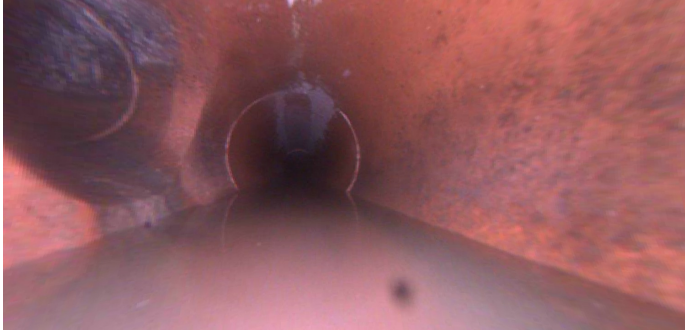
Code: **TF**  
Description: **Tap Factory**

Distance (ft): **89.2**  
Structural Grade: **0**  
O&M Grade: **0**  
Clock Start/From: **10**  
Clock To:  
1st Value: **4.000**  
2nd Value:  
Value Percent:  
Continuous Index:  
Within 8" of Joint: **YES**  
Remarks:

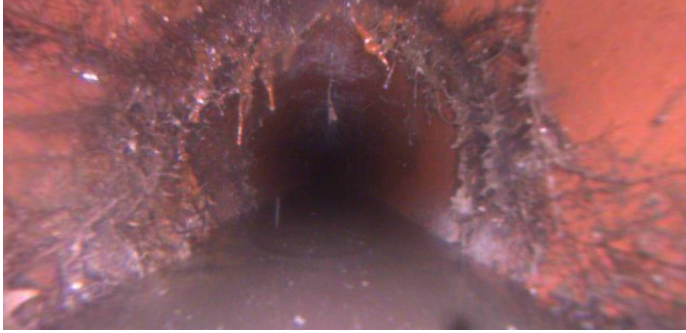
Code: **RMJ**  
Description: **Roots Medium Joint**

Distance (ft): **190.9**  
Structural Grade: **0**  
O&M Grade: **3**  
Clock Start/From: **8**  
Clock To: **4**  
1st Value:  
2nd Value:  
Value Percent: **10.000**  
Continuous Index:  
Within 8" of Joint: **YES**  
Remarks:

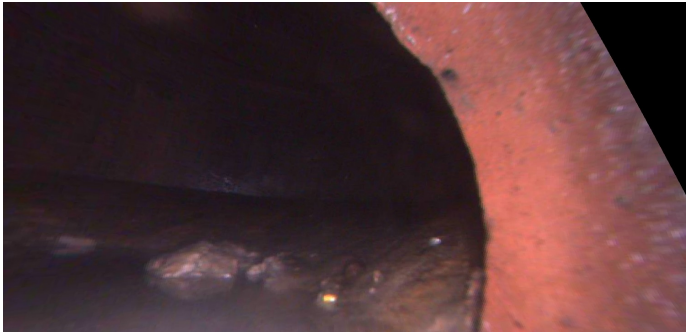
Code: **DAE**  
Description: **Deposits Attached Encrustation**

Distance (ft): **239.8**  
Structural Grade: **0**  
O&M Grade: **2**  
Clock Start/From: **7**  
Clock To: **5**  
1st Value:  
2nd Value:  
Value Percent: **5.000**  
Continuous Index: **F02**  
Within 8" of Joint: **YES**  
Remarks: **wandering**

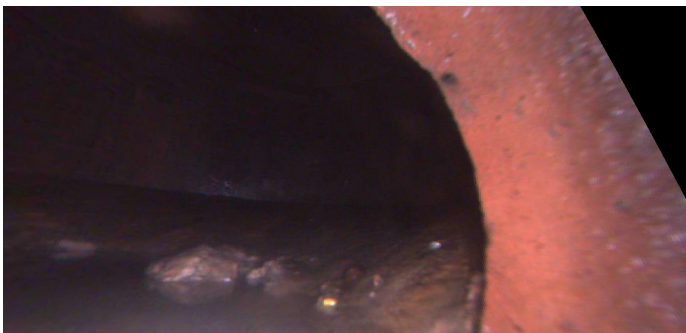
Code: **RFJ**  
Description: **Roots Fine Joint**

Distance (ft): **239.8**  
Structural Grade: **0**  
O&M Grade: **1**  
Clock Start/From: **7**  
Clock To: **5**  
1st Value:  
2nd Value:  
Value Percent:  
Continuous Index: **F01**  
Within 8" of Joint: **YES**  
Remarks: **wandering**
