Profile/Photo Observation Report

Date:	03/25/2018	Weather:		Coding:	PACP 6.0
Pipe Length (ft):	248.7	Owner:	NA	Pre Clean:	No Pre-Cleaning
P.O.#:		Surveyor:	Byrd Fitzgerald	PSR:	P-108-043-044
Customer:		Clean Date:	01/01/1900	Shape:	C

Street:	OFF MISSISSIPPI PL	Flow Control:	Not Controlled
City:	Hobart, IN	Year Renewed:	
Location:	Light Highway	Tape/Media #:	
Purpose:	Routine Assessment	Dia/Height:	10"
Use:	Sanitary	Material:	VCP
Drain Area:	NA	Lining:	
Category:	NA		
Comment:	Flow direction wroong		
Location Details:		Direction of Survey:	Upstream
US MH:	M-108-044	DS MH:	M-108-043
		Total Length Surveyed (ft):	256.5

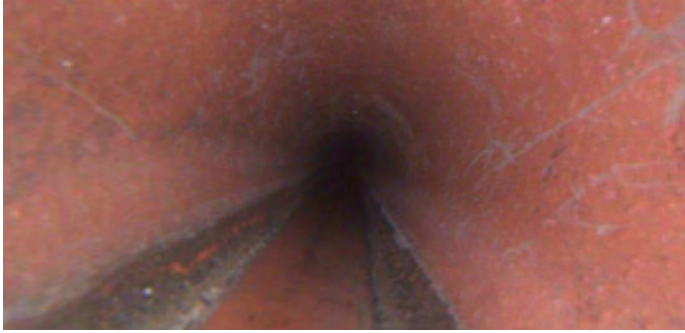
Code: **AMH**
Description: **Manhole**

Distance (ft): **.0**
Structural Grade: **0**
O&M Grade: **0**
Clock Start/From:
Clock To:
1st Value:
2nd Value:
Value Percent:
Continuous Index:
Within 8" of Joint: **NO**
Remarks: **M-108-043**

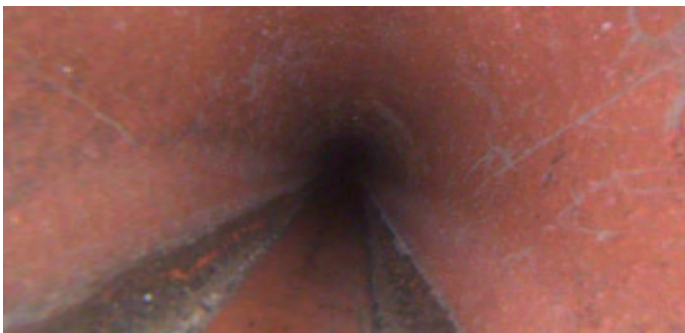
Code: **MWL**
Description: **Water Level**

Distance (ft): **.0**
Structural Grade: **0**
O&M Grade: **0**
Clock Start/From:
Clock To:
1st Value:
2nd Value:
Value Percent: **5.000**
Continuous Index:
Within 8" of Joint: **NO**
Remarks:

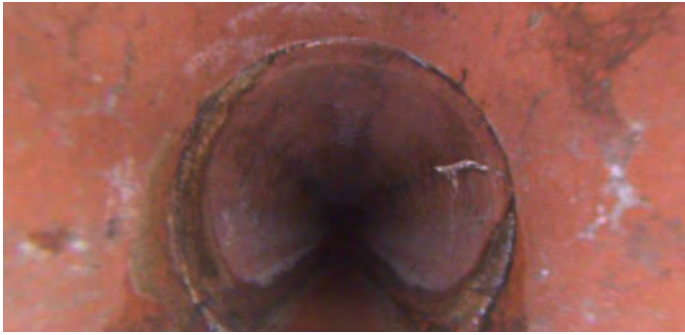
Code: **IW**
Description: **Infil Weeper**

Distance (ft): **14.2**
Structural Grade: **0**
O&M Grade: **2**
Clock Start/From: **8**
Clock To: **4**
1st Value:
2nd Value:
Value Percent:
Continuous Index:
Within 8" of Joint: **YES**
Remarks:

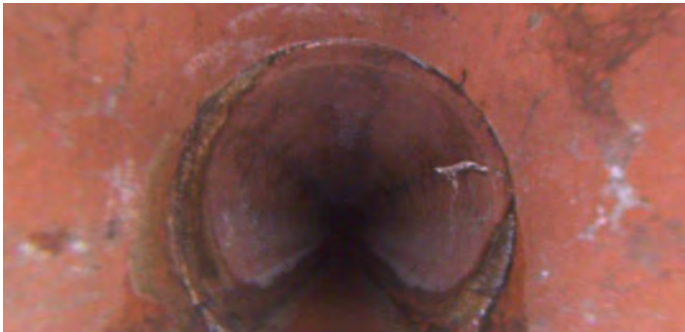
Code: **RFJ**
Description: **Roots Fine Joint**

Distance (ft): **14.2**
Structural Grade: **0**
O&M Grade: **1**
Clock Start/From: **3**
Clock To:
1st Value:
2nd Value:
Value Percent:
Continuous Index:
Within 8" of Joint: **YES**
Remarks:

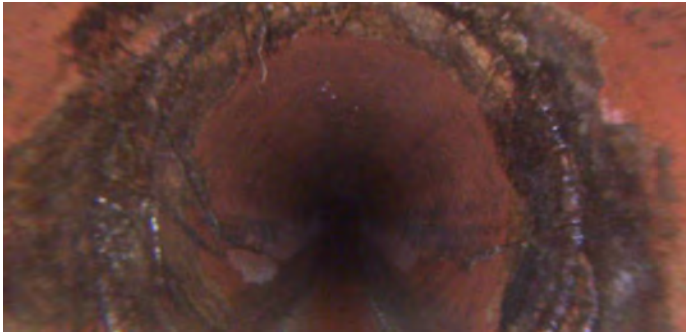
Code: **IW**
Description: **Infil Weeper**

Distance (ft): **24.8**
Structural Grade: **0**
O&M Grade: **2**
Clock Start/From: **8**
Clock To: **4**
1st Value:
2nd Value:
Value Percent:
Continuous Index:
Within 8" of Joint: **YES**
Remarks:

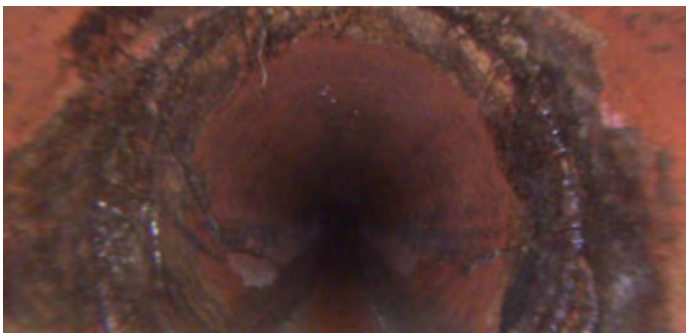
Code: **RFJ**
Description: **Roots Fine Joint**

Distance (ft): **24.8**
Structural Grade: **0**
O&M Grade: **1**
Clock Start/From: **8**
Clock To: **4**
1st Value:
2nd Value:
Value Percent:
Continuous Index:
Within 8" of Joint: **YES**
Remarks:

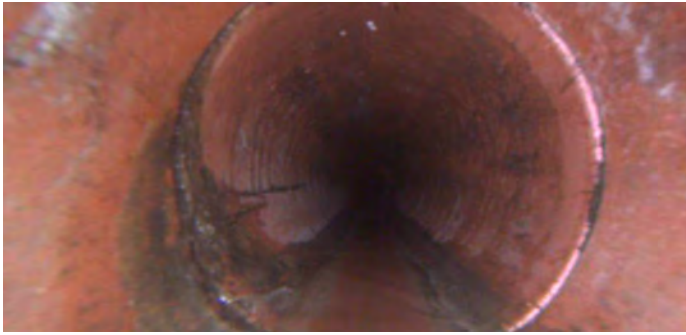
Code: **RFJ**
Description: **Roots Fine Joint**

Distance (ft): **40.3**
Structural Grade: **0**
O&M Grade: **1**
Clock Start/From: **8**
Clock To: **4**
1st Value:
2nd Value:
Value Percent:
Continuous Index:
Within 8" of Joint: **YES**
Remarks:

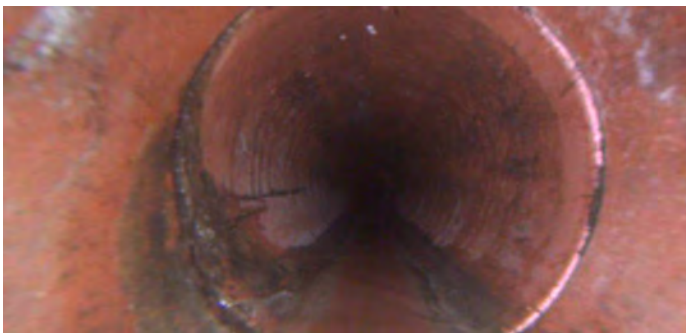
Code: **IW**
Description: **Infil Weeper**

Distance (ft): **40.3**
Structural Grade: **0**
O&M Grade: **2**
Clock Start/From: **7**
Clock To: **10**
1st Value:
2nd Value:
Value Percent:
Continuous Index:
Within 8" of Joint: **YES**
Remarks:

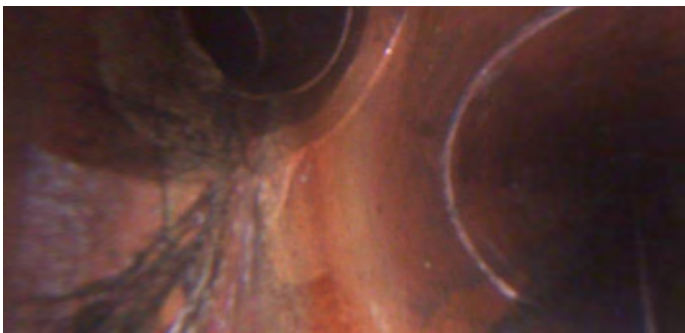
Code: **RFL**
Description: **Roots Fine Lateral**

Distance (ft): **47.1**
Structural Grade: **0**
O&M Grade: **1**
Clock Start/From: **3**
Clock To:
1st Value:
2nd Value:
Value Percent:
Continuous Index:
Within 8" of Joint: **NO**
Remarks:

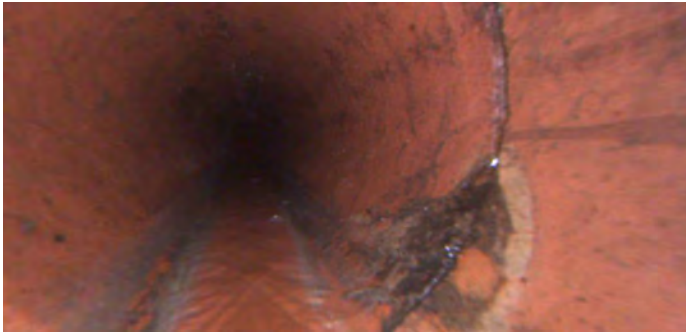
Code: **IW**
Description: **Infil Weeper**

Distance (ft): **47.7**
Structural Grade: **0**
O&M Grade: **2**
Clock Start/From: **3**
Clock To: **4**
1st Value:
2nd Value:
Value Percent:
Continuous Index:
Within 8" of Joint: **YES**
Remarks:

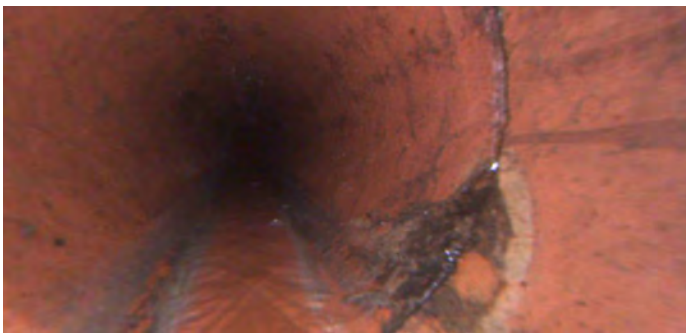
Code: **RFJ**
Description: **Roots Fine Joint**

Distance (ft): **47.7**
Structural Grade: **0**
O&M Grade: **1**
Clock Start/From: **3**
Clock To:
1st Value:
2nd Value:
Value Percent:
Continuous Index:
Within 8" of Joint: **YES**
Remarks:

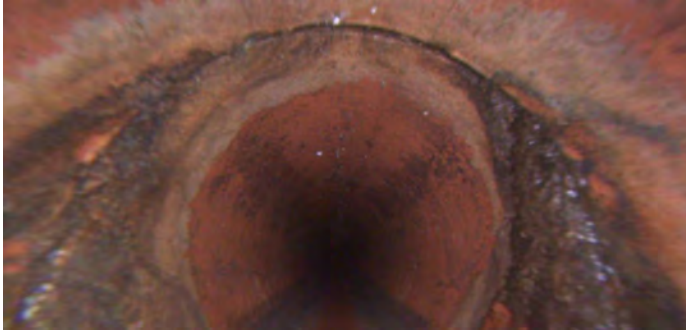
Code: **IW**
Description: **Infil Weeper**

Distance (ft): **53.0**
Structural Grade: **0**
O&M Grade: **2**
Clock Start/From: **8**
Clock To: **4**
1st Value:
2nd Value:
Value Percent:
Continuous Index:
Within 8" of Joint: **YES**
Remarks:

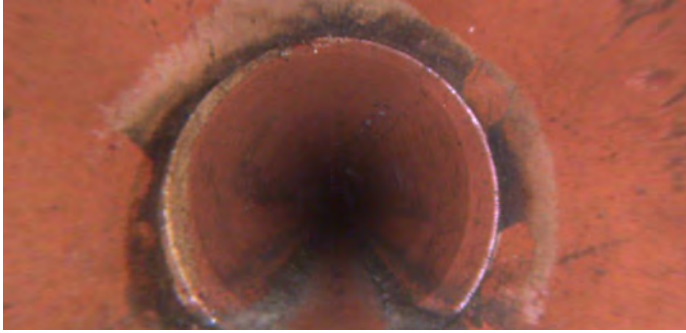
Code: **IW**
Description: **Infil Weeper**

Distance (ft): **73.7**
Structural Grade: **0**
O&M Grade: **2**
Clock Start/From: **8**
Clock To: **4**
1st Value:
2nd Value:
Value Percent:
Continuous Index:
Within 8" of Joint: **YES**
Remarks:

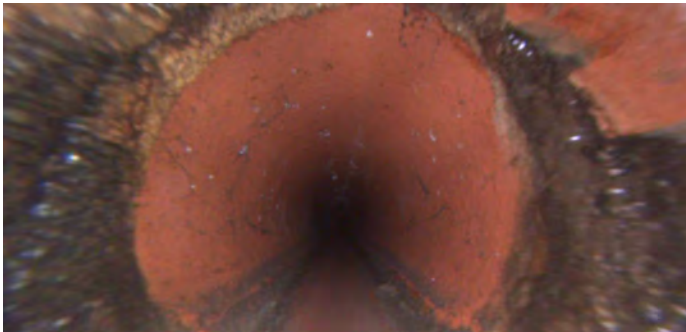
Code: **DAE**
Description: **Deposits Attached Encrustation**

Distance (ft): **84.5**
Structural Grade: **0**
O&M Grade: **2**
Clock Start/From: **8**
Clock To: **4**
1st Value:
2nd Value:
Value Percent: **5.000**
Continuous Index:
Within 8" of Joint: **YES**
Remarks:

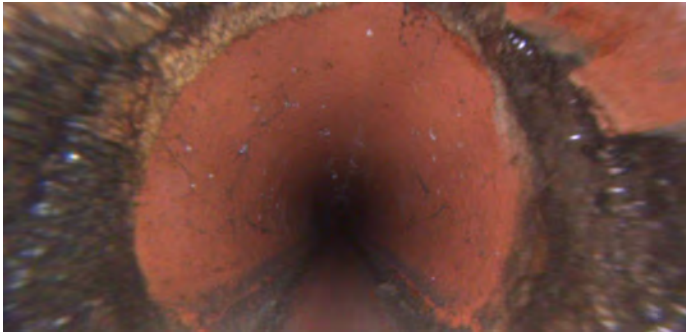
Code: **IW**
Description: **Infil Weeper**

Distance (ft): **84.5**
Structural Grade: **0**
O&M Grade: **2**
Clock Start/From: **8**
Clock To: **4**
1st Value:
2nd Value:
Value Percent:
Continuous Index:
Within 8" of Joint:
Remarks:

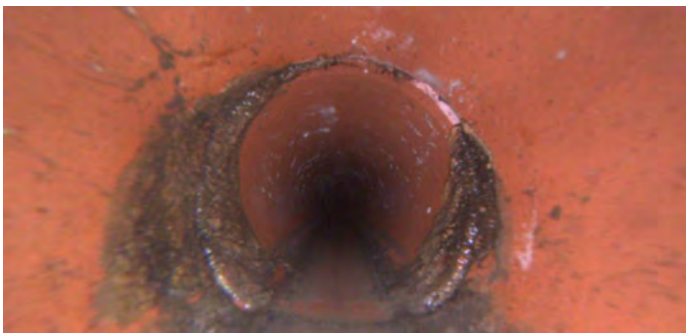
Code: **DAE**
Description: **Deposits Attached Encrustation**

Distance (ft): **99.9**
Structural Grade: **0**
O&M Grade: **2**
Clock Start/From: **8**
Clock To: **4**
1st Value:
2nd Value:
Value Percent: **5.000**
Continuous Index:
Within 8" of Joint: **YES**
Remarks:

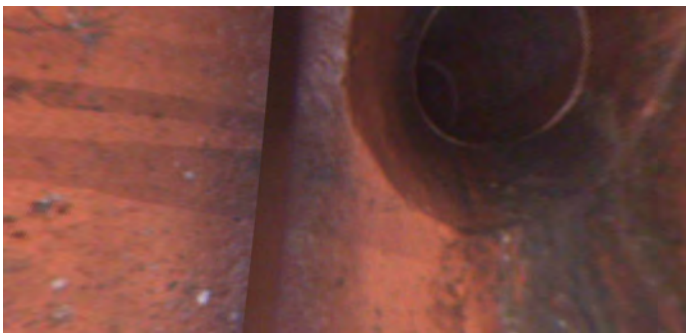
Code: **TF**
Description: **Tap Factory**

Distance (ft): **106.9**
Structural Grade: **0**
O&M Grade: **0**
Clock Start/From: **2**
Clock To:
1st Value: **4.000**
2nd Value:
Value Percent:
Continuous Index:
Within 8" of Joint: **YES**
Remarks:

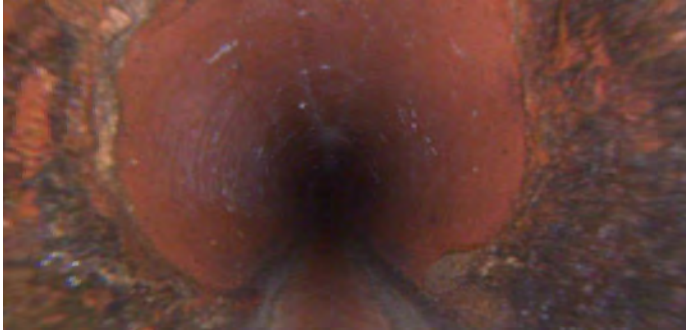
Code:	DAZ
Description:	Deposits Attached Other

Distance (ft):	107.5
Structural Grade:	0
O&M Grade:	2
Clock Start/From:	7
Clock To:	5
1st Value:	
2nd Value:	
Value Percent:	5.000
Continuous Index:	S01
Within 8" of Joint:	YES
Remarks:

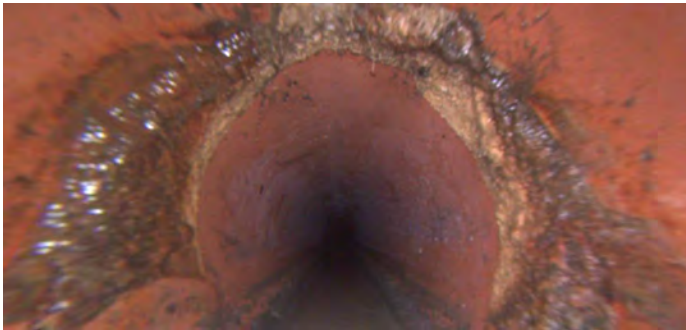
Code:	IW
Description:	Infil Weeper

Distance (ft):	128.4
Structural Grade:	0
O&M Grade:	2
Clock Start/From:	8
Clock To:	4
1st Value:	
2nd Value:	
Value Percent:	
Continuous Index:	
Within 8" of Joint:	YES
Remarks:

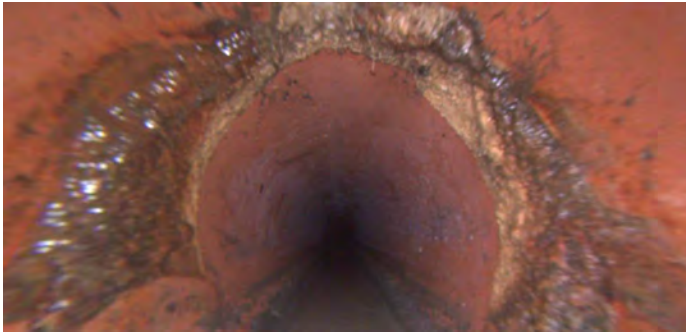
Code: **RFJ**
Description: **Roots Fine Joint**

Distance (ft): **128.4**
Structural Grade: **0**
O&M Grade: **1**
Clock Start/From: **8**
Clock To: **4**
1st Value:
2nd Value:
Value Percent:
Continuous Index:
Within 8" of Joint: **YES**
Remarks:

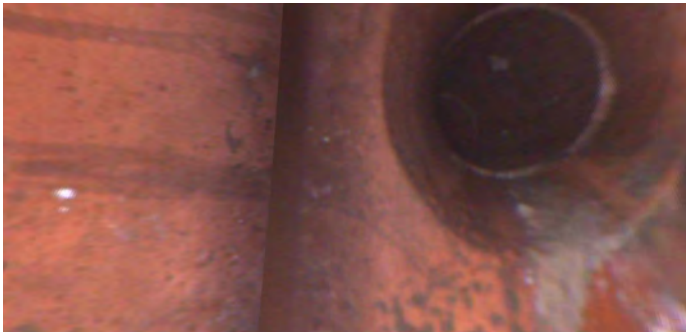
Code: **TF**
Description: **Tap Factory**

Distance (ft): **171.8**
Structural Grade: **0**
O&M Grade: **0**
Clock Start/From: **2**
Clock To:
1st Value: **4.000**
2nd Value:
Value Percent:
Continuous Index:
Within 8" of Joint: **YES**
Remarks:

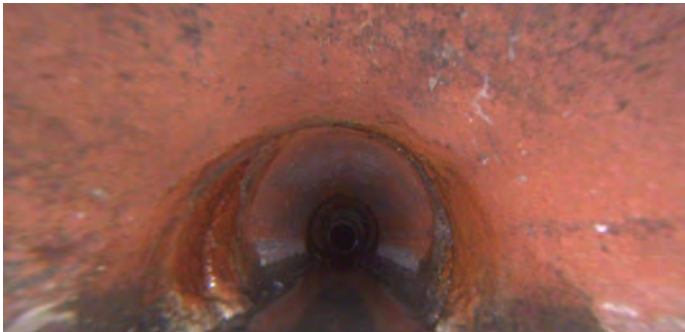
Code: **IW**
Description: **Infil Weeper**

Distance (ft): **252.0**
Structural Grade: **0**
O&M Grade: **2**
Clock Start/From: **8**
Clock To: **4**
1st Value:
2nd Value:
Value Percent:
Continuous Index:
Within 8" of Joint: **YES**
Remarks:

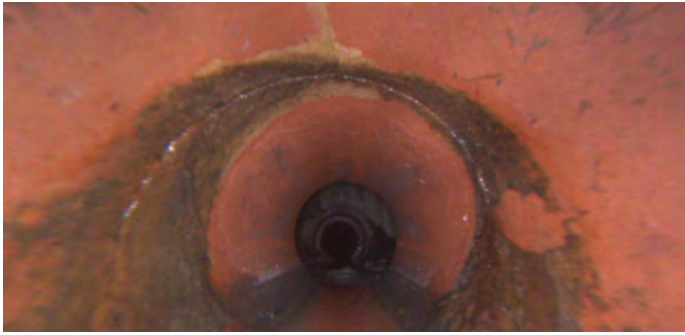
Code: **IW**
Description: **Infil Weeper**

Distance (ft): **253.9**
Structural Grade: **0**
O&M Grade: **2**
Clock Start/From: **8**
Clock To: **4**
1st Value:
2nd Value:
Value Percent:
Continuous Index:
Within 8" of Joint: **YES**
Remarks:

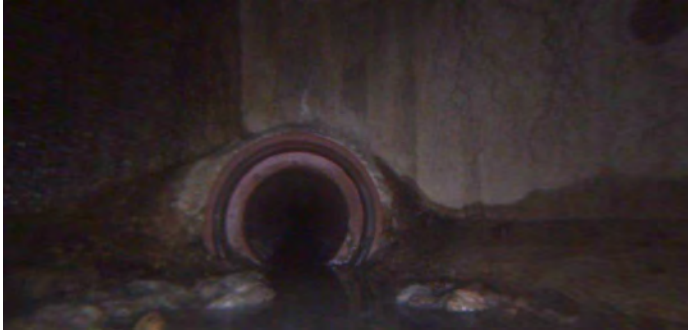
Code:	AMH
Description:	Manhole
Distance (ft):	256.5
Structural Grade:	0
O&M Grade:	0
Clock Start/From:	
Clock To:	
1st Value:	
2nd Value:	
Value Percent:	
Continuous Index:	
Within 8" of Joint:	NO
Remarks:	M-108-044
