Profile/Photo Observation Report

Street:	FOXCROFT STREET	Flow Control:	Not Controlled
City:	Hobart, IN	Year Renewed:	
Location:	Light Highway	Tape/Media #:	
Purpose:	Routine Assessment	Dia/Height:	10"
Use:	Sanitary	Material:	VCP
Drain Area:	NA	Lining:	
Category:	NA		
Comment:	Flow direction wroong		
Location Details:		Direction of Survey:	Upstream
US MH:	M-108-044	DS MH:	M-108-043
		Total Length Surveyed (ft):	256.5

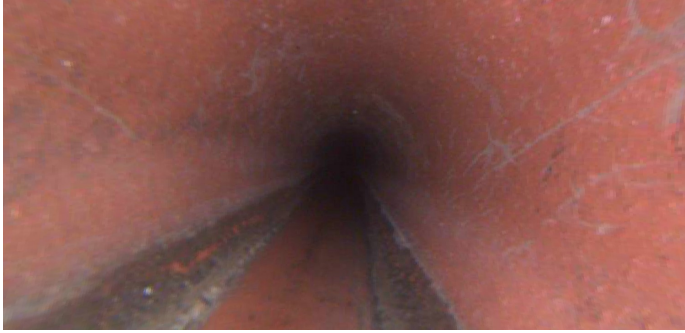
Code: **AMH**
Description: **Manhole**

Distance (ft): **.0**
Structural Grade: **0**
O&M Grade: **0**
Clock Start/From:
Clock To:
1st Value:
2nd Value:
Value Percent:
Continuous Index:
Within 8" of Joint: **NO**
Remarks: **M-108-043**

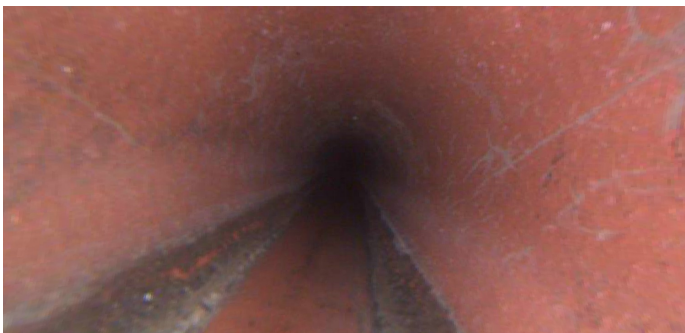
Code: **MWL**
Description: **Water Level**

Distance (ft): **.0**
Structural Grade: **0**
O&M Grade: **0**
Clock Start/From:
Clock To:
1st Value:
2nd Value:
Value Percent: **5.000**
Continuous Index:
Within 8" of Joint: **NO**
Remarks:

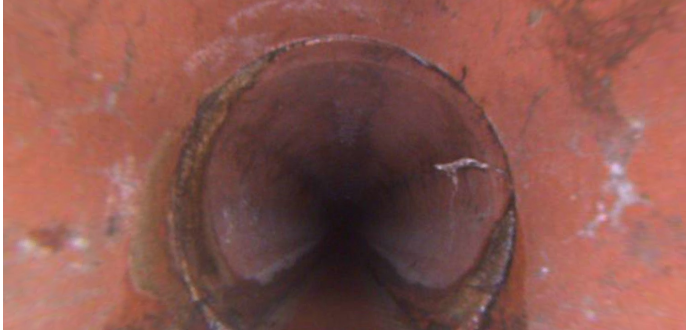
Code: **IW**
Description: **Infil Weeper**

Distance (ft): **14.2**
Structural Grade: **0**
O&M Grade: **2**
Clock Start/From: **8**
Clock To: **4**
1st Value:
2nd Value:
Value Percent:
Continuous Index:
Within 8" of Joint: **YES**
Remarks:

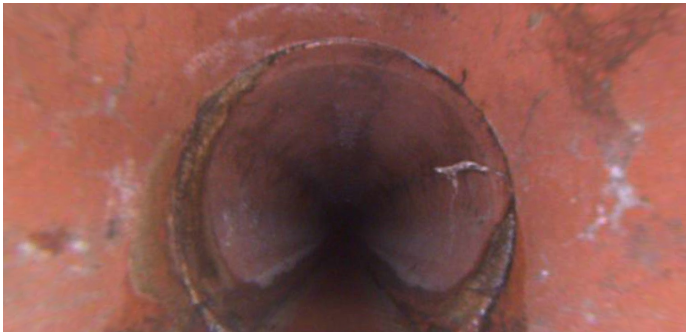
Code: **RFJ**
Description: **Roots Fine Joint**

Distance (ft): **14.2**
Structural Grade: **0**
O&M Grade: **1**
Clock Start/From: **3**
Clock To:
1st Value:
2nd Value:
Value Percent:
Continuous Index:
Within 8" of Joint: **YES**
Remarks:

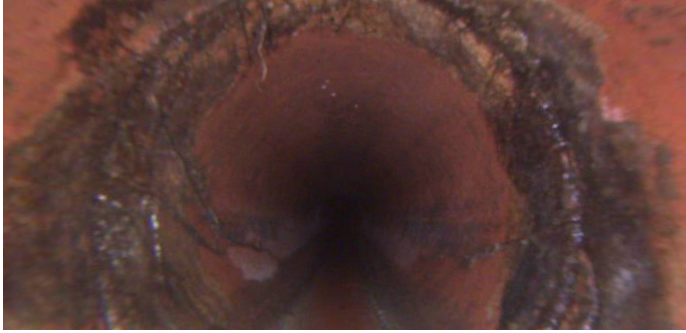
Code: **IW**
Description: **Infil Weeper**

Distance (ft): **24.8**
Structural Grade: **0**
O&M Grade: **2**
Clock Start/From: **8**
Clock To: **4**
1st Value:
2nd Value:
Value Percent:
Continuous Index:
Within 8" of Joint: **YES**
Remarks:

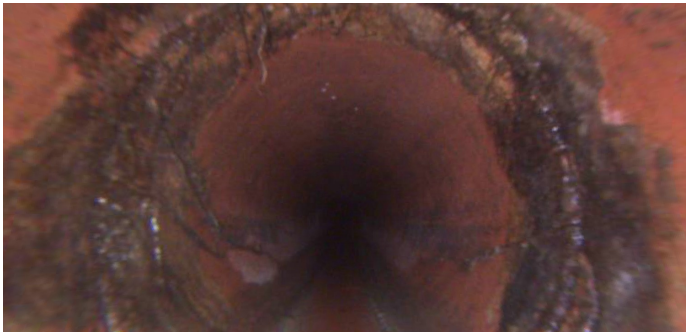
Code: **RFJ**
Description: **Roots Fine Joint**

Distance (ft): **24.8**
Structural Grade: **0**
O&M Grade: **1**
Clock Start/From: **8**
Clock To: **4**
1st Value:
2nd Value:
Value Percent:
Continuous Index:
Within 8" of Joint: **YES**
Remarks:

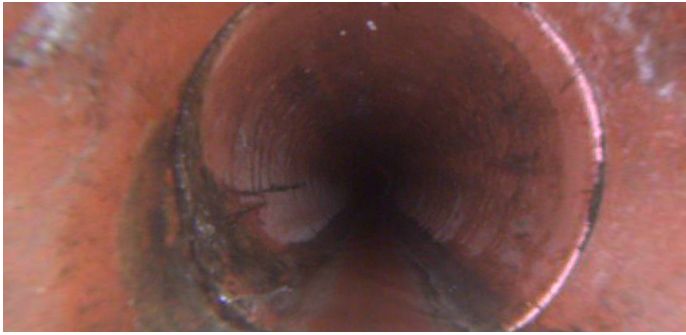
Code: **RFJ**
Description: **Roots Fine Joint**

Distance (ft): **40.3**
Structural Grade: **0**
O&M Grade: **1**
Clock Start/From: **8**
Clock To: **4**
1st Value:
2nd Value:
Value Percent:
Continuous Index:
Within 8" of Joint: **YES**
Remarks:

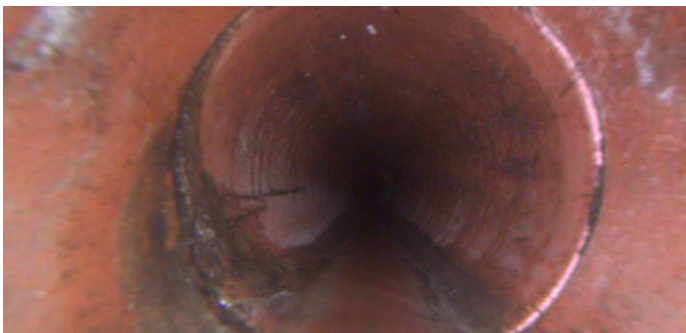
Code: **IW**
Description: **Infil Weeper**

Distance (ft): **40.3**
Structural Grade: **0**
O&M Grade: **2**
Clock Start/From: **7**
Clock To: **10**
1st Value:
2nd Value:
Value Percent:
Continuous Index:
Within 8" of Joint: **YES**
Remarks:

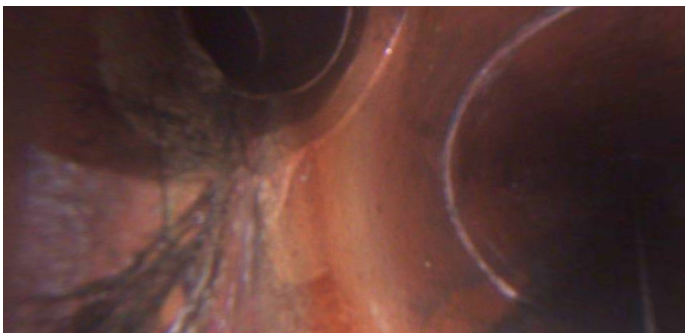
Code: **RFL**
Description: **Roots Fine Lateral**

Distance (ft): **47.1**
Structural Grade: **0**
O&M Grade: **1**
Clock Start/From: **3**
Clock To:
1st Value:
2nd Value:
Value Percent:
Continuous Index:
Within 8" of Joint: **NO**
Remarks:

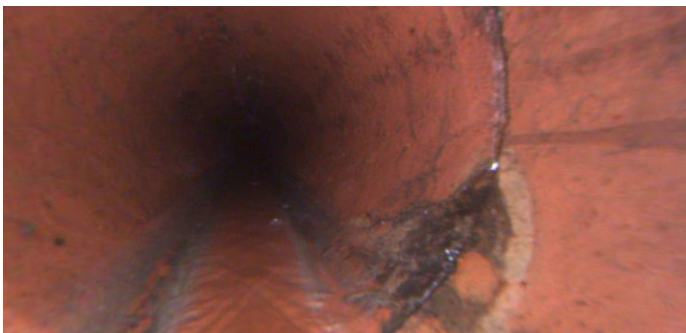
Code: **RFJ**
Description: **Roots Fine Joint**

Distance (ft): **47.7**
Structural Grade: **0**
O&M Grade: **1**
Clock Start/From: **3**
Clock To:
1st Value:
2nd Value:
Value Percent:
Continuous Index:
Within 8" of Joint: **YES**
Remarks:

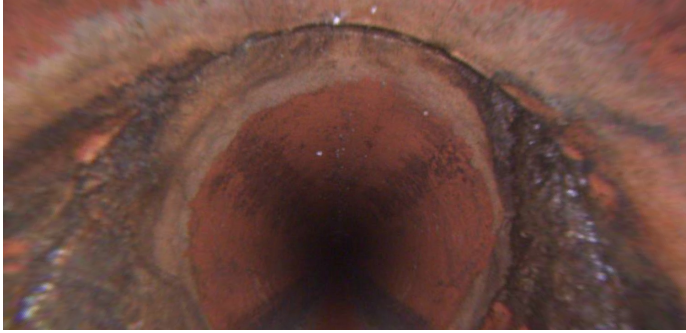
Code: **IW**
Description: **Infil Weeper**

Distance (ft): **53.0**
Structural Grade: **0**
O&M Grade: **2**
Clock Start/From: **8**
Clock To: **4**
1st Value:
2nd Value:
Value Percent:
Continuous Index:
Within 8" of Joint: **YES**
Remarks:

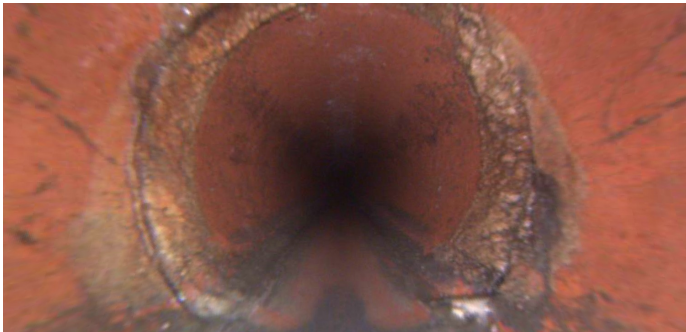
Code: **DAE**
Description: **Deposits Attached Encrustation**

Distance (ft): **63.4**
Structural Grade: **0**
O&M Grade: **2**
Clock Start/From: **8**
Clock To: **4**
1st Value:
2nd Value:
Value Percent: **5.000**
Continuous Index:
Within 8" of Joint: **YES**
Remarks:

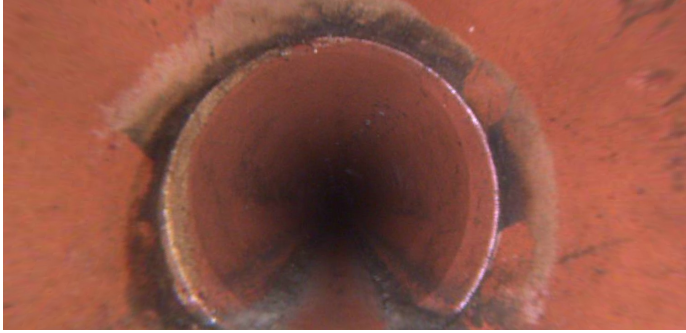
Code: **IW**
Description: **Infil Weeper**

Distance (ft): **73.7**
Structural Grade: **0**
O&M Grade: **2**
Clock Start/From: **8**
Clock To: **4**
1st Value:
2nd Value:
Value Percent:
Continuous Index:
Within 8" of Joint: **YES**
Remarks:

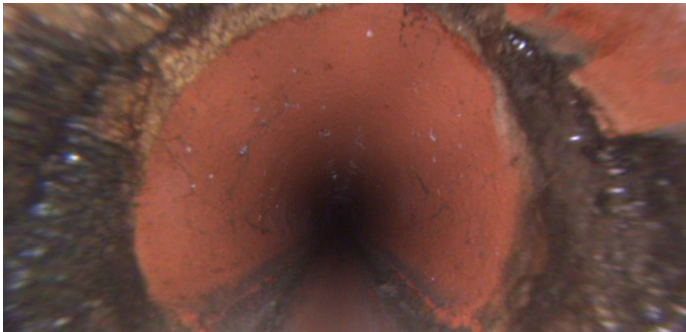
Code: **DAE**
Description: **Deposits Attached Encrustation**

Distance (ft): **84.5**
Structural Grade: **0**
O&M Grade: **2**
Clock Start/From: **8**
Clock To: **4**
1st Value:
2nd Value:
Value Percent: **5.000**
Continuous Index:
Within 8" of Joint: **YES**
Remarks:

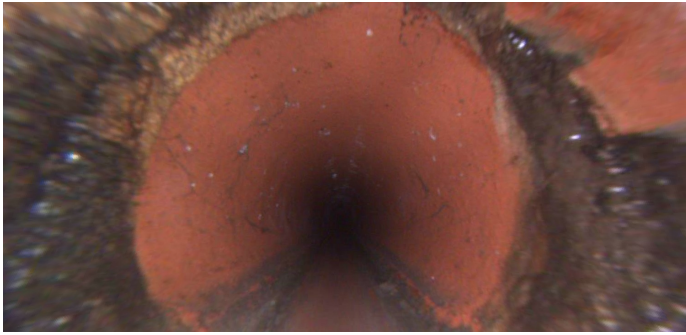
Code: **IW**
Description: **Infil Weeper**

Distance (ft): **84.5**
Structural Grade: **0**
O&M Grade: **2**
Clock Start/From: **8**
Clock To: **4**
1st Value:
2nd Value:
Value Percent:
Continuous Index:
Within 8" of Joint:
Remarks:

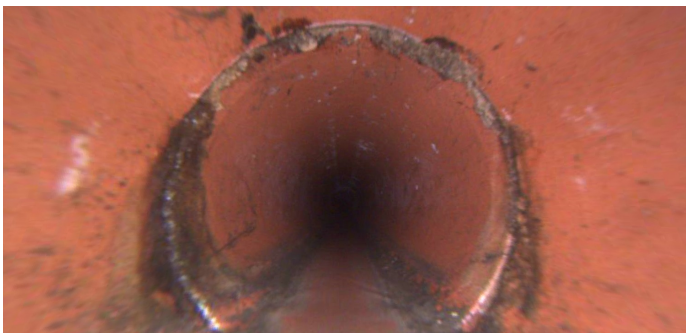
Code: **IW**
Description: **Infil Weeper**

Distance (ft): **89.4**
Structural Grade: **0**
O&M Grade: **2**
Clock Start/From: **8**
Clock To: **4**
1st Value:
2nd Value:
Value Percent:
Continuous Index:
Within 8" of Joint: **YES**
Remarks:

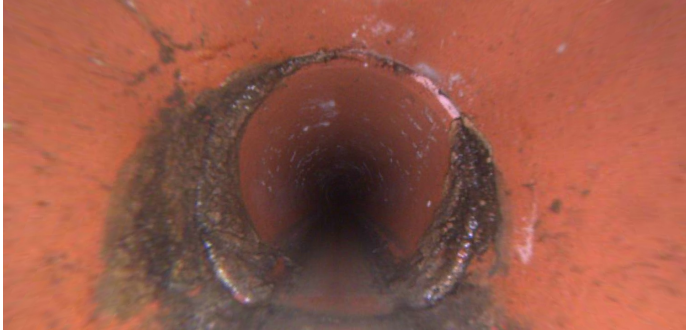
Code: **IW**
Description: **Infil Weeper**

Distance (ft): **99.9**
Structural Grade: **0**
O&M Grade: **2**
Clock Start/From: **8**
Clock To: **4**
1st Value:
2nd Value:
Value Percent:
Continuous Index:
Within 8" of Joint: **YES**
Remarks:

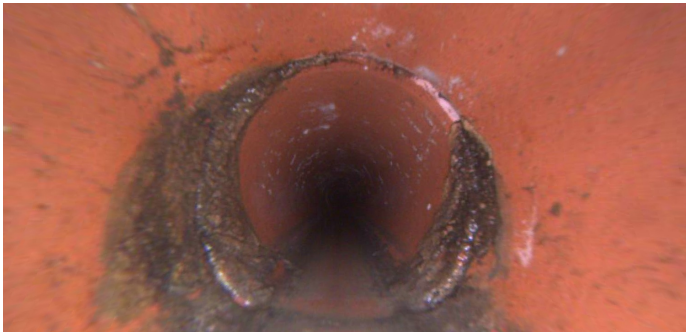
Code: **DAE**
Description: **Deposits Attached Encrustation**

Distance (ft): **99.9**
Structural Grade: **0**
O&M Grade: **2**
Clock Start/From: **8**
Clock To: **4**
1st Value:
2nd Value:
Value Percent: **5.000**
Continuous Index:
Within 8" of Joint: **YES**
Remarks:

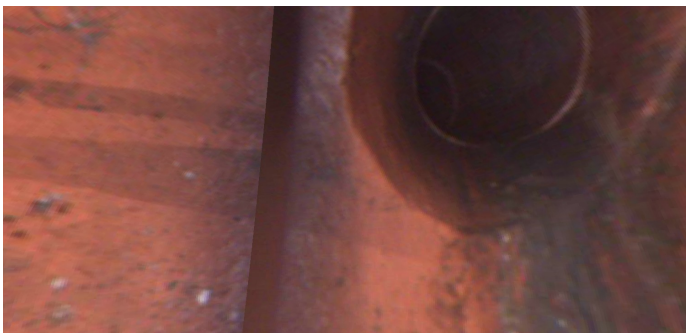
Code: **TF**
Description: **Tap Factory**

Distance (ft): **106.9**
Structural Grade: **0**
O&M Grade: **0**
Clock Start/From: **2**
Clock To:
1st Value: **4.000**
2nd Value:
Value Percent:
Continuous Index:
Within 8" of Joint: **YES**
Remarks:

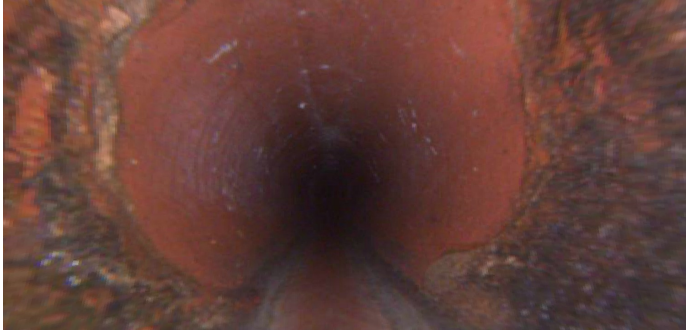
Code: **DAZ**
Description: **Deposits Attached Other**

Distance (ft): **107.5**
Structural Grade: **0**
O&M Grade: **2**
Clock Start/From: **7**
Clock To: **5**
1st Value:
2nd Value:
Value Percent: **5.000**
Continuous Index: **S01**
Within 8" of Joint: **YES**
Remarks:

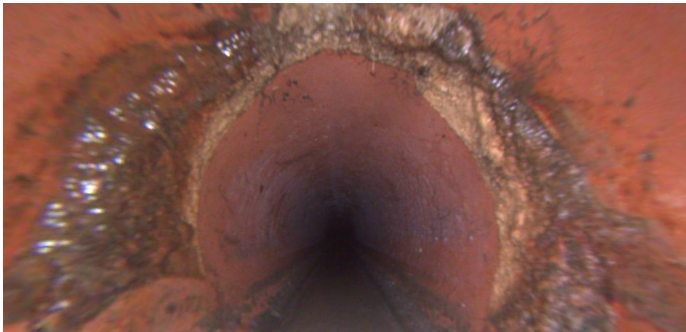
Code: **IW**
Description: **Infil Weeper**

Distance (ft): **128.4**
Structural Grade: **0**
O&M Grade: **2**
Clock Start/From: **8**
Clock To: **4**
1st Value:
2nd Value:
Value Percent:
Continuous Index:
Within 8" of Joint: **YES**
Remarks:

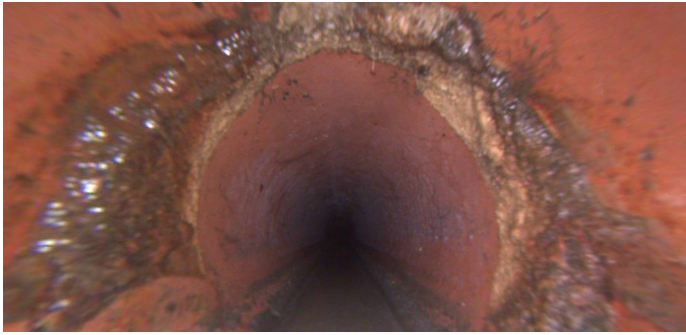
Code: **RFJ**
Description: **Roots Fine Joint**

Distance (ft): **128.4**
Structural Grade: **0**
O&M Grade: **1**
Clock Start/From: **8**
Clock To: **4**
1st Value:
2nd Value:
Value Percent:
Continuous Index:
Within 8" of Joint: **YES**
Remarks:

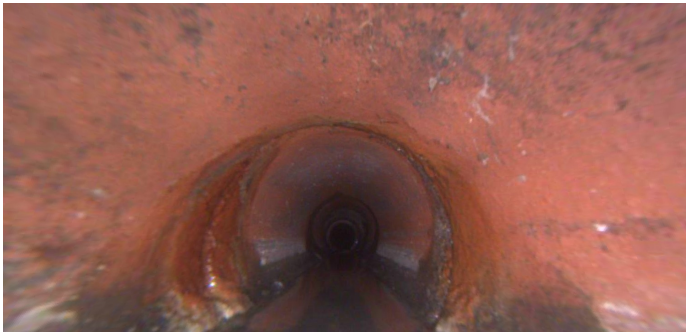
Code: **IW**
Description: **Infil Weeper**

Distance (ft): **252.0**
Structural Grade: **0**
O&M Grade: **2**
Clock Start/From: **8**
Clock To: **4**
1st Value:
2nd Value:
Value Percent:
Continuous Index:
Within 8" of Joint: **YES**
Remarks:

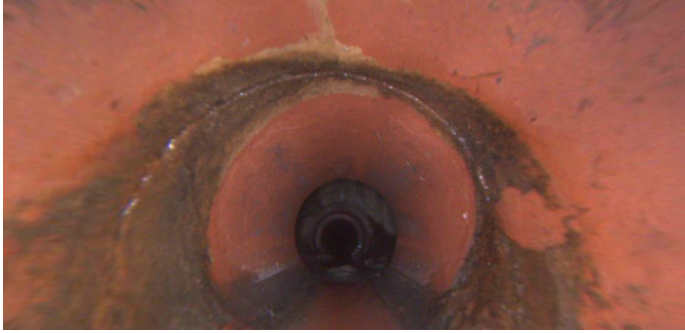
Code: **IW**
Description: **Infil Weeper**

Distance (ft): **253.9**
Structural Grade: **0**
O&M Grade: **2**
Clock Start/From: **8**
Clock To: **4**
1st Value:
2nd Value:
Value Percent:
Continuous Index:
Within 8" of Joint: **YES**
Remarks:

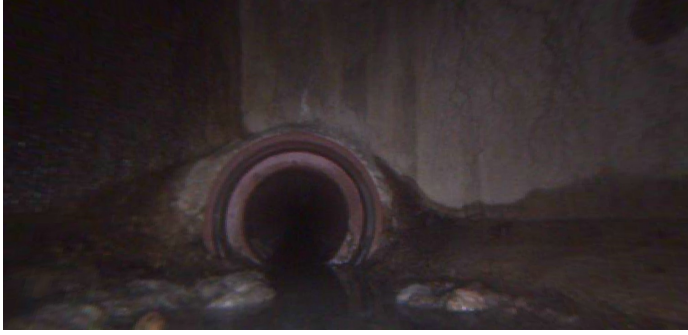
Code:	AMH
Description:	Manhole
Distance (ft):	256.5
Structural Grade:	0
O&M Grade:	0
Clock Start/From:	
Clock To:	
1st Value:	
2nd Value:	
Value Percent:	
Continuous Index:	
Within 8" of Joint:	NO
Remarks:	M-108-044
