Profile/Photo Observation Report

Date:	03/25/2018	Weather:		Coding:	PACP 6.0
Pipe Length (ft):	241.1	Owner:	NA	Pre Clean:	No Pre-Cleaning
P.O.#:		Surveyor:	Byrd Fitzgerald	PSR:	P-108-044-045
Customer:		Clean Date:	01/01/1900	Shape:	C

Street:	OFF MISSISSIPPI PL	Flow Control:	Not Controlled
City:	Hobart, IN	Year Renewed:	
Location:	Light Highway	Tape/Media #:	
Purpose:	Routine Assessment	Dia/Height:	10"
Use:	Sanitary	Material:	VCP
Drain Area:	NA	Lining:	
Category:	NA		
Comment:	Flow direction is wrong

Location Details:		Direction of Survey:	Downstream
US MH:	M-108-045	DS MH:	M-108-044
		Total Length Surveyed (ft):	243.7

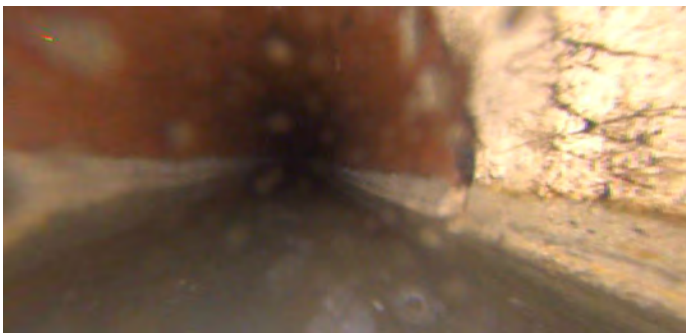
Code: **MMC**
Description: **Material Change**

Distance (ft): **4.7**
Structural Grade: **0**
O&M Grade: **0**
Clock Start/From:
Clock To:
1st Value:
2nd Value:
Value Percent:
Continuous Index:
Within 8" of Joint: **NO**
Remarks: **vcp**

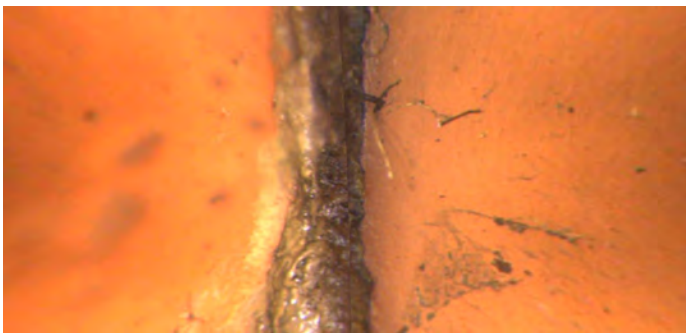
Code: **RFJ**
Description: **Roots Fine Joint**

Distance (ft): **22.6**
Structural Grade: **0**
O&M Grade: **1**
Clock Start/From: **7**
Clock To: **5**
1st Value:
2nd Value:
Value Percent:
Continuous Index: **S02**
Within 8" of Joint: **YES**
Remarks: **wandering**

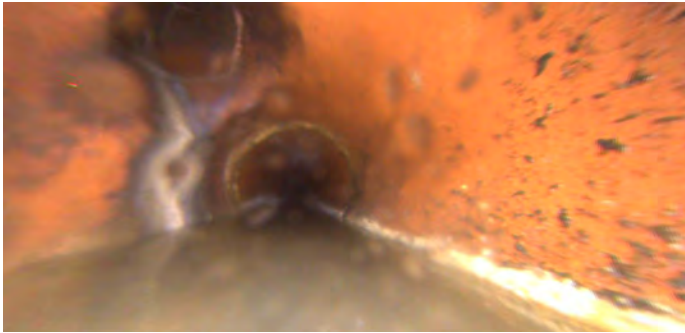
Code: **TF**
Description: **Tap Factory**

Distance (ft): **28.4**
Structural Grade: **0**
O&M Grade: **0**
Clock Start/From: **11**
Clock To:
1st Value: **4.000**
2nd Value:
Value Percent:
Continuous Index:
Within 8" of Joint: **YES**
Remarks:

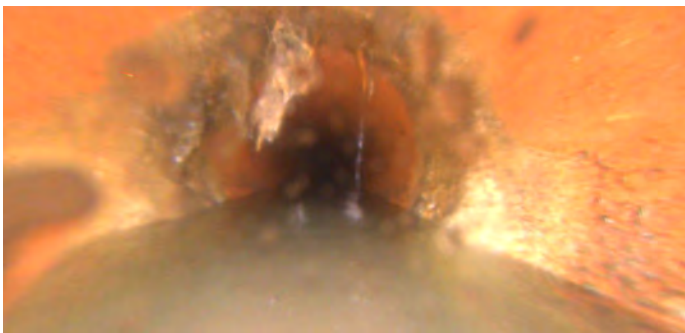
Code: **RMJ**
Description: **Roots Medium Joint**

Distance (ft): **146.4**
Structural Grade: **0**
O&M Grade: **3**
Clock Start/From: **7**
Clock To: **5**
1st Value:
2nd Value:
Value Percent: **10.000**
Continuous Index:
Within 8" of Joint: **YES**
Remarks:

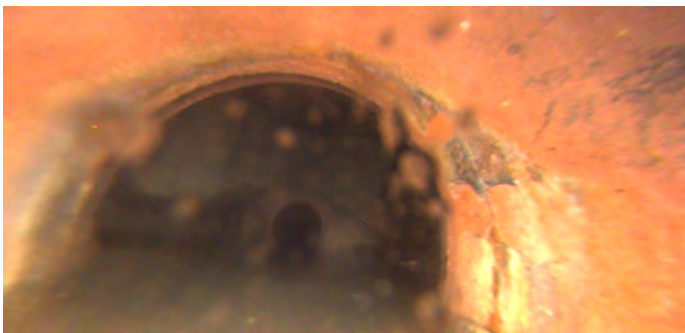
Code: **FM**
Description: **Fracture Multiple**

Distance (ft): **241.1**
Structural Grade: **4**
O&M Grade: **0**
Clock Start/From: **8**
Clock To: **4**
1st Value:
2nd Value:
Value Percent:
Continuous Index:
Within 8" of Joint:
Remarks:

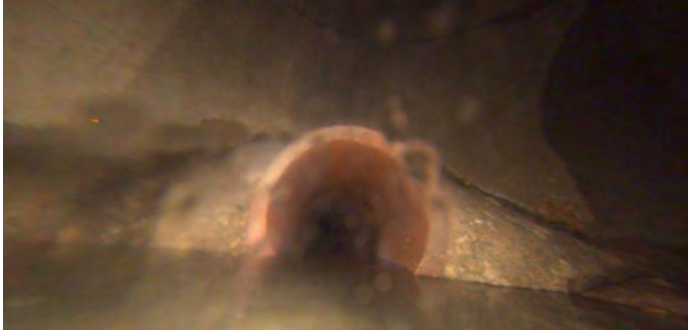
Code:	AMH
Description:	Manhole
Distance (ft):	243.7
Structural Grade:	0
O&M Grade:	0
Clock Start/From:	
Clock To:	
1st Value:	
2nd Value:	
Value Percent:	
Continuous Index:	
Within 8" of Joint:	NO
Remarks:	M-108-044
