## Profile/Photo Observation Report

Street:	<b>FOXCROFT STREET</b>	Flow Control:	<b>Not Controlled</b>
City:	<b>Hobart, IN</b>	Year Renewed:	
Location:	<b>Light Highway</b>	Tape/Media #:	
Purpose:	<b>Routine Assessment</b>	Dia/Height:	<b>10"</b>
Use:	<b>Sanitary</b>	Material:	<b>VCP</b>
Drain Area:	<b>NA</b>	Lining:	
Category:	<b>NA</b>		
Comment:	<b>Flow direction is wrong</b>		
Location Details:		Direction of Survey:	<b>Downstream</b>
US MH:	<b>M-108-045</b>	DS MH:	<b>M-108-044</b>
		Total Length Surveyed (ft):	<b>243.7</b>

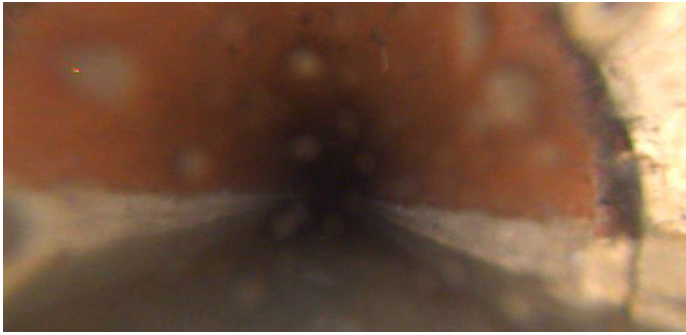
Code: **MMC**  
Description: **Material Change**

Distance (ft): **4.7**  
Structural Grade: **0**  
O&M Grade: **0**  
Clock Start/From:  
Clock To:  
1st Value:  
2nd Value:  
Value Percent:  
Continuous Index:  
Within 8" of Joint: **NO**  
Remarks: **vcp**

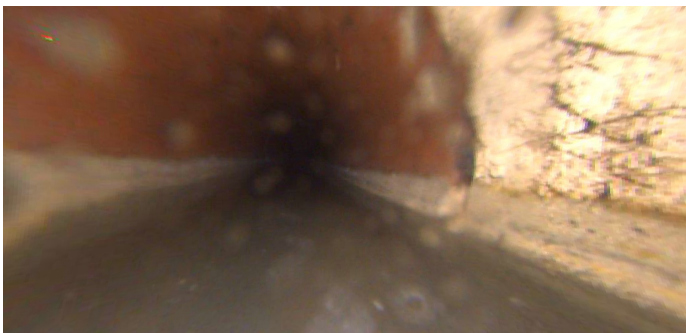
Code: **MMC**  
Description: **Material Change**

Distance (ft): **4.7**  
Structural Grade: **0**  
O&M Grade: **0**  
Clock Start/From:  
Clock To:  
1st Value:  
2nd Value:  
Value Percent:  
Continuous Index:  
Within 8" of Joint: **NO**  
Remarks: **vcp**

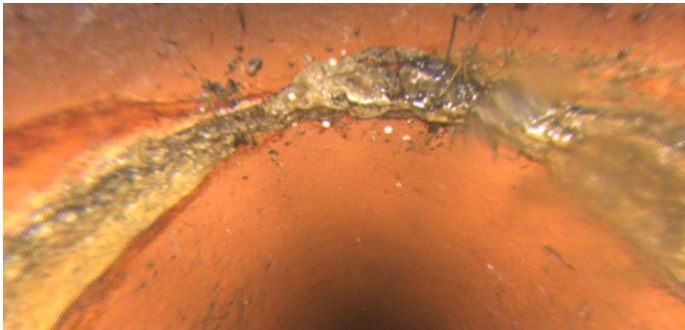
Code: **DAZ**  
Description: **Deposits Attached Other**

Distance (ft): **12.9**  
Structural Grade: **0**  
O&M Grade: **2**  
Clock Start/From: **7**  
Clock To: **5**  
1st Value:  
2nd Value:  
Value Percent: **5.000**  
Continuous Index: **S01**  
Within 8" of Joint: **YES**  
Remarks:

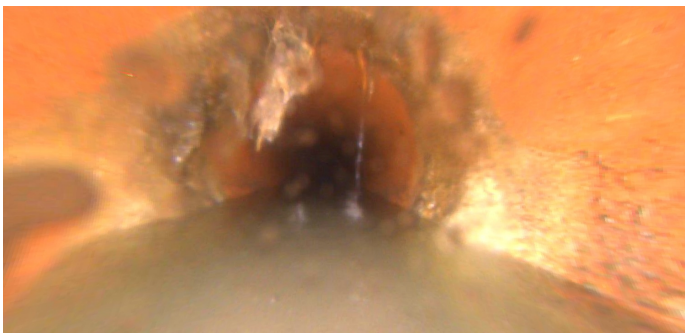
Code: **RMJ**  
Description: **Roots Medium Joint**

Distance (ft): **146.4**  
Structural Grade: **0**  
O&M Grade: **3**  
Clock Start/From: **7**  
Clock To: **5**  
1st Value:  
2nd Value:  
Value Percent: **10.000**  
Continuous Index:  
Within 8" of Joint: **YES**  
Remarks:

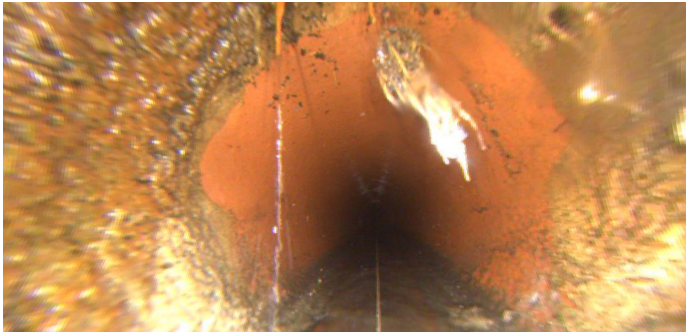
Code: **IR**  
Description: **Infil Runner**

Distance (ft): **147.2**  
Structural Grade: **0**  
O&M Grade: **4**  
Clock Start/From: **1**  
Clock To:  
1st Value:  
2nd Value:  
Value Percent:  
Continuous Index:  
Within 8" of Joint: **YES**  
Remarks:
