Profile/Photo Observation Report

Date:	03/24/2018	Weather:		Coding:	PACP 6.0
Pipe Length (ft):	235.9	Owner:	NA	Pre Clean:	No Pre-Cleaning
P.O.#:		Surveyor:	Justin Gonzales	PSR:	P-108-045-046
Customer:		Clean Date:	01/01/1900	Shape:	C

Street:	FOXCROFT STREET	Flow Control:	Not Controlled
City:	Hobart, IN	Year Renewed:	
Location:	Light Highway	Tape/Media #:	
Purpose:	Routine Assessment	Dia/Height:	10"
Use:	Sanitary	Material:	VCP
Drain Area:	NA	Lining:	
Category:	NA		
Comment:	Flow Direction wrong

Location Details:		Direction of Survey:	Downstream
US MH:	M-108-046	DS MH:	M-108-045
		Total Length Surveyed (ft):	246.9

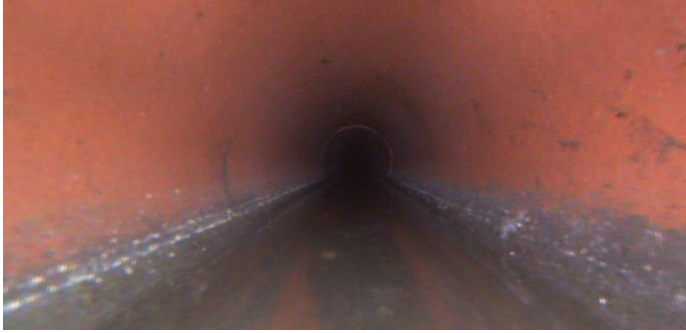
Code: **AMH**
Description: **Manhole**

Distance (ft): **.0**
Structural Grade: **0**
O&M Grade: **0**
Clock Start/From:
Clock To:
1st Value:
2nd Value:
Value Percent:
Continuous Index:
Within 8" of Joint: **NO**
Remarks: **M-108-046**

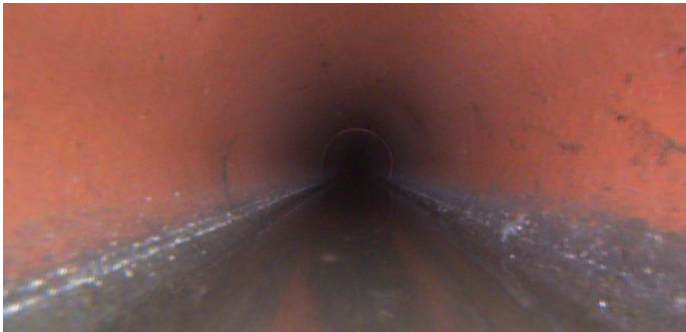
Code: **MWL**
Description: **Water Level**

Distance (ft): **.0**
Structural Grade: **0**
O&M Grade: **0**
Clock Start/From:
Clock To:
1st Value:
2nd Value:
Value Percent: **10.000**
Continuous Index:
Within 8" of Joint: **NO**
Remarks:

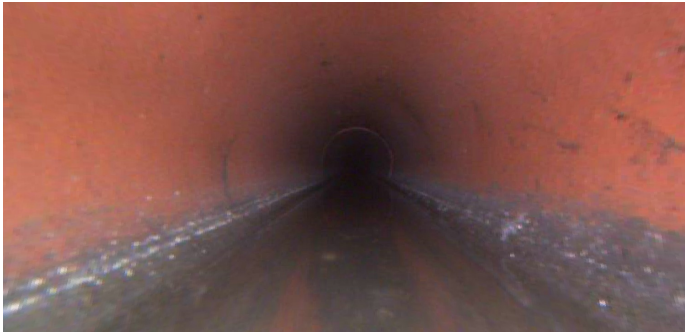
Code: **DAZ**
Description: **Deposits Attached Other**

Distance (ft): **.0**
Structural Grade: **0**
O&M Grade: **2**
Clock Start/From: **7**
Clock To: **5**
1st Value:
2nd Value:
Value Percent: **5.000**
Continuous Index: **S01**
Within 8" of Joint: **YES**
Remarks: **WANDER**

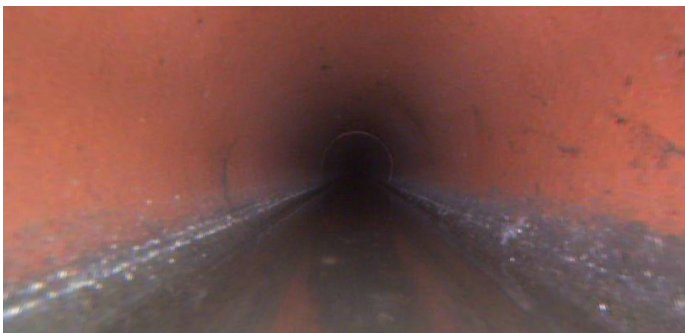
Code: **DSF**
Description: **Deposits Settled Fine**

Distance (ft): **.0**
Structural Grade: **0**
O&M Grade: **2**
Clock Start/From: **6**
Clock To:
1st Value:
2nd Value:
Value Percent: **5.000**
Continuous Index:
Within 8" of Joint: **NO**
Remarks:

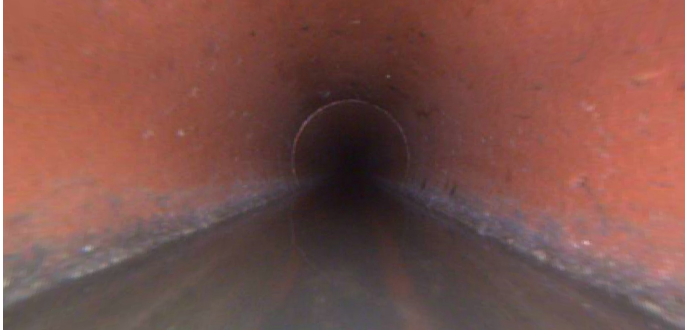
Code: **DSF**
Description: **Deposits Settled Fine**

Distance (ft): **7.3**
Structural Grade: **0**
O&M Grade: **2**
Clock Start/From: **6**
Clock To:
1st Value:
2nd Value:
Value Percent: **5.000**
Continuous Index:
Within 8" of Joint: **NO**
Remarks:

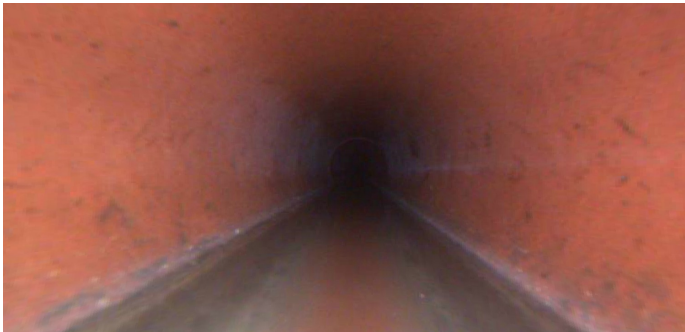
Code: **DAGS**
Description: **Deposits Attached Grease**

Distance (ft): **15.5**
Structural Grade: **0**
O&M Grade: **2**
Clock Start/From: **7**
Clock To: **5**
1st Value:
2nd Value:
Value Percent: **5.000**
Continuous Index: **S02**
Within 8" of Joint: **YES**
Remarks: **WANDER**

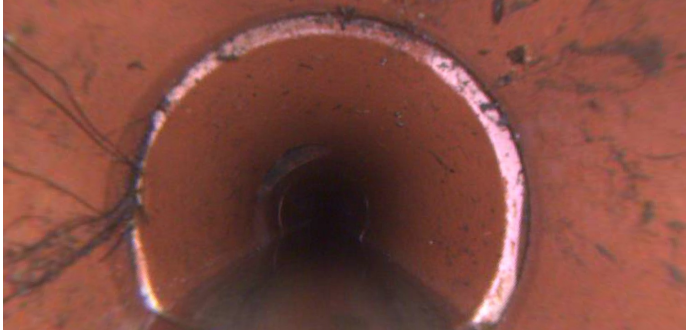
Code: **RFJ**
Description: **Roots Fine Joint**

Distance (ft): **28.9**
Structural Grade: **0**
O&M Grade: **1**
Clock Start/From: **8**
Clock To: **4**
1st Value:
2nd Value:
Value Percent:
Continuous Index:
Within 8" of Joint: **YES**
Remarks:

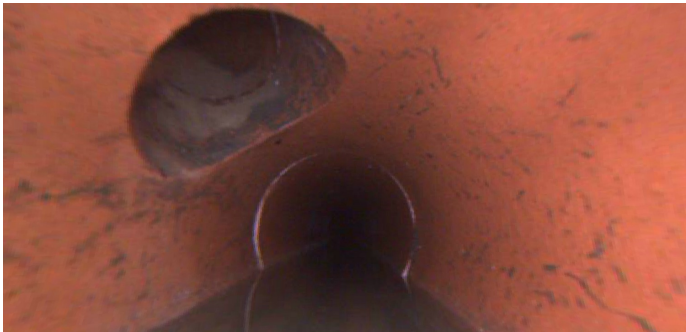
Code: **TF**
Description: **Tap Factory**

Distance (ft): **30.1**
Structural Grade: **0**
O&M Grade: **0**
Clock Start/From: **10**
Clock To:
1st Value: **4.000**
2nd Value:
Value Percent:
Continuous Index:
Within 8" of Joint:
Remarks:

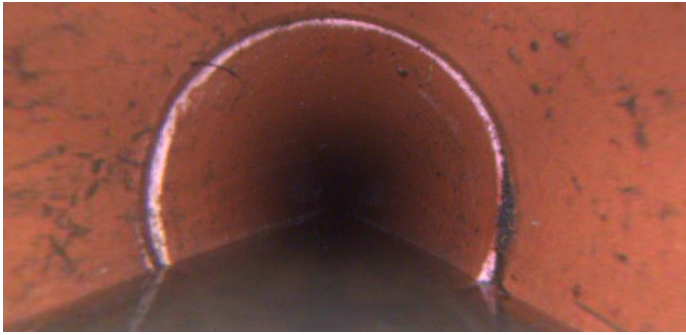
Code: **RFJ**
Description: **Roots Fine Joint**

Distance (ft): **30.9**
Structural Grade: **0**
O&M Grade: **1**
Clock Start/From: **8**
Clock To: **4**
1st Value:
2nd Value:
Value Percent:
Continuous Index:
Within 8" of Joint: **YES**
Remarks:

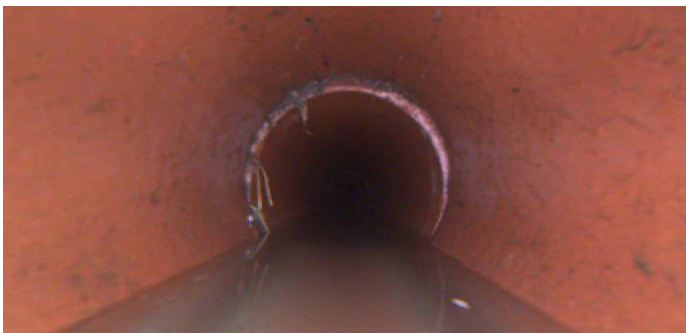
Code: **RFJ**
Description: **Roots Fine Joint**

Distance (ft): **46.0**
Structural Grade: **0**
O&M Grade: **1**
Clock Start/From: **7**
Clock To: **1**
1st Value:
2nd Value:
Value Percent:
Continuous Index:
Within 8" of Joint: **YES**
Remarks:

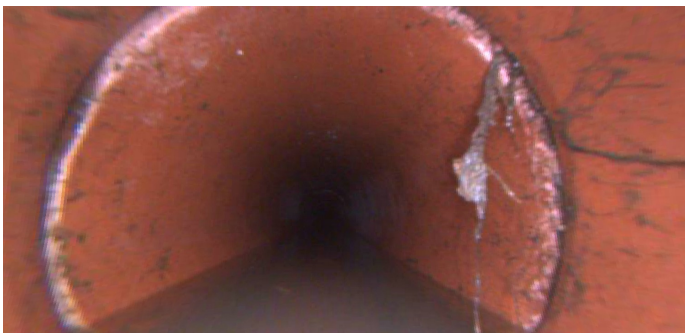
Code: **RFJ**
Description: **Roots Fine Joint**

Distance (ft): **77.9**
Structural Grade: **0**
O&M Grade: **1**
Clock Start/From: **2**
Clock To:
1st Value:
2nd Value:
Value Percent:
Continuous Index:
Within 8" of Joint: **YES**
Remarks:

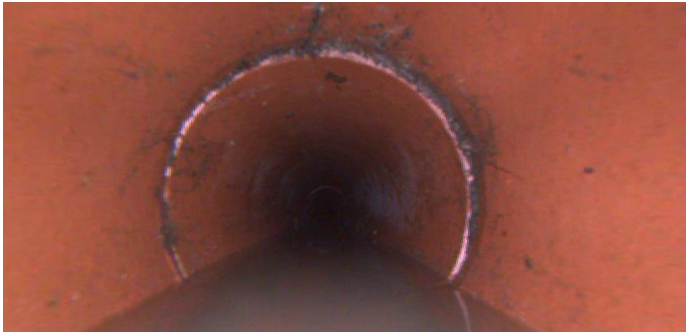
Code: **RFJ**
Description: **Roots Fine Joint**

Distance (ft): **82.8**
Structural Grade: **0**
O&M Grade: **1**
Clock Start/From: **8**
Clock To: **4**
1st Value:
2nd Value:
Value Percent:
Continuous Index:
Within 8" of Joint: **YES**
Remarks:

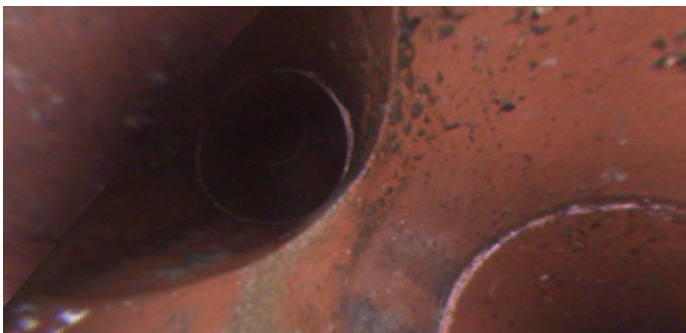
Code: **TF**
Description: **Tap Factory**

Distance (ft): **90.0**
Structural Grade: **0**
O&M Grade: **0**
Clock Start/From: **10**
Clock To:
1st Value: **4.000**
2nd Value:
Value Percent:
Continuous Index:
Within 8" of Joint:
Remarks:

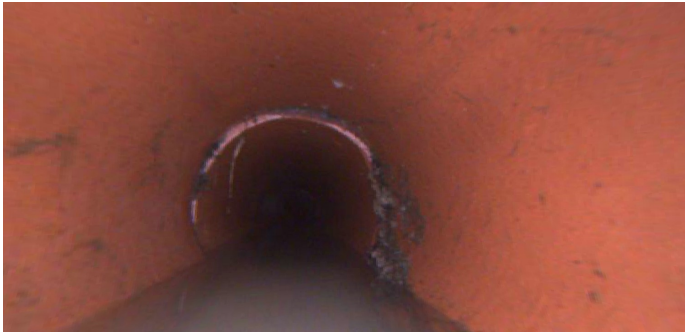
Code: **RFJ**
Description: **Roots Fine Joint**

Distance (ft): **110.4**
Structural Grade: **0**
O&M Grade: **1**
Clock Start/From: **9**
Clock To: **5**
1st Value:
2nd Value:
Value Percent:
Continuous Index: **S03**
Within 8" of Joint: **YES**
Remarks:

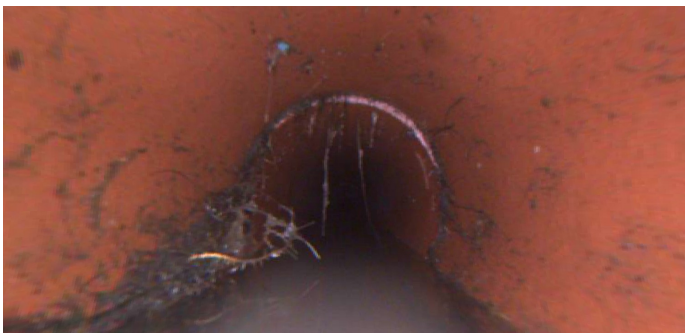
Code: **RMJ**
Description: **Roots Medium Joint**

Distance (ft): **120.9**
Structural Grade: **0**
O&M Grade: **3**
Clock Start/From: **7**
Clock To: **5**
1st Value:
2nd Value:
Value Percent: **10.000**
Continuous Index:
Within 8" of Joint: **YES**
Remarks:

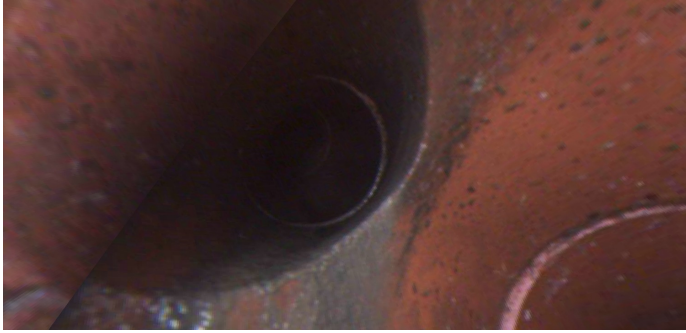
Code: **TF**
Description: **Tap Factory**

Distance (ft): **154.6**
Structural Grade: **0**
O&M Grade: **0**
Clock Start/From: **10**
Clock To:
1st Value: **4.000**
2nd Value:
Value Percent:
Continuous Index:
Within 8" of Joint:
Remarks:

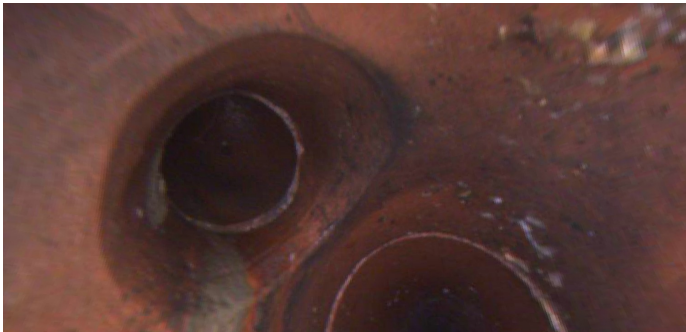
Code: **TF**
Description: **Tap Factory**

Distance (ft): **218.8**
Structural Grade: **0**
O&M Grade: **0**
Clock Start/From: **10**
Clock To:
1st Value: **4.000**
2nd Value:
Value Percent:
Continuous Index:
Within 8" of Joint:
Remarks:

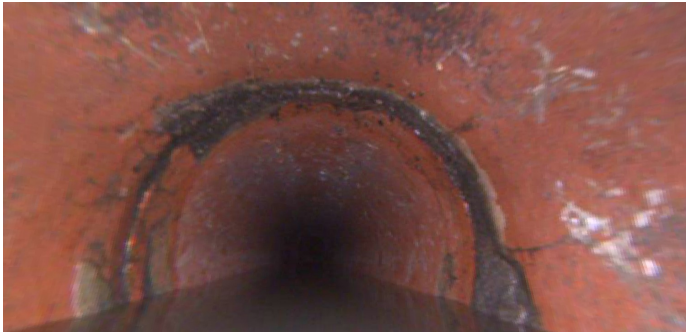
Code: **IS**
Description: **Infil Stain**

Distance (ft): **240.2**
Structural Grade: **0**
O&M Grade: **0**
Clock Start/From: **7**
Clock To: **5**
1st Value:
2nd Value:
Value Percent:
Continuous Index:
Within 8" of Joint: **YES**
Remarks:

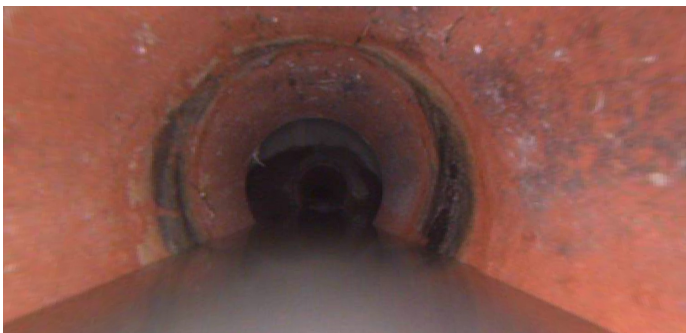
Code: **IS**
Description: **Infil Stain**

Distance (ft): **244.3**
Structural Grade: **0**
O&M Grade: **0**
Clock Start/From: **7**
Clock To: **5**
1st Value:
2nd Value:
Value Percent:
Continuous Index:
Within 8" of Joint: **YES**
Remarks:

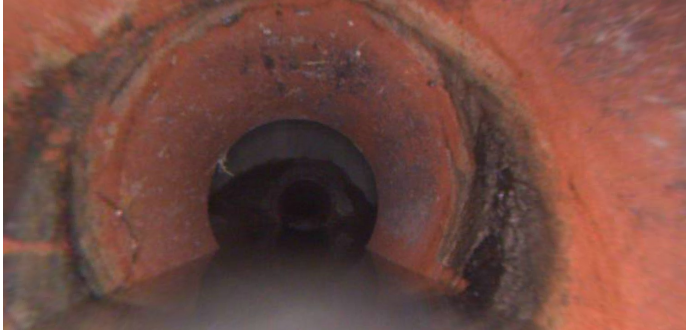
Code: **RFJ**
Description: **Roots Fine Joint**

Distance (ft): **244.6**
Structural Grade: **0**
O&M Grade: **1**
Clock Start/From: **9**
Clock To: **5**
1st Value:
2nd Value:
Value Percent:
Continuous Index: **F03**
Within 8" of Joint: **YES**
Remarks:

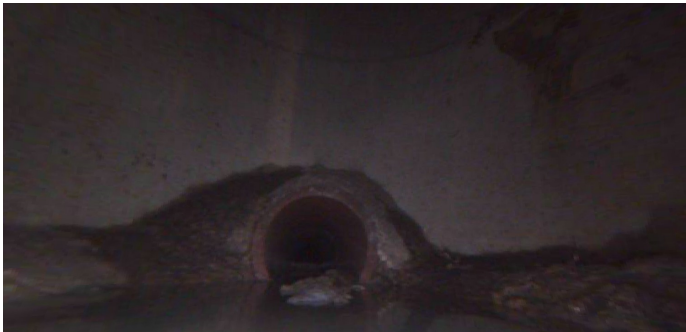
Code: **AMH**
Description: **Manhole**

Distance (ft): **246.9**
Structural Grade: **0**
O&M Grade: **0**
Clock Start/From:
Clock To:
1st Value:
2nd Value:
Value Percent:
Continuous Index:
Within 8" of Joint: **NO**
Remarks: **M-108-045**

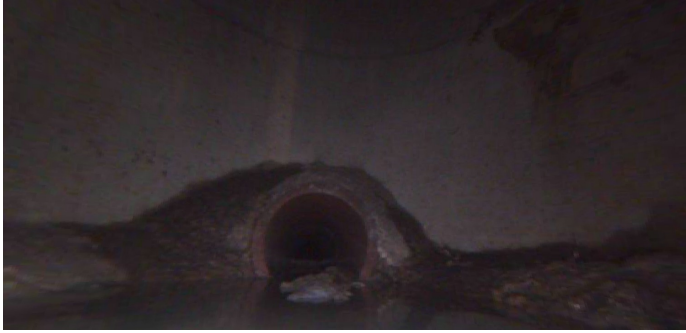
Code: **DAGS**
Description: **Deposits Attached Grease**

Distance (ft): **246.9**
Structural Grade: **0**
O&M Grade: **2**
Clock Start/From: **7**
Clock To: **5**
1st Value:
2nd Value:
Value Percent: **5.000**
Continuous Index: **F02**
Within 8" of Joint: **YES**
Remarks: **WANDER**

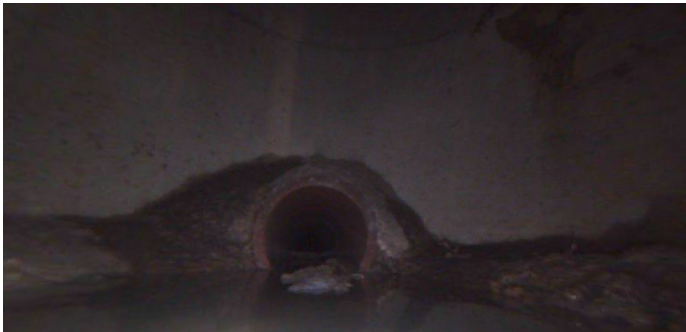
Code: **DAZ**
Description: **Deposits Attached Other**

Distance (ft): **246.9**
Structural Grade: **0**
O&M Grade: **2**
Clock Start/From: **7**
Clock To: **5**
1st Value:
2nd Value:
Value Percent: **5.000**
Continuous Index: **F01**
Within 8" of Joint: **YES**
Remarks: **WANDER**
