## Profile/Photo Observation Report

Street:	<b>57TH ST</b>	Flow Control:	<b>Not Controlled</b>
City:	<b>Hobart, IN</b>	Year Renewed:	
Location:	<b>Light Highway</b>	Tape/Media #:	
Purpose:	<b>Routine Assessment</b>	Dia/Height:	<b>12"</b>
Use:	<b>Sanitary</b>	Material:	<b>VCP</b>
Drain Area:	<b>NA</b>	Lining:	
Category:	<b>NA</b>		
Comment:

Location Details:		Direction of Survey:	<b>Upstream</b>
US MH:	<b>M-108-047</b>	DS MH:	<b>M-108-046</b>
		Total Length Surveyed (ft):	<b>325.7</b>

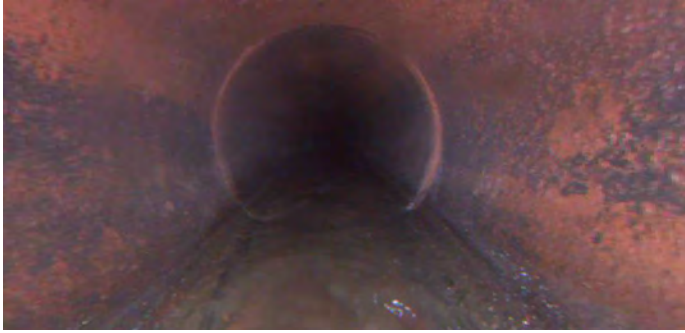
Code: **AMH**  
Description: **Manhole**

Distance (ft): **.0**  
Structural Grade: **0**  
O&M Grade: **0**  
Clock Start/From:  
Clock To:  
1st Value:  
2nd Value:  
Value Percent:  
Continuous Index:  
Within 8" of Joint: **NO**  
Remarks: **M-108-046**

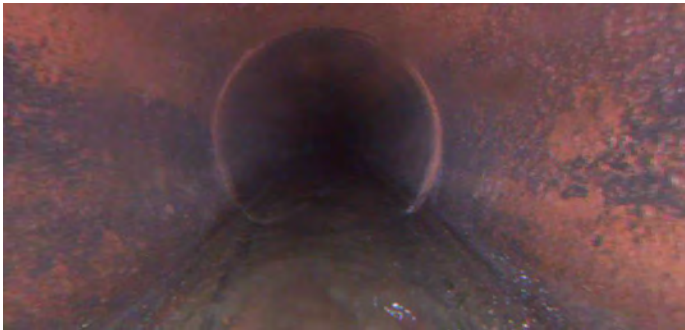
Code: **MWL**  
Description: **Water Level**

Distance (ft): **.0**  
Structural Grade: **0**  
O&M Grade: **0**  
Clock Start/From:  
Clock To:  
1st Value:  
2nd Value:  
Value Percent: **15.000**  
Continuous Index:  
Within 8" of Joint: **NO**  
Remarks:

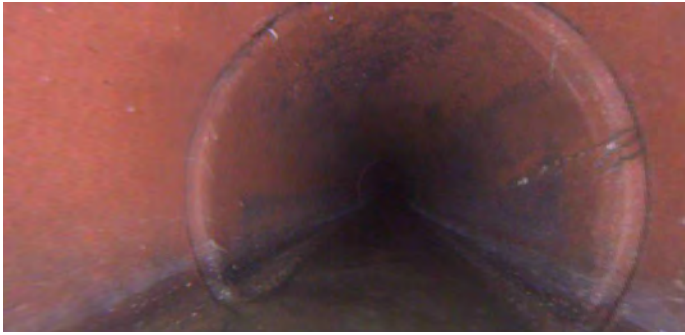
Code: **RFJ**  
Description: **Roots Fine Joint**

Distance (ft): **5.8**  
Structural Grade: **0**  
O&M Grade: **1**  
Clock Start/From: **7**  
Clock To: **5**  
1st Value:  
2nd Value:  
Value Percent:  
Continuous Index:  
Within 8" of Joint: **YES**  
Remarks:

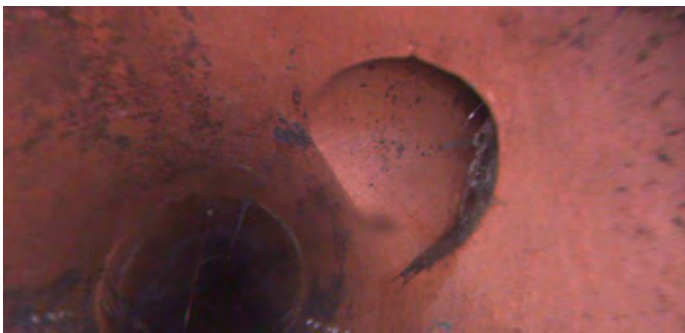
Code: **TFD**  
Description: **Tap Factory Defective**

Distance (ft): **26.4**  
Structural Grade: **0**  
O&M Grade: **2**  
Clock Start/From: **2**  
Clock To:  
1st Value: **4.000**  
2nd Value:  
Value Percent:  
Continuous Index:  
Within 8" of Joint:  
Remarks: **ROOTS COMING FROM TAP**

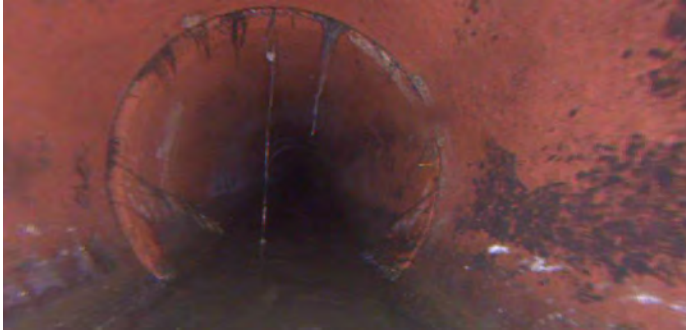
Code: **RFJ**  
Description: **Roots Fine Joint**

Distance (ft): **27.2**  
Structural Grade: **0**  
O&M Grade: **1**  
Clock Start/From: **7**  
Clock To: **5**  
1st Value:  
2nd Value:  
Value Percent:  
Continuous Index:  
Within 8" of Joint: **YES**  
Remarks:

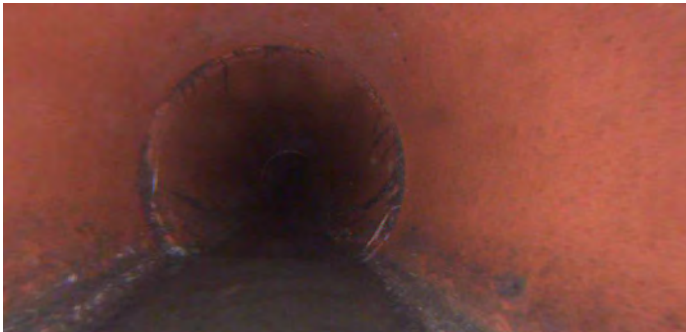
Code: **RFJ**  
Description: **Roots Fine Joint**

Distance (ft): **58.8**  
Structural Grade: **0**  
O&M Grade: **1**  
Clock Start/From: **7**  
Clock To: **5**  
1st Value:  
2nd Value:  
Value Percent:  
Continuous Index:  
Within 8" of Joint: **YES**  
Remarks:

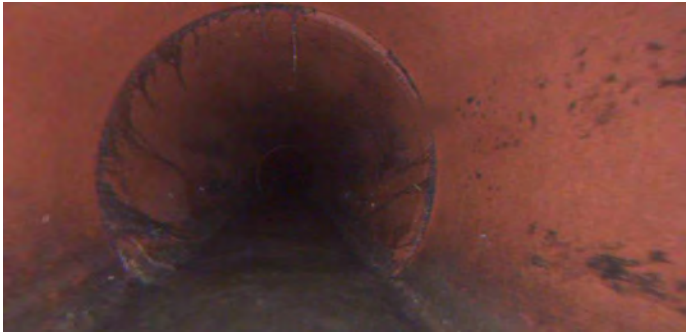
Code: **RFJ**  
Description: **Roots Fine Joint**

Distance (ft): **67.0**  
Structural Grade: **0**  
O&M Grade: **1**  
Clock Start/From: **7**  
Clock To: **5**  
1st Value:  
2nd Value:  
Value Percent:  
Continuous Index:  
Within 8" of Joint: **YES**  
Remarks:

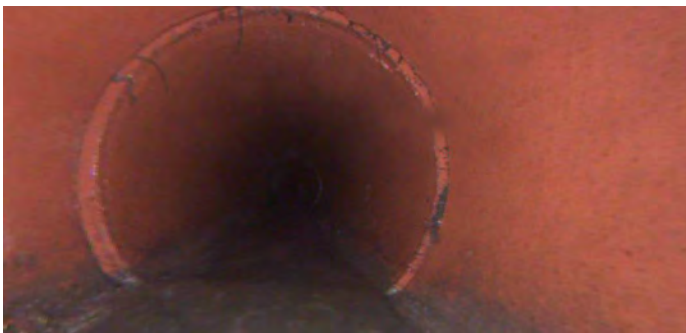
Code: **RFJ**  
Description: **Roots Fine Joint**

Distance (ft): **74.9**  
Structural Grade: **0**  
O&M Grade: **1**  
Clock Start/From: **10**  
Clock To: **2**  
1st Value:  
2nd Value:  
Value Percent:  
Continuous Index:  
Within 8" of Joint: **YES**  
Remarks:

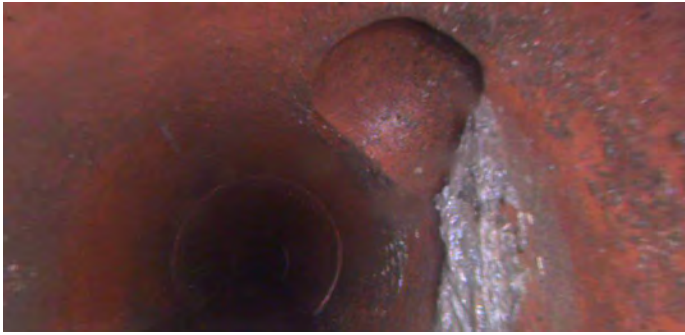
Code: **TFD**  
Description: **Tap Factory Defective**

Distance (ft): **87.9**  
Structural Grade: **0**  
O&M Grade: **2**  
Clock Start/From: **2**  
Clock To:  
1st Value: **4.000**  
2nd Value:  
Value Percent:  
Continuous Index:  
Within 8" of Joint:  
Remarks: **dar**

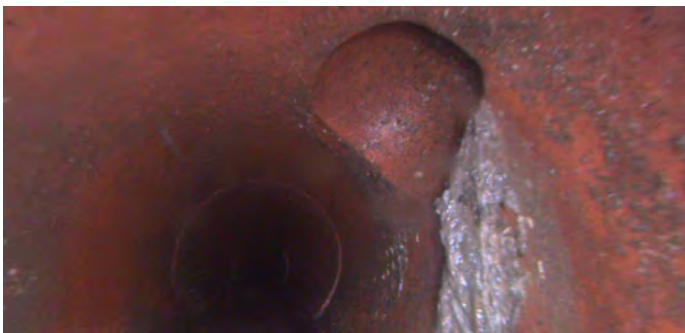
Code: **DAR**  
Description: **Deposits Attached Ragging**

Distance (ft): **87.9**  
Structural Grade: **0**  
O&M Grade: **2**  
Clock Start/From: **2**  
Clock To: **4**  
1st Value:  
2nd Value:  
Value Percent: **5.000**  
Continuous Index:  
Within 8" of Joint: **NO**  
Remarks:

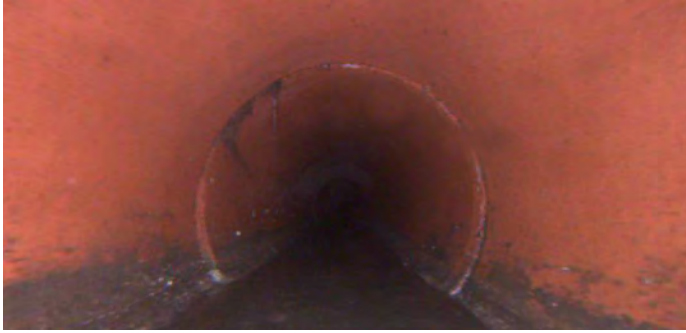
Code: **RFJ**  
Description: **Roots Fine Joint**

Distance (ft): **128.6**  
Structural Grade: **0**  
O&M Grade: **1**  
Clock Start/From: **10**  
Clock To: **11**  
1st Value:  
2nd Value:  
Value Percent:  
Continuous Index:  
Within 8" of Joint: **YES**  
Remarks:

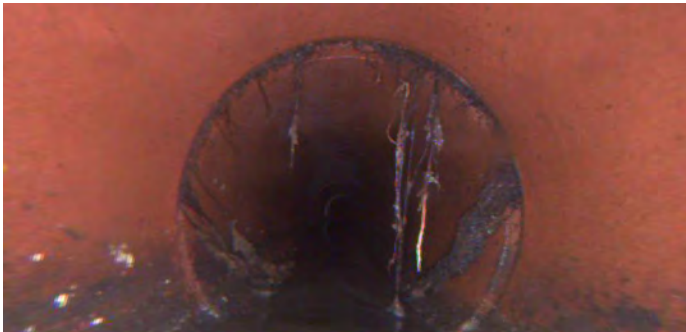
Code: **RFJ**  
Description: **Roots Fine Joint**

Distance (ft): **136.9**  
Structural Grade: **0**  
O&M Grade: **1**  
Clock Start/From: **7**  
Clock To: **5**  
1st Value:  
2nd Value:  
Value Percent:  
Continuous Index:  
Within 8" of Joint: **YES**  
Remarks:

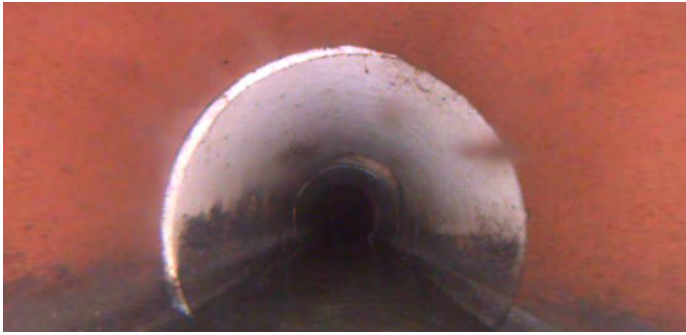
Code: **RPR**  
Description: **Repair Point Pipe Replaced**

Distance (ft): **144.2**  
Structural Grade: **0**  
O&M Grade: **0**  
Clock Start/From:  
Clock To:  
1st Value:  
2nd Value:  
Value Percent:  
Continuous Index:  
Within 8" of Joint: **NO**  
Remarks: **VCP TO PVC**

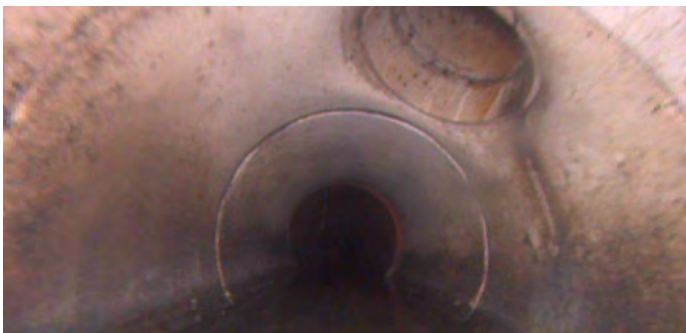
Code: **TF**  
Description: **Tap Factory**

Distance (ft): **145.9**  
Structural Grade: **0**  
O&M Grade: **0**  
Clock Start/From: **1**  
Clock To:  
1st Value: **4.000**  
2nd Value:  
Value Percent:  
Continuous Index:  
Within 8" of Joint:  
Remarks:

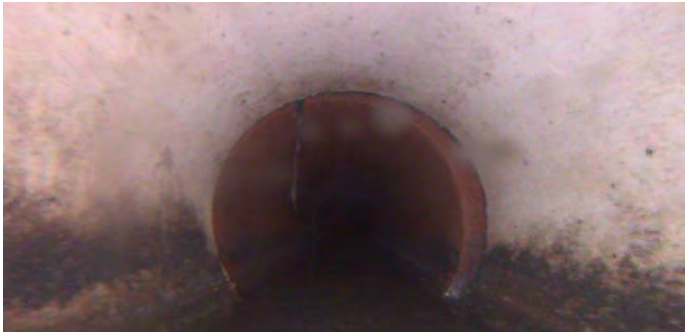
Code: **RFJ**  
Description: **Roots Fine Joint**

Distance (ft): **147.4**  
Structural Grade: **0**  
O&M Grade: **1**  
Clock Start/From: **11**  
Clock To:  
1st Value:  
2nd Value:  
Value Percent:  
Continuous Index:  
Within 8" of Joint: **YES**  
Remarks:

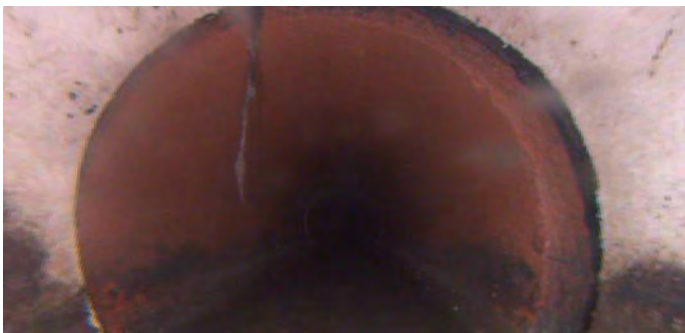
Code: **JOM**  
Description: **Joint Offset Medium**

Distance (ft): **147.9**  
Structural Grade: **1**  
O&M Grade: **0**  
Clock Start/From:  
Clock To:  
1st Value:  
2nd Value:  
Value Percent:  
Continuous Index:  
Within 8" of Joint: **NO**  
Remarks:

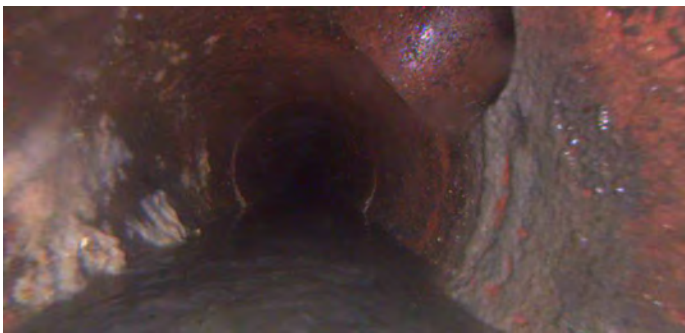
Code: **DAGS**  
Description: **Deposits Attached Grease**

Distance (ft): **207.5**  
Structural Grade: **0**  
O&M Grade: **2**  
Clock Start/From: **8**  
Clock To: **4**  
1st Value:  
2nd Value:  
Value Percent: **5.000**  
Continuous Index:  
Within 8" of Joint: **NO**  
Remarks:

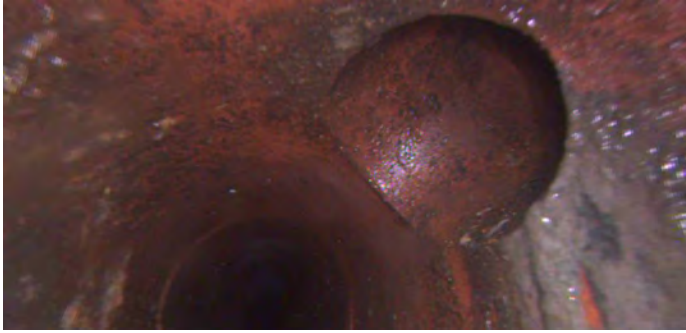
Code: **TF**  
Description: **Tap Factory**

Distance (ft): **207.7**  
Structural Grade: **0**  
O&M Grade: **0**  
Clock Start/From: **2**  
Clock To:  
1st Value: **4.000**  
2nd Value:  
Value Percent:  
Continuous Index:  
Within 8" of Joint:  
Remarks:

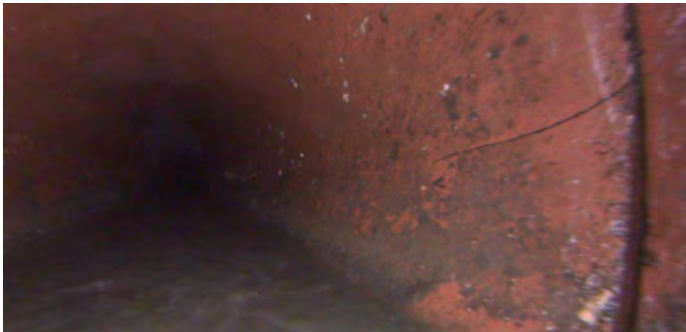
Code: **RFJ**  
Description: **Roots Fine Joint**

Distance (ft): **209.3**  
Structural Grade: **0**  
O&M Grade: **1**  
Clock Start/From: **3**  
Clock To:  
1st Value:  
2nd Value:  
Value Percent:  
Continuous Index:  
Within 8" of Joint: **YES**  
Remarks:

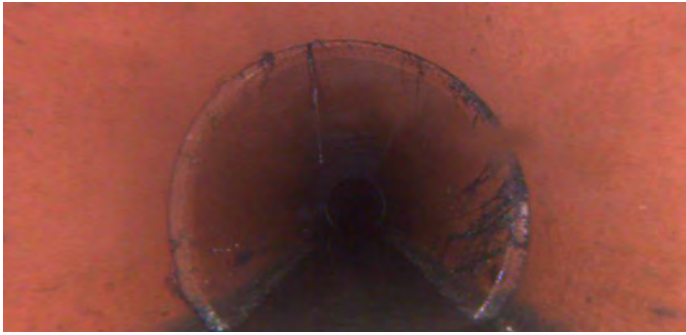
Code: **RFJ**  
Description: **Roots Fine Joint**

Distance (ft): **232.3**  
Structural Grade: **0**  
O&M Grade: **1**  
Clock Start/From: **11**  
Clock To: **5**  
1st Value:  
2nd Value:  
Value Percent:  
Continuous Index:  
Within 8" of Joint: **YES**  
Remarks:

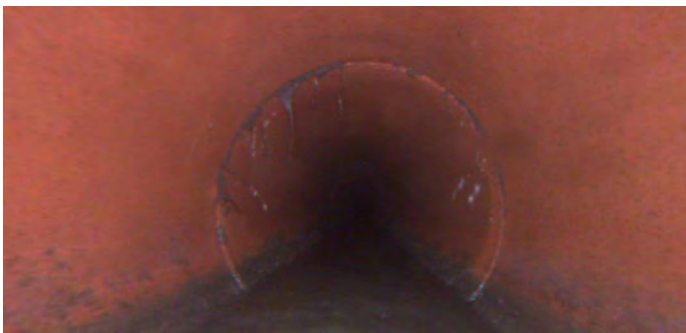
Code: **RFJ**  
Description: **Roots Fine Joint**

Distance (ft): **251.9**  
Structural Grade: **0**  
O&M Grade: **1**  
Clock Start/From: **9**  
Clock To: **2**  
1st Value:  
2nd Value:  
Value Percent:  
Continuous Index:  
Within 8" of Joint: **YES**  
Remarks:

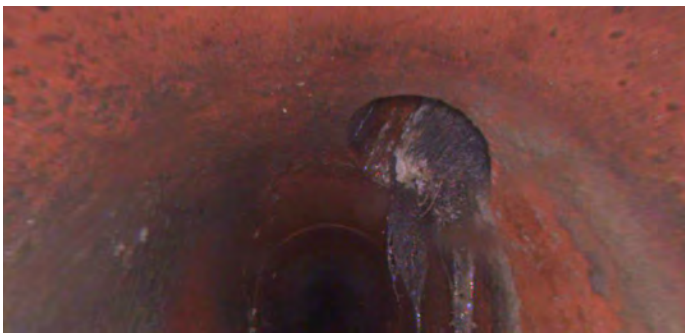
Code: **RML**  
Description: **Roots Medium Lateral**

Distance (ft): **276.7**  
Structural Grade: **0**  
O&M Grade: **3**  
Clock Start/From: **1**  
Clock To: **2**  
1st Value:  
2nd Value:  
Value Percent: **5.000**  
Continuous Index:  
Within 8" of Joint: **NO**  
Remarks:

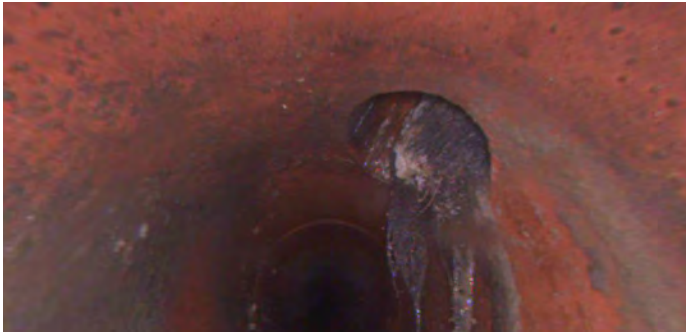
Code: **TFD**  
Description: **Tap Factory Defective**

Distance (ft): **276.7**  
Structural Grade: **0**  
O&M Grade: **2**  
Clock Start/From: **1**  
Clock To:  
1st Value: **4.000**  
2nd Value:  
Value Percent:  
Continuous Index:  
Within 8" of Joint:

Remarks: **ROOTS COMING FROM TAP**
