Profile/Photo Observation Report

Street:	FOXCROFT STREET	Flow Control:	Not Controlled
City:	Hobart, IN	Year Renewed:	
Location:	Light Highway	Tape/Media #:	
Purpose:	Routine Assessment	Dia/Height:	12"
Use:	Sanitary	Material:	VCP
Drain Area:	NA	Lining:	
Category:	NA		
Comment:

Location Details:		Direction of Survey:	Upstream
US MH:	M-108-047	DS MH:	M-108-046
		Total Length Surveyed (ft):	325.7

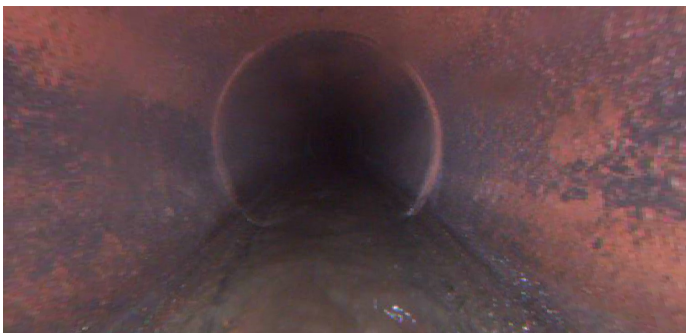
Code: **MWL**
Description: **Water Level**

Distance (ft): **.0**
Structural Grade: **0**
O&M Grade: **0**
Clock Start/From:
Clock To:
1st Value:
2nd Value:
Value Percent: **15.000**
Continuous Index:
Within 8" of Joint: **NO**
Remarks:

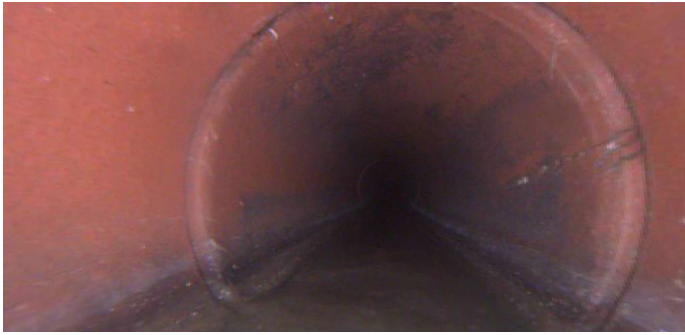
Code: **RFJ**
Description: **Roots Fine Joint**

Distance (ft): **5.8**
Structural Grade: **0**
O&M Grade: **1**
Clock Start/From: **7**
Clock To: **5**
1st Value:
2nd Value:
Value Percent:
Continuous Index:
Within 8" of Joint: **YES**
Remarks:

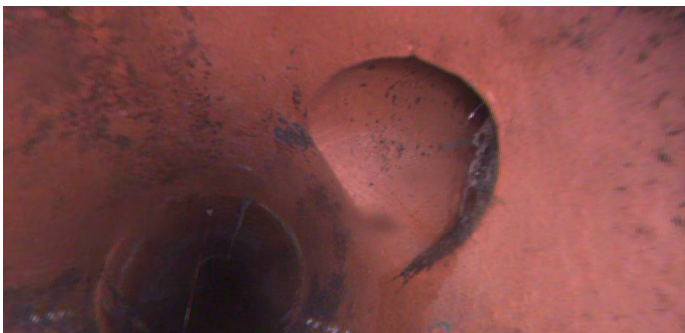
Code: **TFD**
Description: **Tap Factory Defective**

Distance (ft): **26.4**
Structural Grade: **0**
O&M Grade: **2**
Clock Start/From: **2**
Clock To:
1st Value: **4.000**
2nd Value:
Value Percent:
Continuous Index:
Within 8" of Joint:
Remarks: **ROOTS COMING FROM TAP**

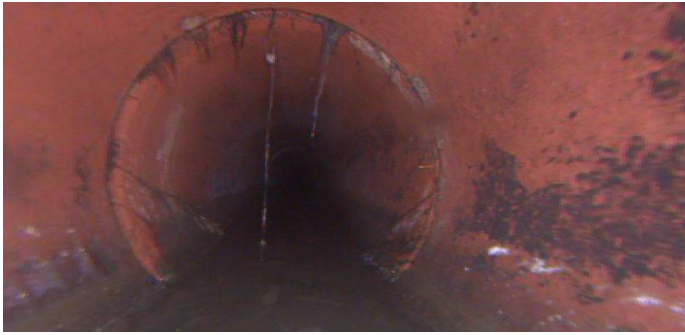
Code: **RFJ**
Description: **Roots Fine Joint**

Distance (ft): **27.2**
Structural Grade: **0**
O&M Grade: **1**
Clock Start/From: **7**
Clock To: **5**
1st Value:
2nd Value:
Value Percent:
Continuous Index:
Within 8" of Joint: **YES**
Remarks:

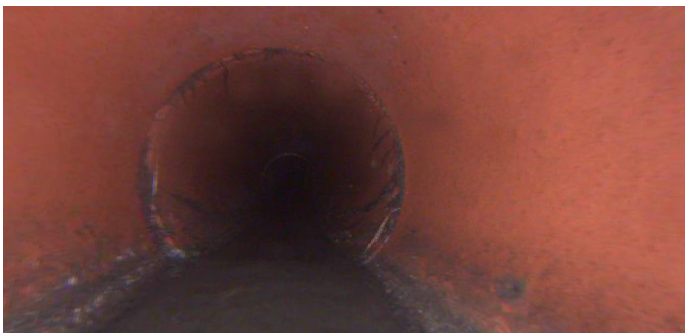
Code: **RFJ**
Description: **Roots Fine Joint**

Distance (ft): **58.8**
Structural Grade: **0**
O&M Grade: **1**
Clock Start/From: **7**
Clock To: **5**
1st Value:
2nd Value:
Value Percent:
Continuous Index:
Within 8" of Joint: **YES**
Remarks:

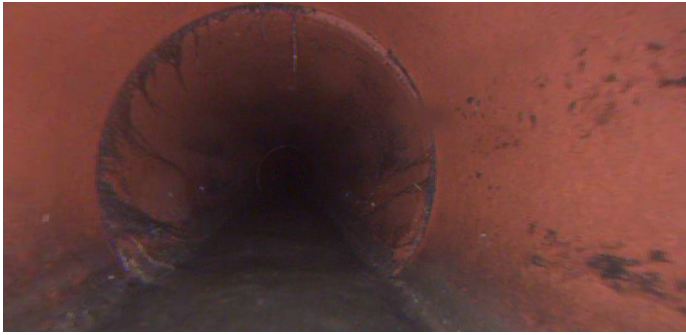
Code: **RFJ**
Description: **Roots Fine Joint**

Distance (ft): **67.0**
Structural Grade: **0**
O&M Grade: **1**
Clock Start/From: **7**
Clock To: **5**
1st Value:
2nd Value:
Value Percent:
Continuous Index:
Within 8" of Joint: **YES**
Remarks:

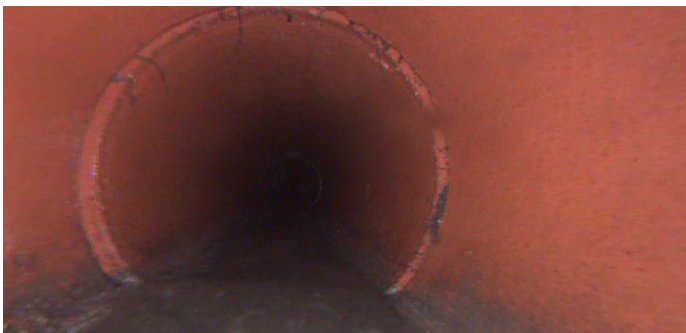
Code: **RFJ**
Description: **Roots Fine Joint**

Distance (ft): **74.9**
Structural Grade: **0**
O&M Grade: **1**
Clock Start/From: **10**
Clock To: **2**
1st Value:
2nd Value:
Value Percent:
Continuous Index:
Within 8" of Joint: **YES**
Remarks:

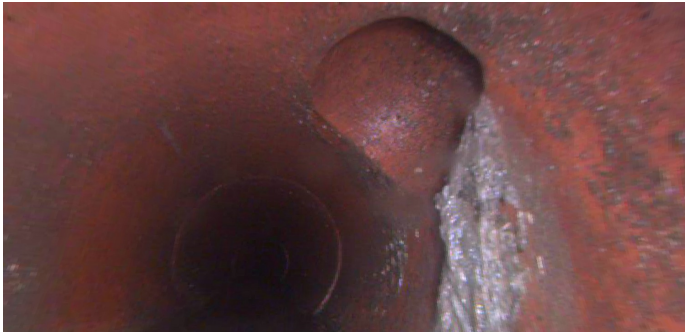
Code: **TFD**
Description: **Tap Factory Defective**

Distance (ft): **87.9**
Structural Grade: **0**
O&M Grade: **2**
Clock Start/From: **2**
Clock To:
1st Value: **4.000**
2nd Value:
Value Percent:
Continuous Index:
Within 8" of Joint:
Remarks: **dar**

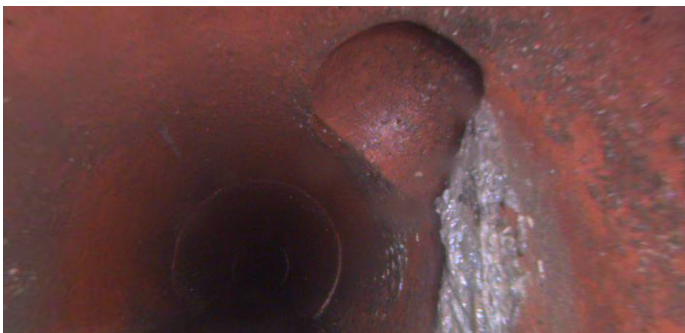
Code: **DAR**
Description: **Deposits Attached Ragging**

Distance (ft): **87.9**
Structural Grade: **0**
O&M Grade: **2**
Clock Start/From: **2**
Clock To: **4**
1st Value:
2nd Value:
Value Percent: **5.000**
Continuous Index:
Within 8" of Joint: **NO**
Remarks:

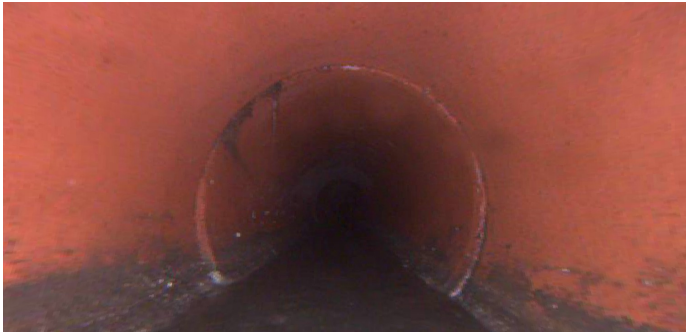
Code: **RFJ**
Description: **Roots Fine Joint**

Distance (ft): **128.6**
Structural Grade: **0**
O&M Grade: **1**
Clock Start/From: **10**
Clock To: **11**
1st Value:
2nd Value:
Value Percent:
Continuous Index:
Within 8" of Joint: **YES**
Remarks:

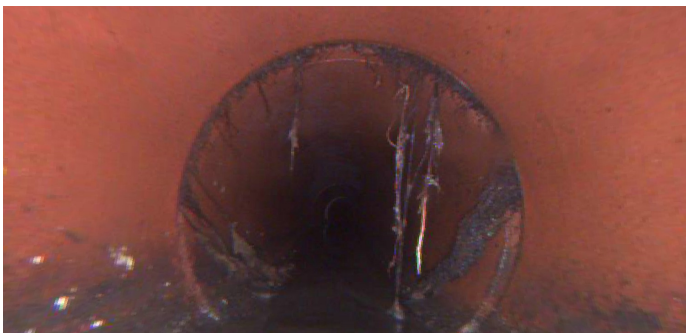
Code: **RFJ**
Description: **Roots Fine Joint**

Distance (ft): **136.9**
Structural Grade: **0**
O&M Grade: **1**
Clock Start/From: **7**
Clock To: **5**
1st Value:
2nd Value:
Value Percent:
Continuous Index:
Within 8" of Joint: **YES**
Remarks:

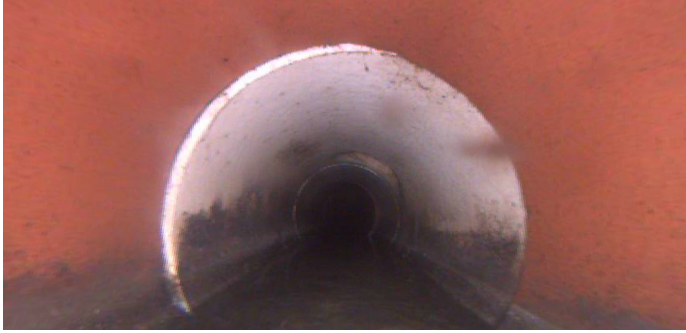
Code: **RPR**
Description: **Repair Point Pipe Replaced**

Distance (ft): **144.2**
Structural Grade: **0**
O&M Grade: **0**
Clock Start/From:
Clock To:
1st Value:
2nd Value:
Value Percent:
Continuous Index:
Within 8" of Joint: **NO**
Remarks: **VCP TO PVC**

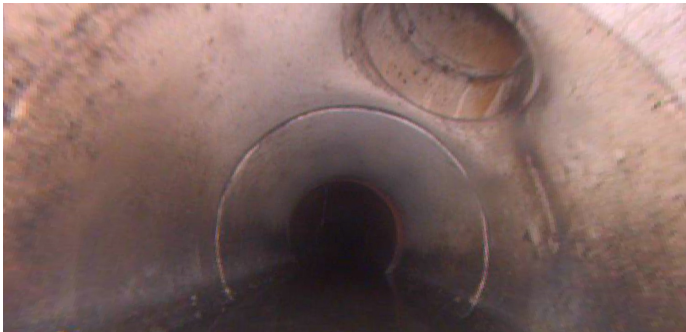
Code: **TF**
Description: **Tap Factory**

Distance (ft): **145.9**
Structural Grade: **0**
O&M Grade: **0**
Clock Start/From: **1**
Clock To:
1st Value: **4.000**
2nd Value:
Value Percent:
Continuous Index:
Within 8" of Joint:
Remarks:

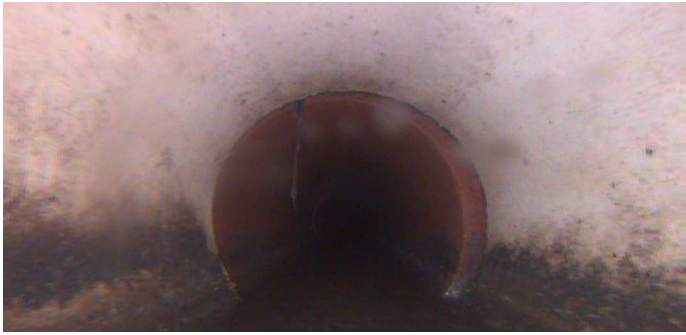
Code: **RFJ**
Description: **Roots Fine Joint**

Distance (ft): **147.4**
Structural Grade: **0**
O&M Grade: **1**
Clock Start/From: **11**
Clock To:
1st Value:
2nd Value:
Value Percent:
Continuous Index:
Within 8" of Joint: **YES**
Remarks:

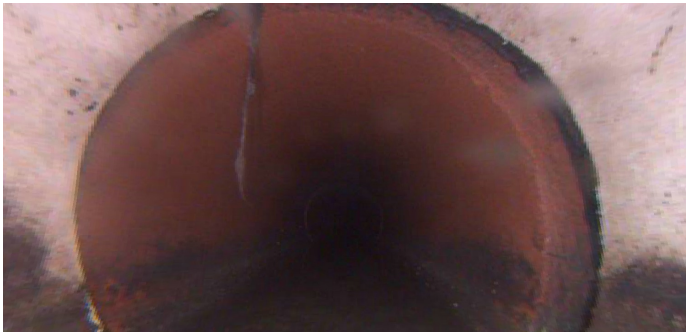
Code: **JOM**
Description: **Joint Offset Medium**

Distance (ft): **147.9**
Structural Grade: **1**
O&M Grade: **0**
Clock Start/From:
Clock To:
1st Value:
2nd Value:
Value Percent:
Continuous Index:
Within 8" of Joint: **NO**
Remarks:

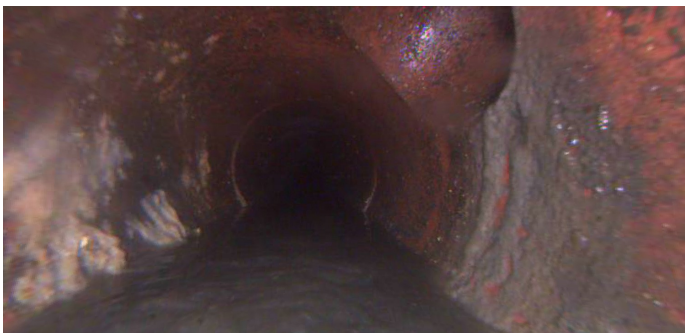
Code: **DAGS**
Description: **Deposits Attached Grease**

Distance (ft): **207.5**
Structural Grade: **0**
O&M Grade: **2**
Clock Start/From: **8**
Clock To: **4**
1st Value:
2nd Value:
Value Percent: **5.000**
Continuous Index:
Within 8" of Joint: **NO**
Remarks:

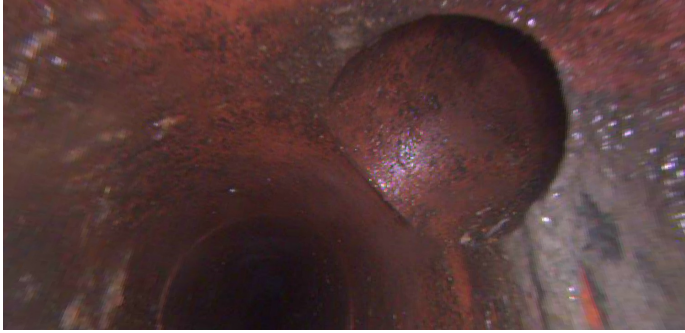
Code: **TF**
Description: **Tap Factory**

Distance (ft): **207.7**
Structural Grade: **0**
O&M Grade: **0**
Clock Start/From: **2**
Clock To:
1st Value: **4.000**
2nd Value:
Value Percent:
Continuous Index:
Within 8" of Joint:
Remarks:

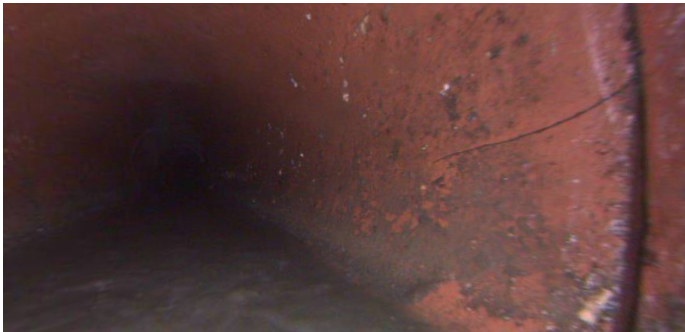
Code: **RFJ**
Description: **Roots Fine Joint**

Distance (ft): **209.3**
Structural Grade: **0**
O&M Grade: **1**
Clock Start/From: **3**
Clock To:
1st Value:
2nd Value:
Value Percent:
Continuous Index:
Within 8" of Joint: **YES**
Remarks:

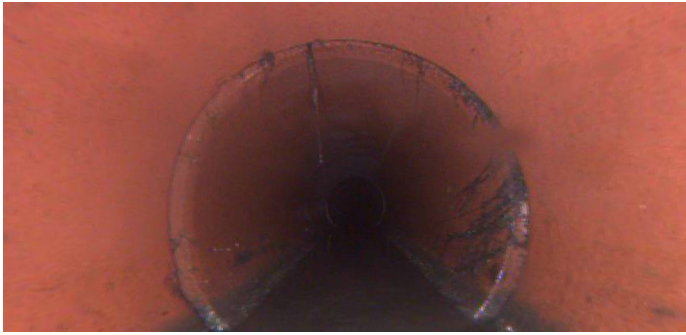
Code: **RFJ**
Description: **Roots Fine Joint**

Distance (ft): **232.3**
Structural Grade: **0**
O&M Grade: **1**
Clock Start/From: **11**
Clock To: **5**
1st Value:
2nd Value:
Value Percent:
Continuous Index:
Within 8" of Joint: **YES**
Remarks:

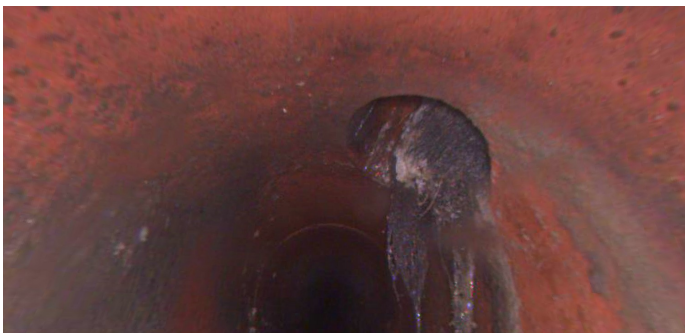
Code: **RML**
Description: **Roots Medium Lateral**

Distance (ft): **276.7**
Structural Grade: **0**
O&M Grade: **3**
Clock Start/From: **1**
Clock To: **2**
1st Value:
2nd Value:
Value Percent: **5.000**
Continuous Index:
Within 8" of Joint: **NO**
Remarks:

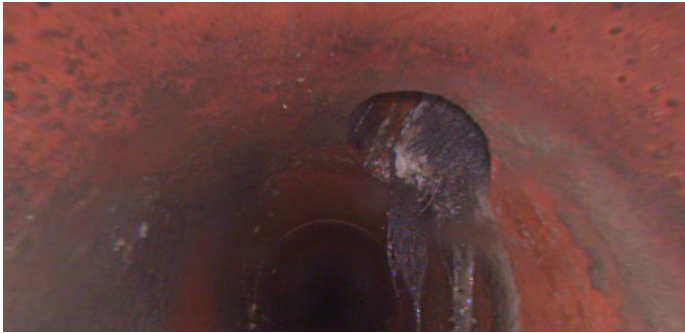
Code: **TFD**
Description: **Tap Factory Defective**

Distance (ft): **276.7**
Structural Grade: **0**
O&M Grade: **2**
Clock Start/From: **1**
Clock To:
1st Value: **4.000**
2nd Value:
Value Percent:
Continuous Index:
Within 8" of Joint:
Remarks: **ROOTS COMING FROM TAP**
