Profile/Photo Observation Report

Street:	57TH ST	Flow Control:	Not Controlled
City:	Hobart, IN	Year Renewed:	
Location:	Light Highway	Tape/Media #:	
Purpose:	Routine Assessment	Dia/Height:	12"
Use:	Sanitary	Material:	VCP
Drain Area:	NA	Lining:	
Category:	NA		
Comment:	Flow direction Wrong

Location Details:		Direction of Survey:	Downstream
US MH:	M-108-047	DS MH:	M-108-046
		Total Length Surveyed (ft):	320.0

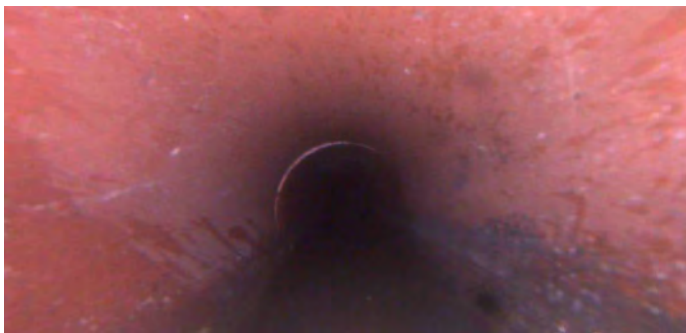
Code: **AMH**
Description: **Manhole**

Distance (ft): **.0**
Structural Grade: **0**
O&M Grade: **0**
Clock Start/From:
Clock To:
1st Value:
2nd Value:
Value Percent:
Continuous Index:
Within 8" of Joint: **NO**
Remarks: **M-108-047**

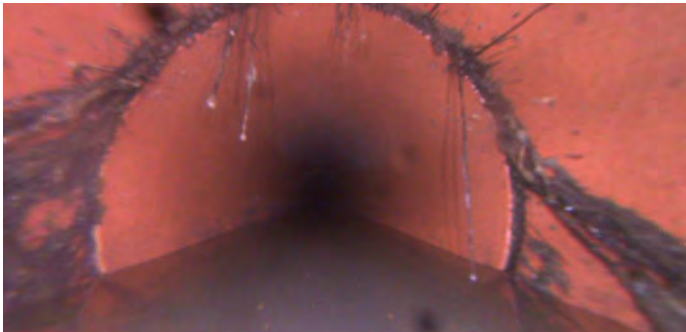
Code: **RMJ**
Description: **Roots Medium Joint**

Distance (ft): **59.5**
Structural Grade: **0**
O&M Grade: **3**
Clock Start/From: **7**
Clock To: **5**
1st Value:
2nd Value:
Value Percent: **5.000**
Continuous Index:
Within 8" of Joint: **YES**
Remarks:

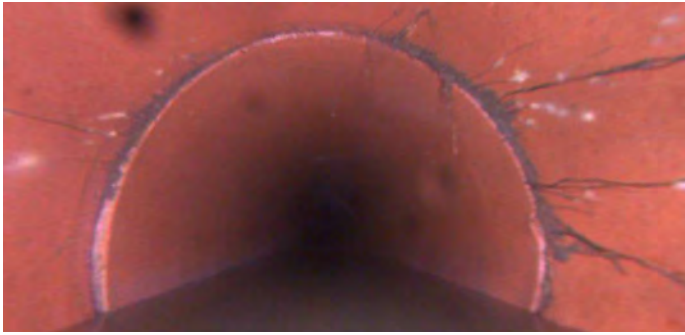
Code: **RFJ**
Description: **Roots Fine Joint**

Distance (ft): **67.2**
Structural Grade: **0**
O&M Grade: **1**
Clock Start/From: **8**
Clock To: **4**
1st Value:
2nd Value:
Value Percent:
Continuous Index:
Within 8" of Joint: **YES**
Remarks:

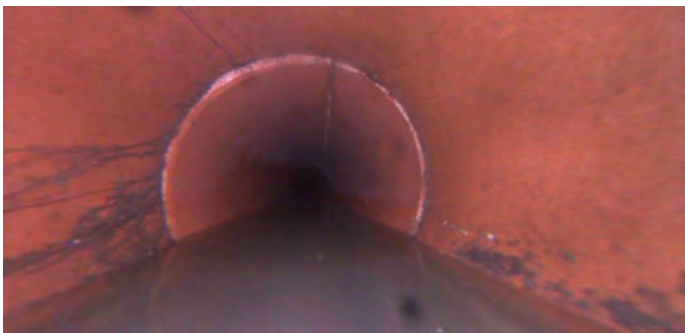
Code: **RFJ**
Description: **Roots Fine Joint**

Distance (ft): **86.6**
Structural Grade: **0**
O&M Grade: **1**
Clock Start/From: **7**
Clock To: **12**
1st Value:
2nd Value:
Value Percent:
Continuous Index:
Within 8" of Joint: **YES**
Remarks:

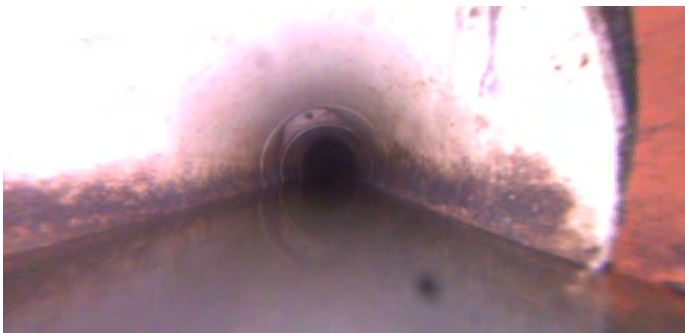
Code: **MMC**
Description: **Material Change**

Distance (ft): **171.3**
Structural Grade: **0**
O&M Grade: **0**
Clock Start/From:
Clock To:
1st Value:
2nd Value:
Value Percent:
Continuous Index:
Within 8" of Joint: **NO**
Remarks: **pvc**

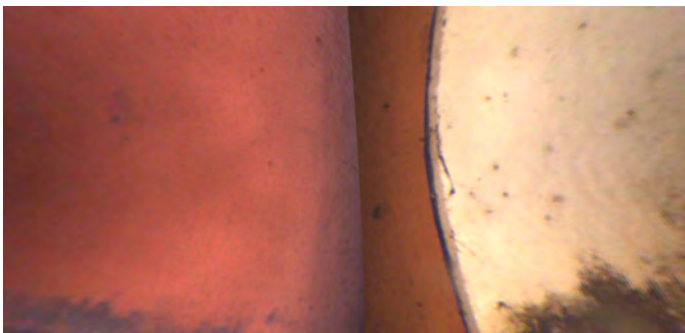
Code: **MMC**
Description: **Material Change**

Distance (ft): **175.1**
Structural Grade: **0**
O&M Grade: **0**
Clock Start/From:
Clock To:
1st Value:
2nd Value:
Value Percent:
Continuous Index:
Within 8" of Joint: **NO**
Remarks: **vcp**

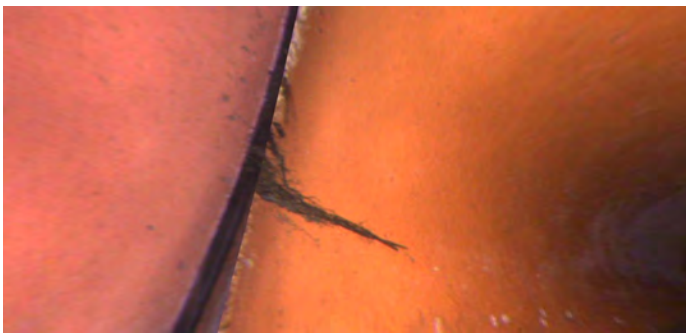
Code: **RFJ**
Description: **Roots Fine Joint**

Distance (ft): **190.1**
Structural Grade: **0**
O&M Grade: **1**
Clock Start/From: **2**
Clock To:
1st Value:
2nd Value:
Value Percent:
Continuous Index: **S01**
Within 8" of Joint: **YES**
Remarks: **wandering**

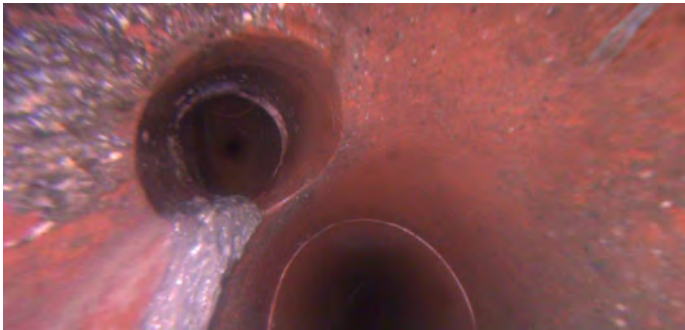
Code: **TFD**
Description: **Tap Factory Defective**

Distance (ft): **230.2**
Structural Grade: **0**
O&M Grade: **2**
Clock Start/From: **10**
Clock To:
1st Value: **4.000**
2nd Value:
Value Percent:
Continuous Index:
Within 8" of Joint:
Remarks: **DAGS**

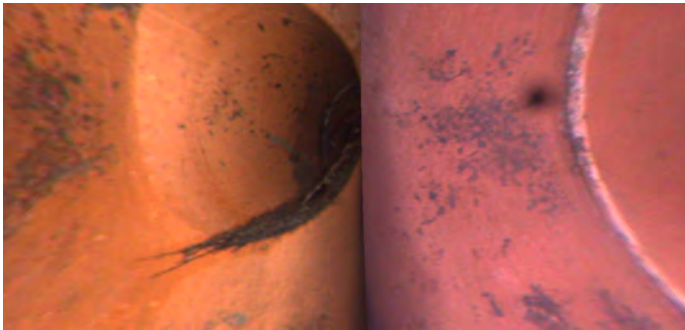
Code: **TF**
Description: **Tap Factory**

Distance (ft): **292.0**
Structural Grade: **0**
O&M Grade: **0**
Clock Start/From: **10**
Clock To:
1st Value: **4.000**
2nd Value:
Value Percent:
Continuous Index:
Within 8" of Joint: **YES**
Remarks:

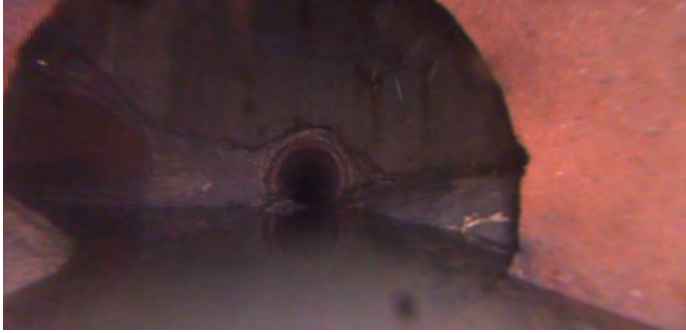
Code: **RFJ**
Description: **Roots Fine Joint**

Distance (ft): **318.8**
Structural Grade: **0**
O&M Grade: **1**
Clock Start/From: **2**
Clock To:
1st Value:
2nd Value:
Value Percent:
Continuous Index: **F01**
Within 8" of Joint: **YES**
Remarks: **wandering**

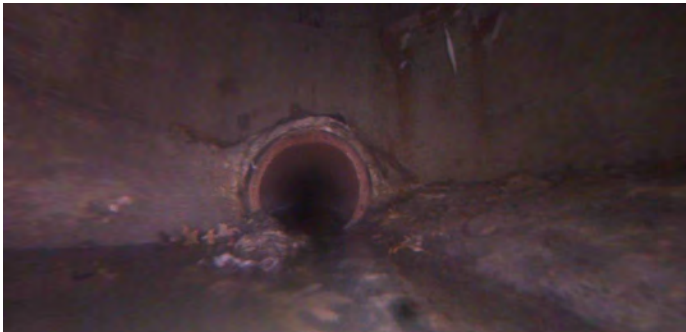
Code: **AMH**
Description: **Manhole**

Distance (ft): **320.0**
Structural Grade: **0**
O&M Grade: **0**
Clock Start/From:
Clock To:
1st Value:
2nd Value:
Value Percent:
Continuous Index:
Within 8" of Joint: **NO**
Remarks: **M-108-046**
