Profile/Photo Observation Report

Street:	FOXCROFT STREET	Flow Control:	Not Controlled
City:	Hobart, IN	Year Renewed:	
Location:	Light Highway	Tape/Media #:	
Purpose:	Routine Assessment	Dia/Height:	10"
Use:	Sanitary	Material:	PVC
Drain Area:	NA	Lining:	
Category:	NA		
Comment:	P_C at 253 ft nothing visible . Flow direction wrong		
Location Details:		Direction of Survey:	Downstream
US MH:	M-108-053	DS MH:	M-108-052
		Total Length Surveyed (ft):	254.1

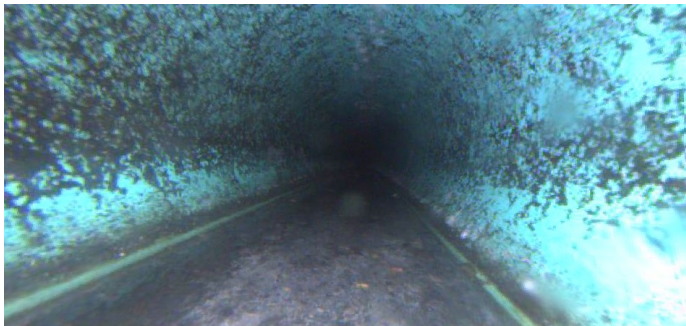
Code: **AMH**
Description: **Manhole**

Distance (ft): **.0**
Structural Grade: **0**
O&M Grade: **0**
Clock Start/From:
Clock To:
1st Value:
2nd Value:
Value Percent:
Continuous Index:
Within 8" of Joint: **NO**
Remarks: **M-108-053**

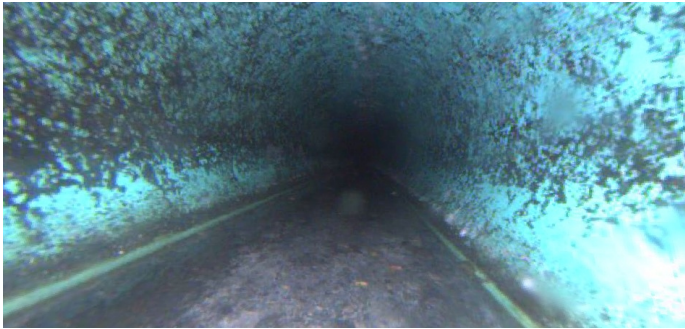
Code:	MWL
Description:	Water Level

Distance (ft):	.0
Structural Grade:	0
O&M Grade:	0
Clock Start/From:	
Clock To:	
1st Value:	
2nd Value:	
Value Percent:	20.000
Continuous Index:	
Within 8" of Joint:	NO
Remarks:

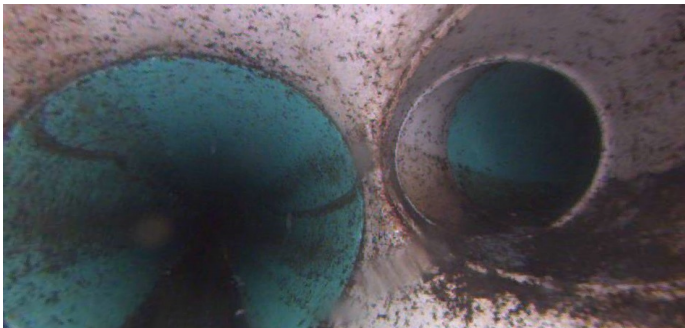
Code:	TF
Description:	Tap Factory

Distance (ft):	13.3
Structural Grade:	0
O&M Grade:	0
Clock Start/From:	2
Clock To:	
1st Value:	4.000
2nd Value:	
Value Percent:	
Continuous Index:	
Within 8" of Joint:	
Remarks:

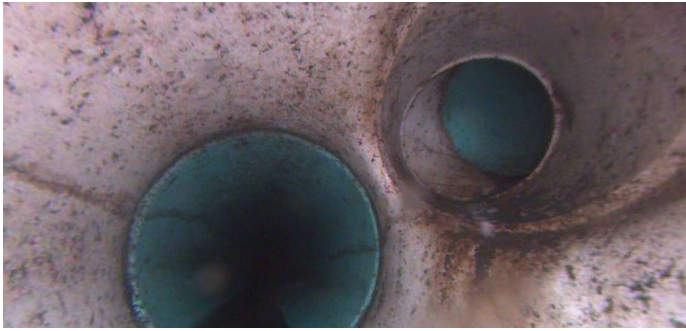
Code: **TF**
Description: **Tap Factory**

Distance (ft): **115.5**
Structural Grade: **0**
O&M Grade: **0**
Clock Start/From: **2**
Clock To:
1st Value: **4.000**
2nd Value:
Value Percent:
Continuous Index:
Within 8" of Joint:
Remarks:

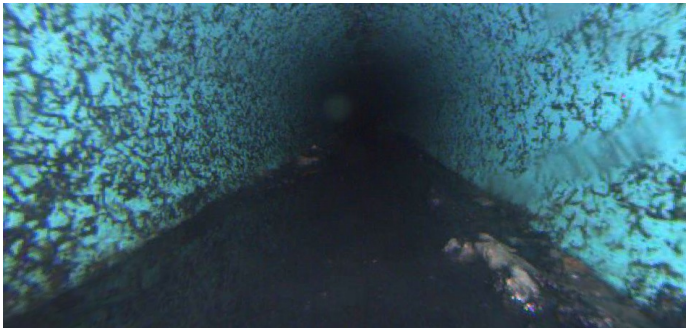
Code: **MWL**
Description: **Water Level**

Distance (ft): **228.8**
Structural Grade: **0**
O&M Grade: **0**
Clock Start/From:
Clock To:
1st Value:
2nd Value:
Value Percent: **25.000**
Continuous Index:
Within 8" of Joint: **NO**
Remarks:

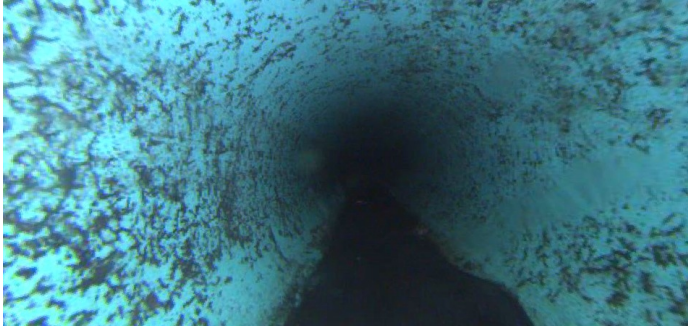
Code:	MSA
Description:	Abandoned Survey
Distance (ft):	254.1
Structural Grade:	0
O&M Grade:	0
Clock Start/From:	
Clock To:	
1st Value:	
2nd Value:	
Value Percent:	
Continuous Index:	
Within 8" of Joint:	NO
Remarks:	DSF
