Profile/Photo Observation Report

Date:	03/20/2018	Weather:		Coding:	PACP 6.0
Pipe Length (ft):	397.6	Owner:	NA	Pre Clean:	No Pre-Cleaning
P.O.#:		Surveyor:	John Kuglmaier	PSR:	P-108-053-054
Customer:		Clean Date:	01/01/1900	Shape:	C

Street:	W 61ST AVE	Flow Control:	Not Controlled
City:	Hobart, IN	Year Renewed:	
Location:	Light Highway	Tape/Media #:	
Purpose:	Routine Assessment	Dia/Height:	10"
Use:	Sanitary	Material:	PVC
Drain Area:	NA	Lining:	
Category:	NA		
Comment:	Flow direction wrong		
Location Details:		Direction of Survey:	Upstream
US MH:	M-108-054	DS MH:	M-108-053
		Total Length Surveyed (ft):	413.4

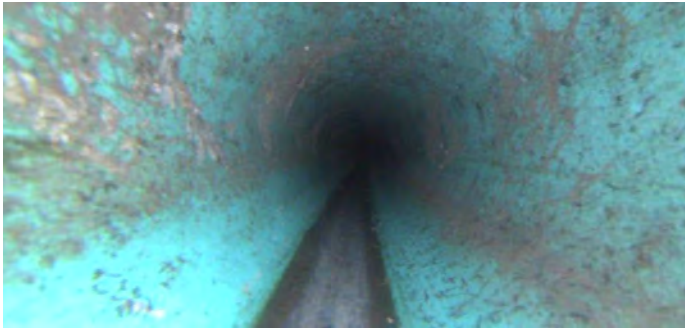
Code:	MWL
Description:	Water Level

Distance (ft):	.0
Structural Grade:	0
O&M Grade:	0
Clock Start/From:	
Clock To:	
1st Value:	
2nd Value:	
Value Percent:	5.000
Continuous Index:	
Within 8" of Joint:	NO
Remarks:

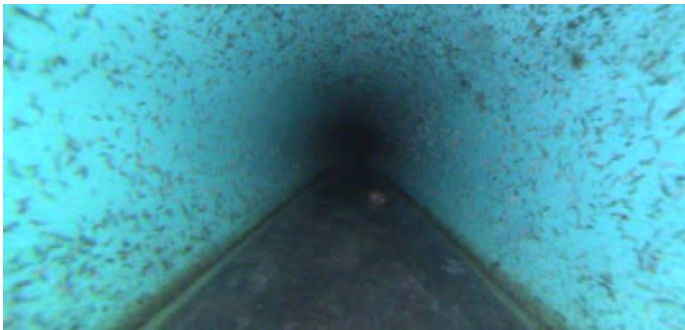
Code:	MWL
Description:	Water Level

Distance (ft):	81.9
Structural Grade:	0
O&M Grade:	0
Clock Start/From:	
Clock To:	
1st Value:	
2nd Value:	
Value Percent:	20.000
Continuous Index:	
Within 8" of Joint:	NO
Remarks:

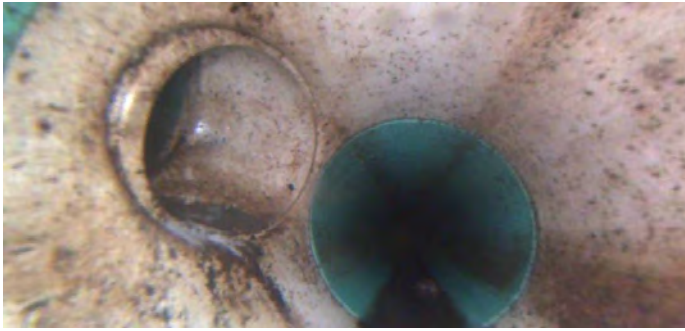
Code: **TF**
Description: **Tap Factory**

Distance (ft): **105.3**
Structural Grade: **0**
O&M Grade: **0**
Clock Start/From: **10**
Clock To:
1st Value: **4.000**
2nd Value:
Value Percent:
Continuous Index:
Within 8" of Joint:
Remarks:

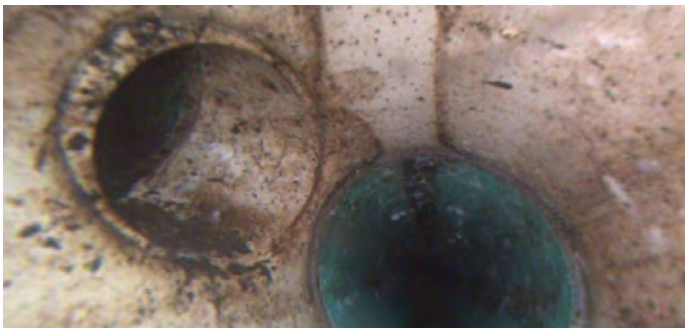
Code: **TF**
Description: **Tap Factory**

Distance (ft): **324.3**
Structural Grade: **0**
O&M Grade: **0**
Clock Start/From: **10**
Clock To:
1st Value: **4.000**
2nd Value:
Value Percent:
Continuous Index:
Within 8" of Joint:
Remarks:

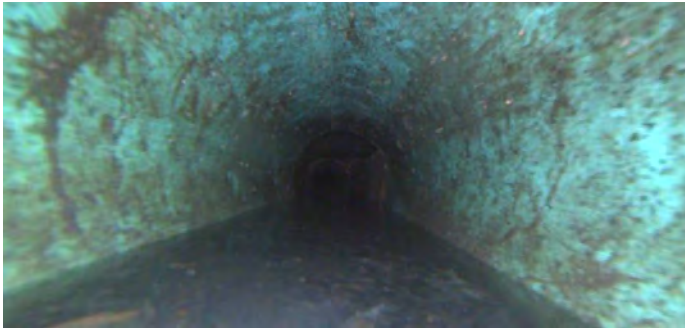
Code: **MWL**
Description: **Water Level**

Distance (ft): **409.0**
Structural Grade: **0**
O&M Grade: **0**
Clock Start/From:
Clock To:
1st Value:
2nd Value:
Value Percent: **30.000**
Continuous Index:
Within 8" of Joint: **NO**
Remarks:

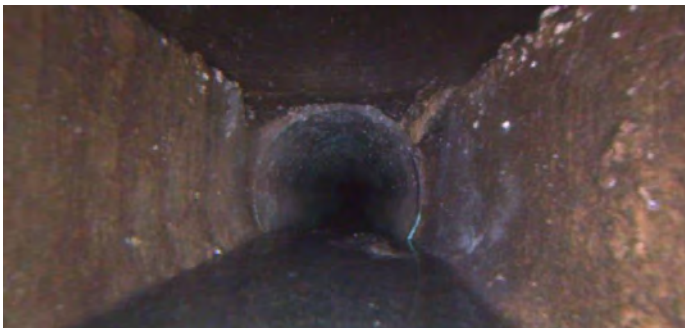
Code: **AMH**
Description: **Manhole**

Distance (ft): **413.4**
Structural Grade: **0**
O&M Grade: **0**
Clock Start/From:
Clock To:
1st Value:
2nd Value:
Value Percent:
Continuous Index:
Within 8" of Joint: **NO**
Remarks: **M-108-054**
