# Profile/Photo Observation Report

Date:	<b>04/05/2018</b>	Weather:		Coding:	<b>PACP 6.0</b>
Pipe Length (ft):	<b>336.8</b>	Owner:	<b>NA</b>	Pre Clean:	<b>Not Known</b>
P.O.#:		Surveyor:	<b>Jen Costello</b>	PSR:	<b>P-203-003-002</b>
Customer:		Clean Date:	<b>01/01/1900</b>	Shape:	<b>C</b>

Street:	<b>old ridge rd</b>	Flow Control:	<b>Not Controlled</b>
City:	<b>Hobart, IN</b>	Year Renewed:	
Location:	<b>Other</b>	Tape/Media #:	
Purpose:	<b>Not Known</b>	Dia/Height:	<b>12"</b>
Use:	<b>Sanitary</b>	Material:	<b>VCP</b>
Drain Area:	<b>NA</b>	Lining:	
Category:	<b>NA</b>		
Comment:			
Location Details:		Direction of Survey:	<b>Downstream</b>
US MH:	<b>M-203-003</b>	DS MH:	<b>M-203-002</b>
		Total Length Surveyed (ft):	<b>323.1</b>

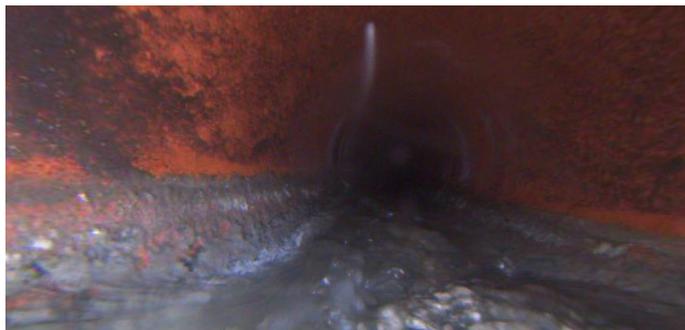
Code: **AMH**  
Description: **Manhole**

Distance (ft): **.0**  
Structural Grade: **0**  
O&M Grade: **0**  
Clock Start/From:  
Clock To:  
1st Value:  
2nd Value:  
Value Percent:  
Continuous Index:  
Within 8" of Joint: **NO**  
Remarks: **M-203-003**

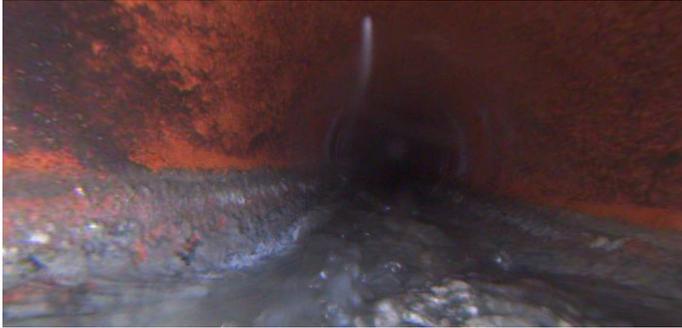
Code: **MWL**  
Description: **Water Level**

Distance (ft): **.0**  
Structural Grade: **0**  
O&M Grade: **0**  
Clock Start/From:  
Clock To:  
1st Value:  
2nd Value:  
Value Percent: **20.000**  
Continuous Index:  
Within 8" of Joint: **NO**  
Remarks:

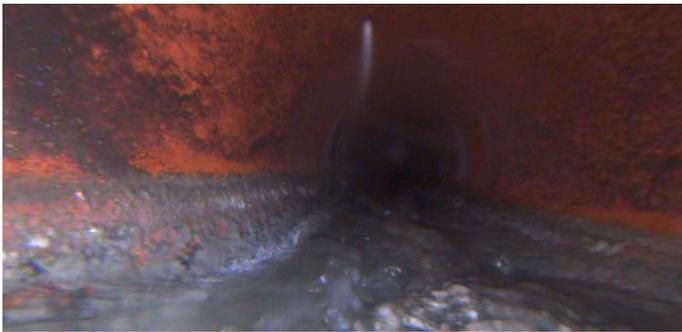
Code: **DAGS**  
Description: **Deposits Attached Grease**

Distance (ft): **.0**  
Structural Grade: **0**  
O&M Grade: **2**  
Clock Start/From: **8**  
Clock To: **4**  
1st Value:  
2nd Value:  
Value Percent: **5.000**  
Continuous Index: **S01**  
Within 8" of Joint: **NO**  
Remarks:

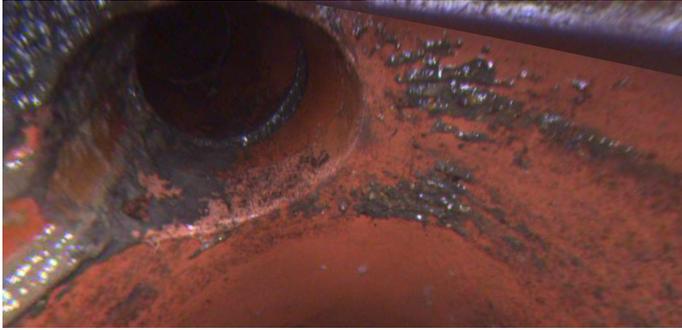
Code: **TF**  
Description: **Tap Factory**

Distance (ft): **91.0**  
Structural Grade: **0**  
O&M Grade: **0**  
Clock Start/From: **11**  
Clock To:  
1st Value: **4.000**  
2nd Value:  
Value Percent:  
Continuous Index:  
Within 8" of Joint:  
Remarks:

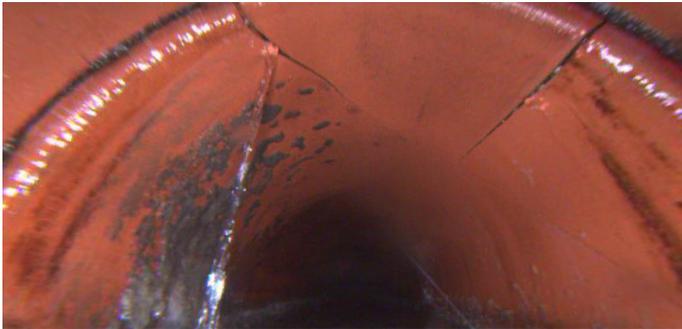
Code: **FM**  
Description: **Fracture Multiple**

Distance (ft): **191.0**  
Structural Grade: **4**  
O&M Grade: **0**  
Clock Start/From: **11**  
Clock To: **1**  
1st Value:  
2nd Value:  
Value Percent:  
Continuous Index:  
Within 8" of Joint: **YES**  
Remarks:

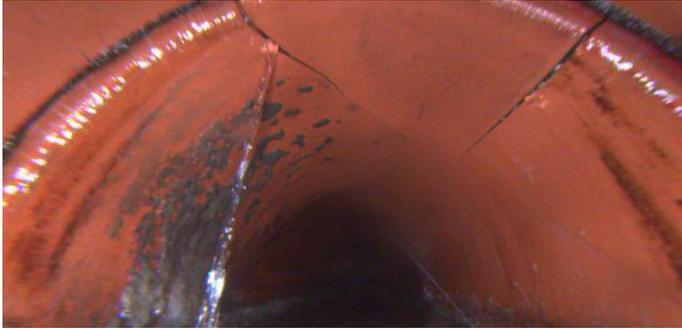
Code: **IR**  
Description: **Infil Runner**

Distance (ft): **191.0**  
Structural Grade: **0**  
O&M Grade: **4**  
Clock Start/From: **11**  
Clock To: **1**  
1st Value:  
2nd Value:  
Value Percent:  
Continuous Index:  
Within 8" of Joint: **YES**  
Remarks:

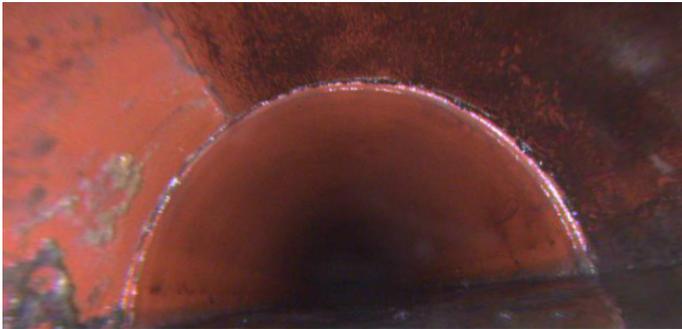
Code: **FL**  
Description: **Fracture Longitudinal**

Distance (ft): **205.6**  
Structural Grade: **3**  
O&M Grade: **0**  
Clock Start/From: **11**  
Clock To:  
1st Value:  
2nd Value:  
Value Percent:  
Continuous Index:  
Within 8" of Joint: **YES**  
Remarks:

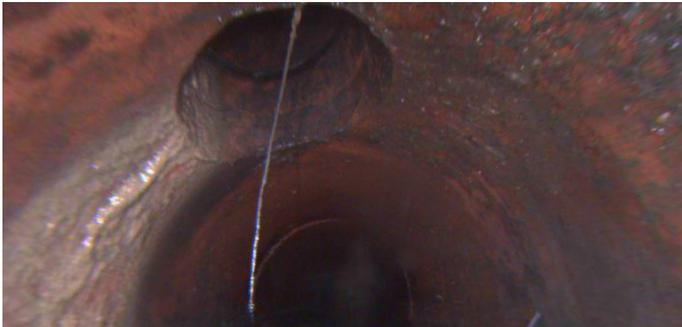
Code: **TFD**  
Description: **Tap Factory Defective**

Distance (ft): **243.2**  
Structural Grade: **0**  
O&M Grade: **2**  
Clock Start/From: **12**  
Clock To:  
1st Value: **4.000**  
2nd Value: **1.000**  
Value Percent:  
Continuous Index:  
Within 8" of Joint:  
Remarks: **RFL**

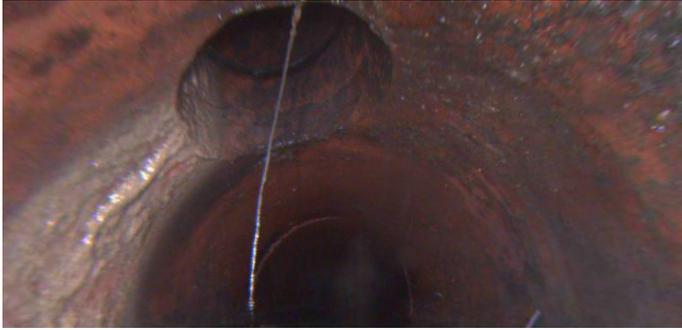
Code: **RFL**  
Description: **Roots Fine Lateral**

Distance (ft): **243.2**  
Structural Grade: **0**  
O&M Grade: **1**  
Clock Start/From: **11**  
Clock To:  
1st Value:  
2nd Value:  
Value Percent:  
Continuous Index:  
Within 8" of Joint: **NO**  
Remarks:

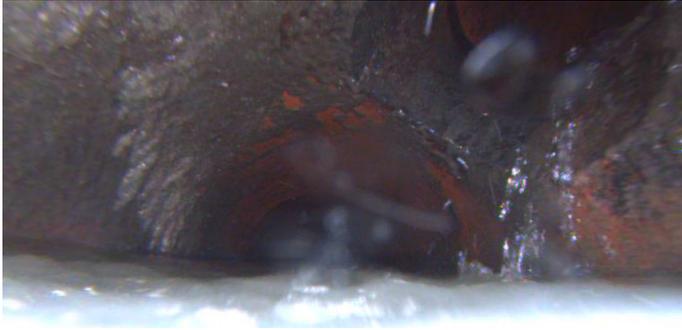
Code: **MWL**  
Description: **Water Level**

Distance (ft): **250.4**  
Structural Grade: **0**  
O&M Grade: **0**  
Clock Start/From:  
Clock To:  
1st Value:  
2nd Value:  
Value Percent: **40.000**  
Continuous Index:  
Within 8" of Joint: **NO**  
Remarks:

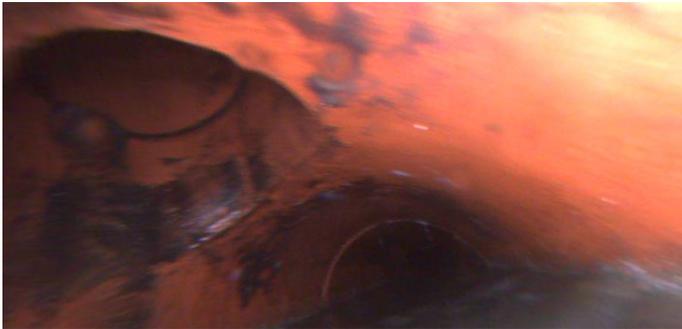
Code: **TF**  
Description: **Tap Factory**

Distance (ft): **252.5**  
Structural Grade: **0**  
O&M Grade: **0**  
Clock Start/From: **11**  
Clock To:  
1st Value: **4.000**  
2nd Value:  
Value Percent:  
Continuous Index:  
Within 8" of Joint:  
Remarks:

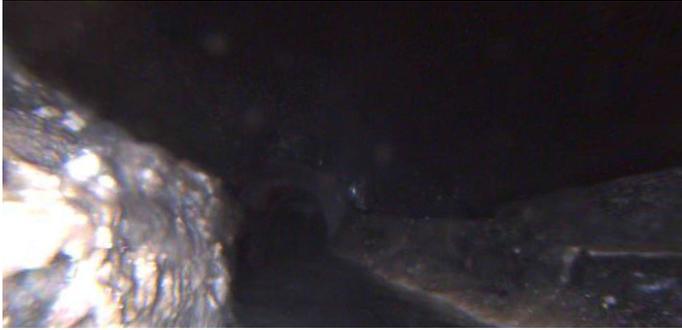
Code: **DAGS**  
Description: **Deposits Attached Grease**

Distance (ft): **323.1**  
Structural Grade: **0**  
O&M Grade: **2**  
Clock Start/From: **8**  
Clock To: **4**  
1st Value:  
2nd Value:  
Value Percent: **5.000**  
Continuous Index: **F01**  
Within 8" of Joint: **NO**  
Remarks:

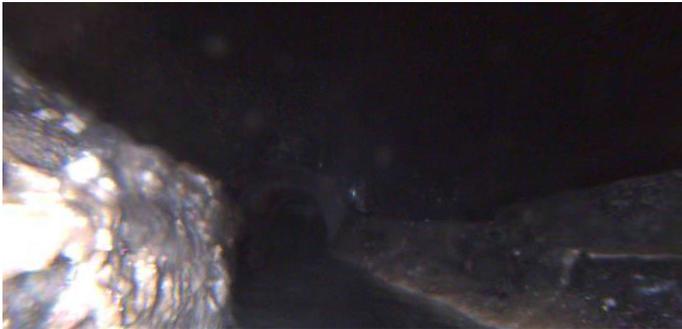
Code: **AMH**  
Description: **Manhole**

Distance (ft): **323.1**  
Structural Grade: **0**  
O&M Grade: **0**  
Clock Start/From:  
Clock To:  
1st Value:  
2nd Value:  
Value Percent:  
Continuous Index:  
Within 8" of Joint: **NO**  
Remarks: **M-203-002**
