Profile/Photo Observation Report

Date:	04/05/2018	Weather:		Coding:	PACP 6.0
Pipe Length (ft):	261.5	Owner:	NA	Pre Clean:	Not Known
P.O.#:		Surveyor:	Jen Costello	PSR:	P-203-004-003
Customer:		Clean Date:	01/01/1900	Shape:	C

Street:	W OLD RIDGE RD & PARKER ST	Flow Control:	Not Controlled
City:	Hobart, IN	Year Renewed:	
Location:	Other	Tape/Media #:	
Purpose:	Not Known	Dia/Height:	10"
Use:	Sanitary	Material:	PVC
Drain Area:	NA	Lining:	
Category:	NA		
Comment:

Location Details:		Direction of Survey:	Downstream
US MH:	M-203-003	DS MH:	M-203-004
		Total Length Surveyed (ft):	248.3

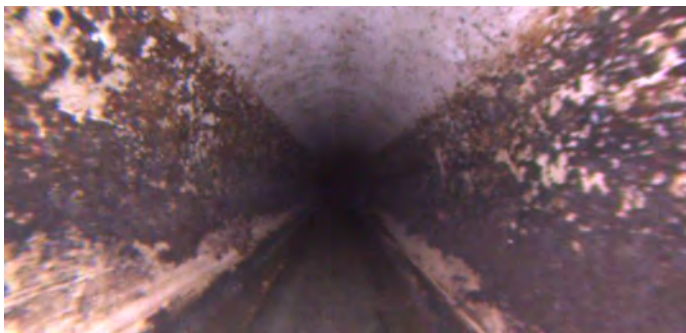
Code: **AMH**
Description: **Manhole**

Distance (ft): **.0**
Structural Grade: **0**
O&M Grade: **0**
Clock Start/From:
Clock To:
1st Value:
2nd Value:
Value Percent:
Continuous Index:
Within 8" of Joint: **NO**
Remarks: **M-203-003**

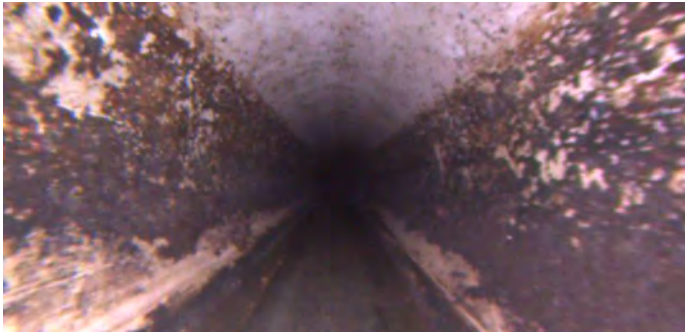
Code:	MWL
Description:	Water Level

Distance (ft):	.0
Structural Grade:	0
O&M Grade:	0
Clock Start/From:	
Clock To:	
1st Value:	
2nd Value:	
Value Percent:	5.000
Continuous Index:	
Within 8" of Joint:	NO
Remarks:

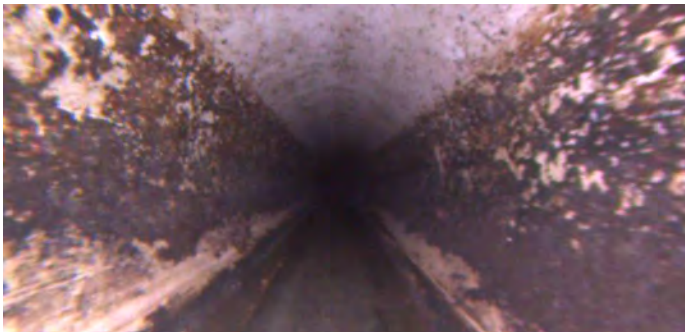
Code:	DAGS
Description:	Deposits Attached Grease

Distance (ft):	.0
Structural Grade:	0
O&M Grade:	2
Clock Start/From:	7
Clock To:	5
1st Value:	
2nd Value:	
Value Percent:	5.000
Continuous Index:	S01
Within 8" of Joint:	NO
Remarks:

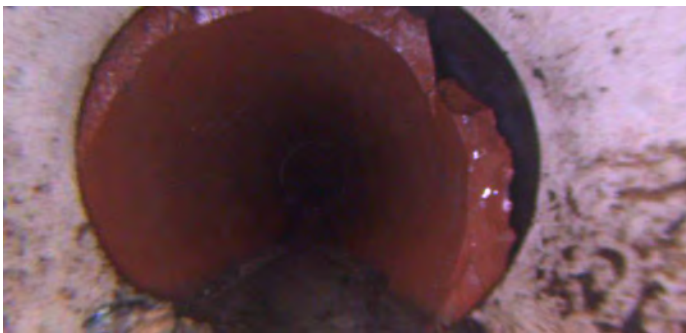
Code: **SSS**
Description: **Surface Spalling**

Distance (ft): **11.0**
Structural Grade: **2**
O&M Grade: **0**
Clock Start/From: **9**
Clock To: **4**
1st Value:
2nd Value:
Value Percent:
Continuous Index:
Within 8" of Joint: **YES**
Remarks:

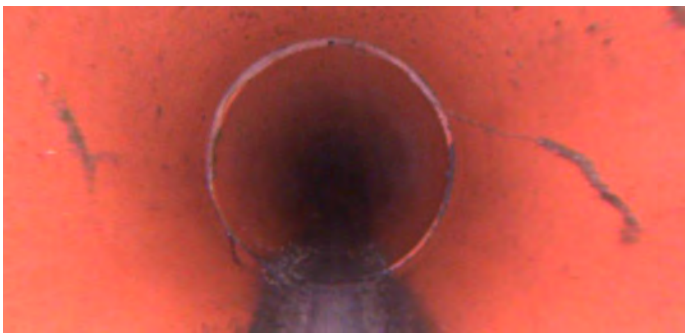
Code: **RFJ**
Description: **Roots Fine Joint**

Distance (ft): **53.9**
Structural Grade: **0**
O&M Grade: **1**
Clock Start/From: **2**
Clock To:
1st Value:
2nd Value:
Value Percent:
Continuous Index:
Within 8" of Joint: **YES**
Remarks:

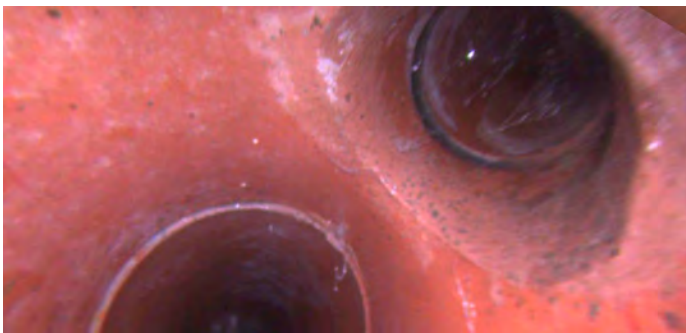
Code: **TF**
Description: **Tap Factory**

Distance (ft): **121.2**
Structural Grade: **0**
O&M Grade: **0**
Clock Start/From: **2**
Clock To:
1st Value: **4.000**
2nd Value:
Value Percent:
Continuous Index:
Within 8" of Joint:
Remarks:

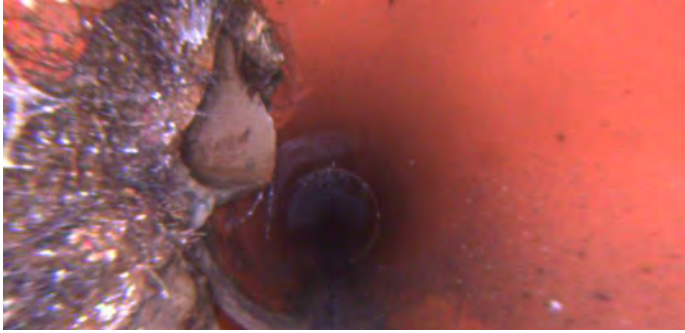
Code: **TBI**
Description: **Tap Break-in Intruding**

Distance (ft): **124.8**
Structural Grade: **0**
O&M Grade: **2**
Clock Start/From: **9**
Clock To:
1st Value: **4.000**
2nd Value: **2.000**
Value Percent:
Continuous Index:
Within 8" of Joint:
Remarks: **ROOTS**

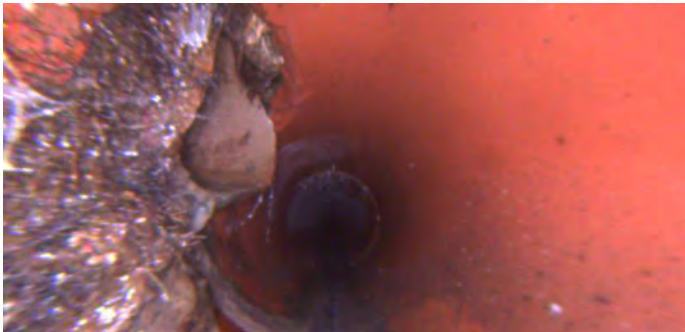
Code: **RMC**
Description: **Roots Medium Connection**

Distance (ft): **124.8**
Structural Grade: **0**
O&M Grade: **3**
Clock Start/From: **7**
Clock To: **11**
1st Value:
2nd Value:
Value Percent: **10.000**
Continuous Index:
Within 8" of Joint: **NO**
Remarks:

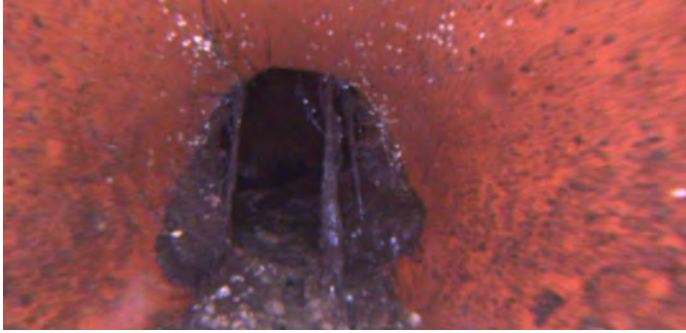
Code: **RMJ**
Description: **Roots Medium Joint**

Distance (ft): **245.2**
Structural Grade: **0**
O&M Grade: **3**
Clock Start/From: **8**
Clock To: **4**
1st Value:
2nd Value:
Value Percent: **10.000**
Continuous Index:
Within 8" of Joint: **YES**
Remarks:

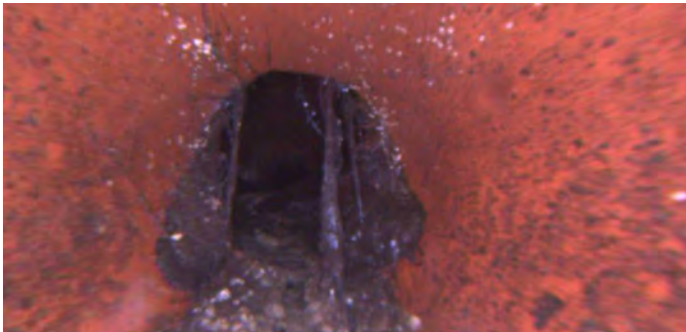
Code: **DSF**
Description: **Deposits Settled Fine**

Distance (ft): **245.2**
Structural Grade: **0**
O&M Grade: **2**
Clock Start/From: **4**
Clock To: **8**
1st Value:
2nd Value:
Value Percent: **10.000**
Continuous Index:
Within 8" of Joint: **NO**
Remarks:

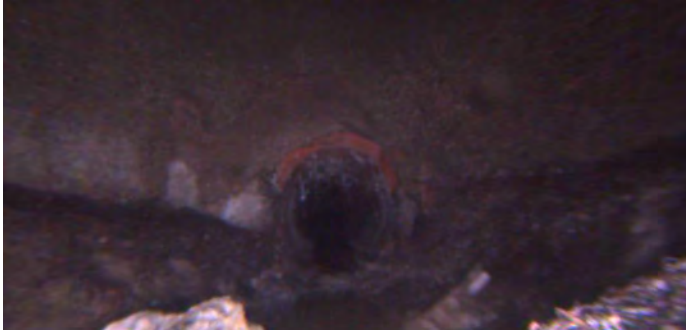
Code: **AMH**
Description: **Manhole**

Distance (ft): **248.3**
Structural Grade: **0**
O&M Grade: **0**
Clock Start/From:
Clock To:
1st Value:
2nd Value:
Value Percent:
Continuous Index:
Within 8" of Joint: **NO**
Remarks: **M-203-004**

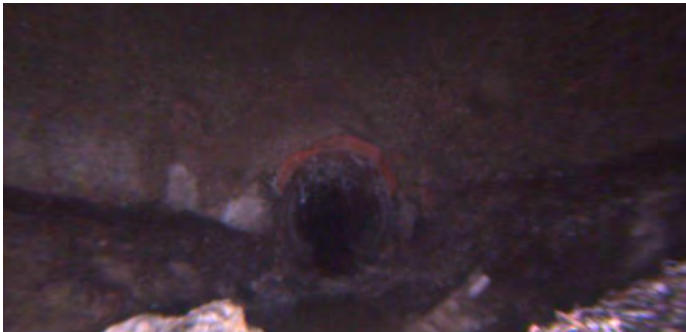
Code: **DAGS**
Description: **Deposits Attached Grease**

Distance (ft): **248.3**
Structural Grade: **0**
O&M Grade: **2**
Clock Start/From: **7**
Clock To: **5**
1st Value:
2nd Value:
Value Percent: **5.000**
Continuous Index: **F01**
Within 8" of Joint: **NO**
Remarks:
