Profile/Photo Observation Report

Street:	W OLD RIDGE RD	Flow Control:	Not Controlled
City:	Hobart, IN	Year Renewed:	
Location:	Other	Tape/Media #:	
Purpose:	Not Known	Dia/Height:	12"
Use:	Sanitary	Material:	VCP
Drain Area:	NA	Lining:	
Category:	NA		
Comment:

Location Details:		Direction of Survey:	Upstream
US MH:	M-203-009	DS MH:	M-203-006
		Total Length Surveyed (ft):	351.0

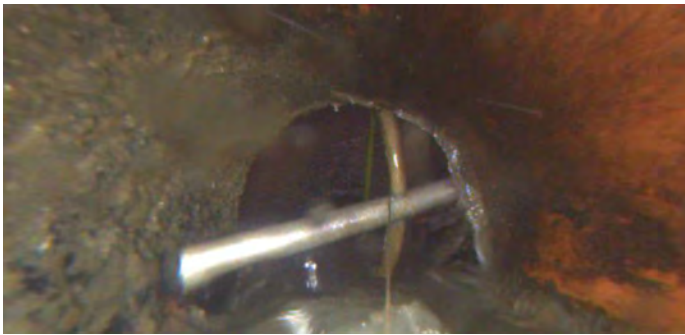
Code:	MGO
Description:	General Observation

Distance (ft):	.9
Structural Grade:	0
O&M Grade:	0
Clock Start/From:	
Clock To:	
1st Value:	
2nd Value:	
Value Percent:	
Continuous Index:	
Within 8" of Joint:	NO
Remarks:	rear camera

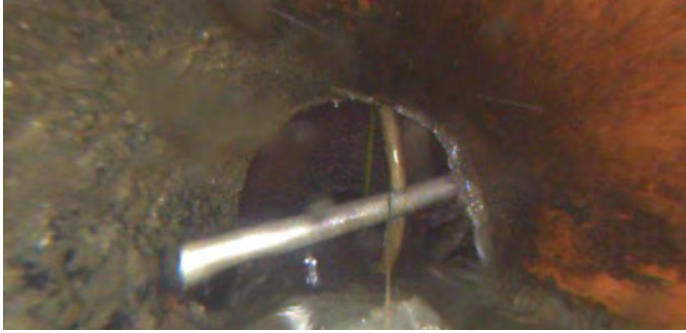
Code: **DAGS**
Description: **Deposits Attached Grease**

Distance (ft): **.9**
Structural Grade: **0**
O&M Grade: **2**
Clock Start/From: **12**
Clock To: **4**
1st Value:
2nd Value:
Value Percent: **5.000**
Continuous Index:
Within 8" of Joint: **NO**
Remarks:

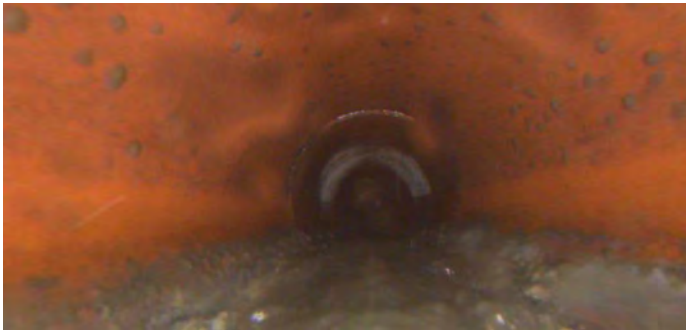
Code: **DAGS**
Description: **Deposits Attached Grease**

Distance (ft): **27.0**
Structural Grade: **0**
O&M Grade: **2**
Clock Start/From: **7**
Clock To: **5**
1st Value:
2nd Value:
Value Percent: **5.000**
Continuous Index: **S01**
Within 8" of Joint: **NO**
Remarks:

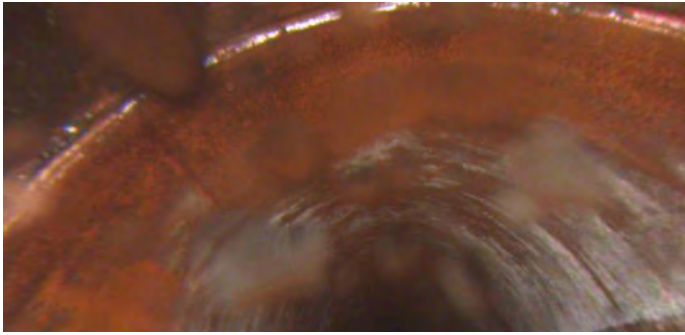
Code: **FL**
Description: **Fracture Longitudinal**

Distance (ft): **56.6**
Structural Grade: **3**
O&M Grade: **0**
Clock Start/From: **10**
Clock To:
1st Value:
2nd Value:
Value Percent:
Continuous Index:
Within 8" of Joint: **YES**
Remarks:

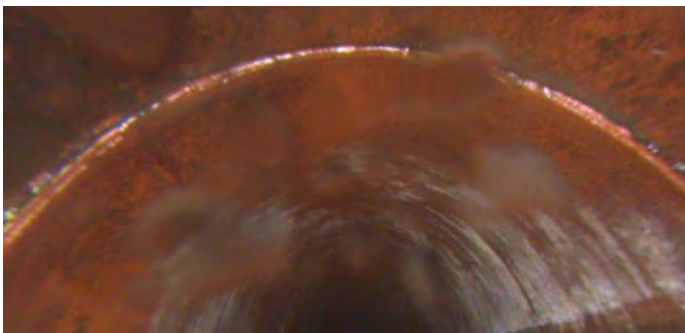
Code: **IW**
Description: **Infil Weeper**

Distance (ft): **56.7**
Structural Grade: **0**
O&M Grade: **2**
Clock Start/From: **8**
Clock To: **4**
1st Value:
2nd Value:
Value Percent:
Continuous Index: **S02**
Within 8" of Joint: **YES**
Remarks:

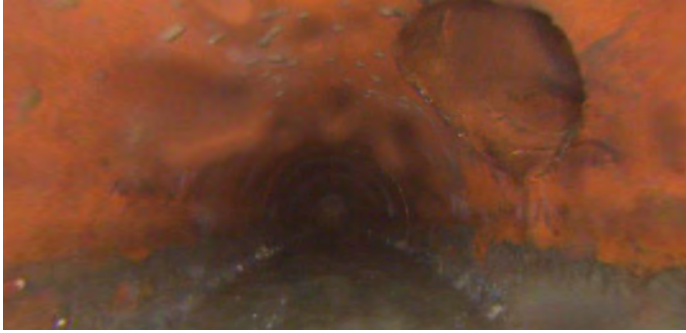
Code: **TFC**
Description: **Tap Factory Capped**

Distance (ft): **74.1**
Structural Grade: **0**
O&M Grade: **0**
Clock Start/From: **10**
Clock To:
1st Value: **4.000**
2nd Value:
Value Percent:
Continuous Index:
Within 8" of Joint:
Remarks:

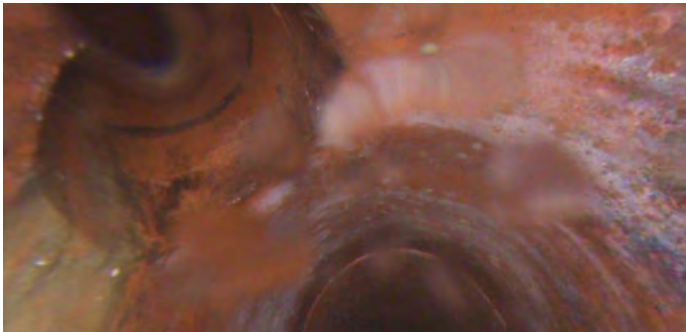
Code: **TF**
Description: **Tap Factory**

Distance (ft): **91.2**
Structural Grade: **0**
O&M Grade: **0**
Clock Start/From: **1**
Clock To:
1st Value: **4.000**
2nd Value:
Value Percent:
Continuous Index:
Within 8" of Joint:
Remarks:

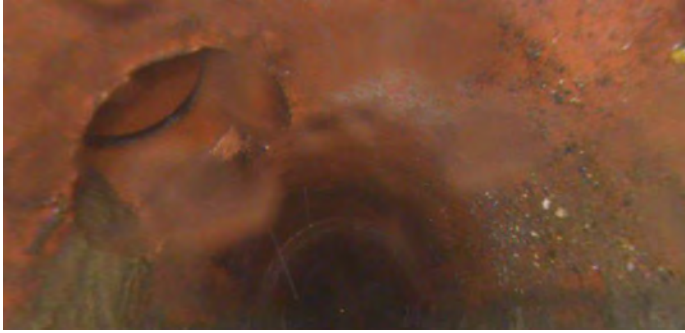
Code: **TF**
Description: **Tap Factory**

Distance (ft): **150.8**
Structural Grade: **0**
O&M Grade: **0**
Clock Start/From: **2**
Clock To:
1st Value: **4.000**
2nd Value:
Value Percent:
Continuous Index:
Within 8" of Joint:
Remarks:

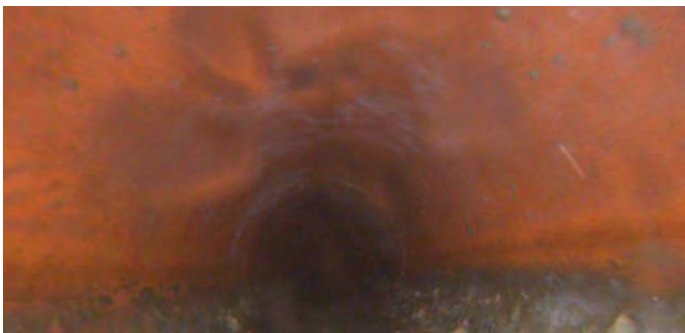
Code: **IW**
Description: **Infil Weeper**

Distance (ft): **158.2**
Structural Grade: **0**
O&M Grade: **2**
Clock Start/From: **8**
Clock To: **4**
1st Value:
2nd Value:
Value Percent:
Continuous Index: **F02**
Within 8" of Joint: **YES**
Remarks:

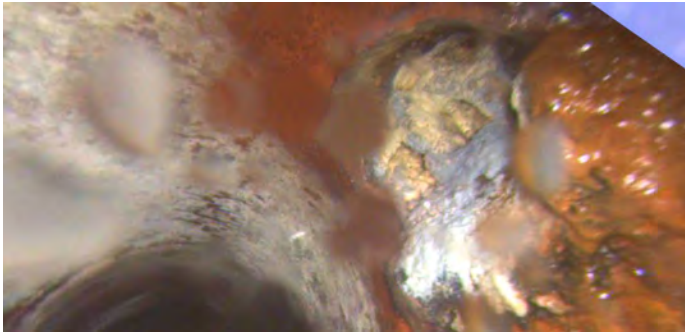
Code: **TFD**
Description: **Tap Factory Defective**

Distance (ft): **168.1**
Structural Grade: **0**
O&M Grade: **2**
Clock Start/From: **10**
Clock To:
1st Value: **4.000**
2nd Value:
Value Percent:
Continuous Index:
Within 8" of Joint:
Remarks: **dae**

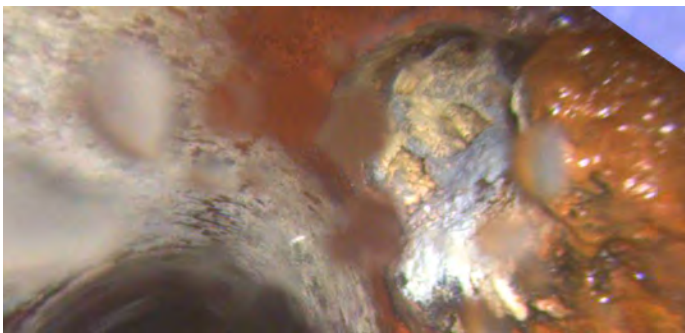
Code: **DAE**
Description: **Deposits Attached Encrustation**

Distance (ft): **168.1**
Structural Grade: **0**
O&M Grade: **2**
Clock Start/From: **9**
Clock To: **10**
1st Value:
2nd Value:
Value Percent: **10.000**
Continuous Index:
Within 8" of Joint: **NO**
Remarks:

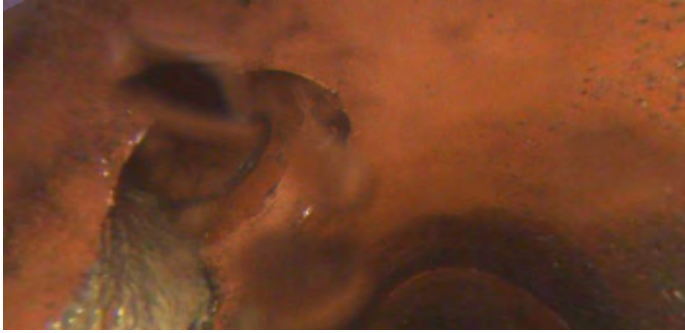
Code: **TFA**
Description: **Tap Factory Active**

Distance (ft): **191.2**
Structural Grade: **0**
O&M Grade: **0**
Clock Start/From: **2**
Clock To:
1st Value: **4.000**
2nd Value:
Value Percent:
Continuous Index:
Within 8" of Joint:
Remarks:

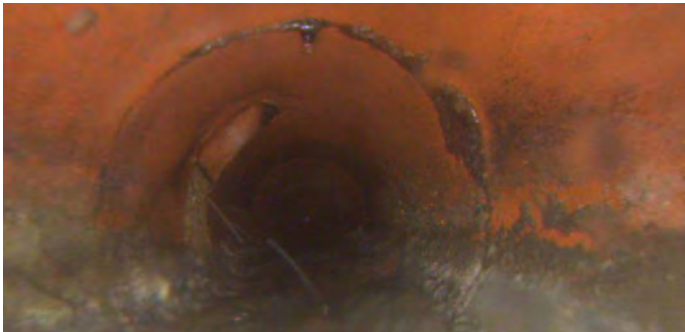
Code: **ID**
Description: **Infil Dripper**

Distance (ft): **192.4**
Structural Grade: **0**
O&M Grade: **3**
Clock Start/From: **12**
Clock To:
1st Value:
2nd Value:
Value Percent:
Continuous Index:
Within 8" of Joint: **YES**
Remarks:

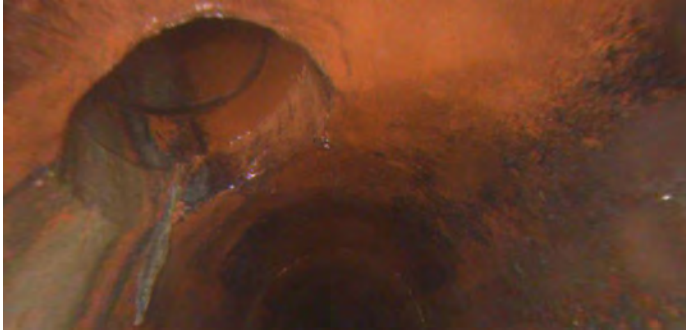
Code: **TF**
Description: **Tap Factory**

Distance (ft): **250.7**
Structural Grade: **0**
O&M Grade: **0**
Clock Start/From: **1**
Clock To:
1st Value: **4.000**
2nd Value:
Value Percent:
Continuous Index:
Within 8" of Joint:
Remarks:

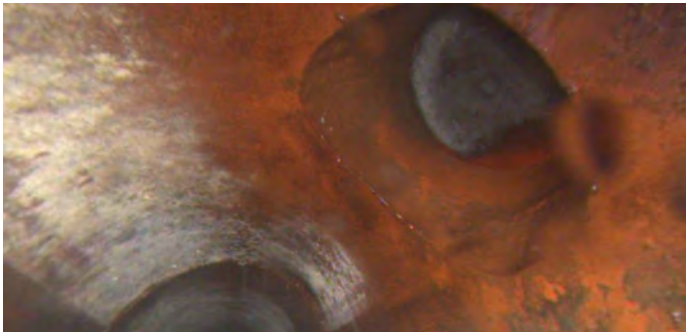
Code: **TFC**
Description: **Tap Factory Capped**

Distance (ft): **299.2**
Structural Grade: **0**
O&M Grade: **0**
Clock Start/From: **10**
Clock To:
1st Value: **4.000**
2nd Value:
Value Percent:
Continuous Index:
Within 8" of Joint:
Remarks:

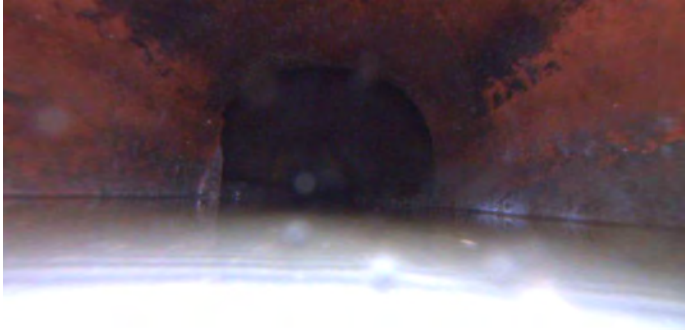
Code: **DAGS**
Description: **Deposits Attached Grease**

Distance (ft): **348.6**
Structural Grade: **0**
O&M Grade: **2**
Clock Start/From: **7**
Clock To: **5**
1st Value:
2nd Value:
Value Percent: **5.000**
Continuous Index: **F01**
Within 8" of Joint: **NO**
Remarks:

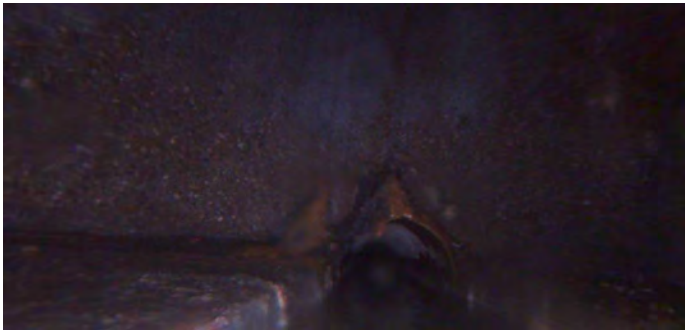
Code: **AMH**
Description: **Manhole**

Distance (ft): **351.0**
Structural Grade: **0**
O&M Grade: **0**
Clock Start/From:
Clock To:
1st Value:
2nd Value:
Value Percent:
Continuous Index:
Within 8" of Joint: **NO**
Remarks: **M-203-009**
