Profile/Photo Observation Report

Street:	old ridge rd	Flow Control:	Not Controlled
City:	Hobart, IN	Year Renewed:	
Location:	Other	Tape/Media #:	
Purpose:	Not Known	Dia/Height:	12"
Use:	Sanitary	Material:	VCP
Drain Area:	NA	Lining:	
Category:	NA		
Comment:

Location Details:		Direction of Survey:	Upstream
US MH:	M-203-009	DS MH:	M-203-006
		Total Length Surveyed (ft):	351.0

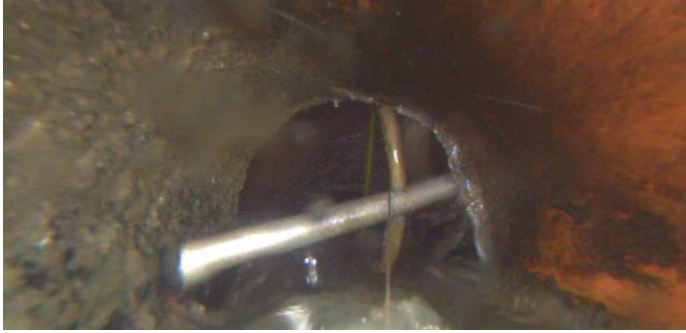
Code: **DAGS**
Description: **Deposits Attached Grease**

Distance (ft): **.9**
Structural Grade: **0**
O&M Grade: **2**
Clock Start/From: **12**
Clock To: **4**
1st Value:
2nd Value:
Value Percent: **5.000**
Continuous Index:
Within 8" of Joint: **NO**
Remarks:

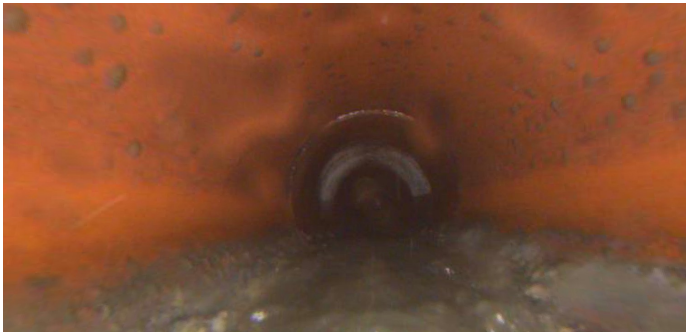
Code: **DAGS**
Description: **Deposits Attached Grease**

Distance (ft): **27.0**
Structural Grade: **0**
O&M Grade: **2**
Clock Start/From: **7**
Clock To: **5**
1st Value:
2nd Value:
Value Percent: **5.000**
Continuous Index: **S01**
Within 8" of Joint: **NO**
Remarks:

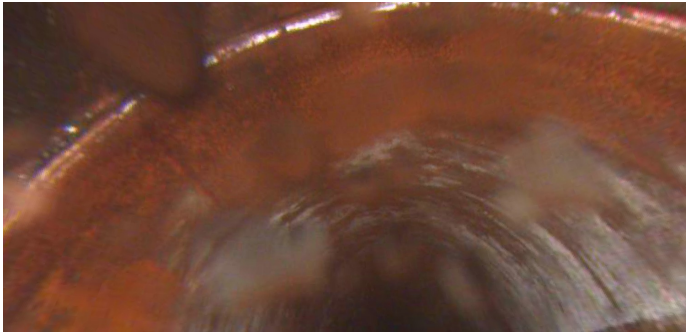
Code: **FL**
Description: **Fracture Longitudinal**

Distance (ft): **56.6**
Structural Grade: **3**
O&M Grade: **0**
Clock Start/From: **10**
Clock To:
1st Value:
2nd Value:
Value Percent:
Continuous Index:
Within 8" of Joint: **YES**
Remarks:

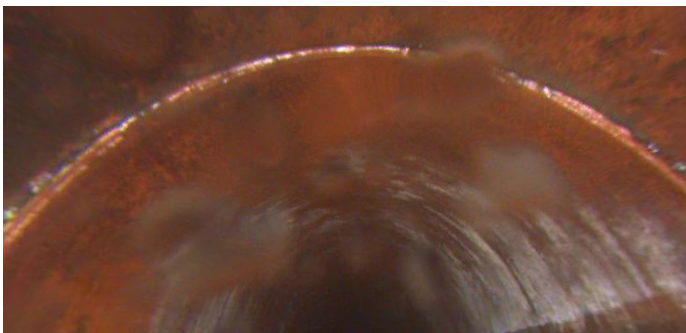
Code: **IW**
Description: **Infil Weeper**

Distance (ft): **56.7**
Structural Grade: **0**
O&M Grade: **2**
Clock Start/From: **8**
Clock To: **4**
1st Value:
2nd Value:
Value Percent:
Continuous Index: **S02**
Within 8" of Joint: **YES**
Remarks:

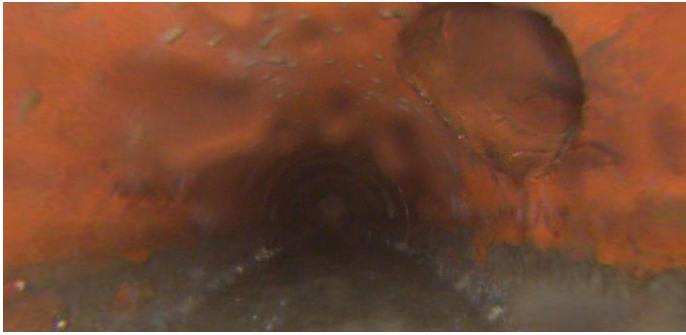
Code: **TFC**
Description: **Tap Factory Capped**

Distance (ft): **74.1**
Structural Grade: **0**
O&M Grade: **0**
Clock Start/From: **10**
Clock To:
1st Value: **4.000**
2nd Value:
Value Percent:
Continuous Index:
Within 8" of Joint:
Remarks:

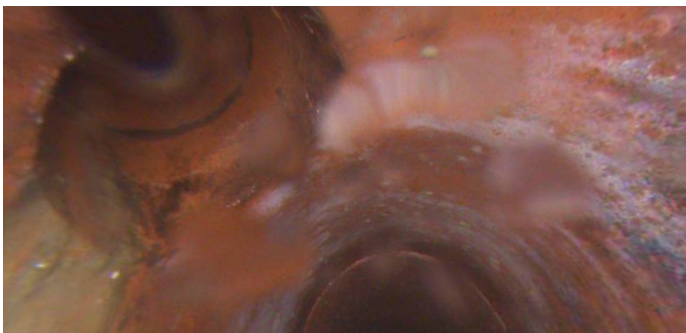
Code: **TF**
Description: **Tap Factory**

Distance (ft): **91.2**
Structural Grade: **0**
O&M Grade: **0**
Clock Start/From: **1**
Clock To:
1st Value: **4.000**
2nd Value:
Value Percent:
Continuous Index:
Within 8" of Joint:
Remarks:

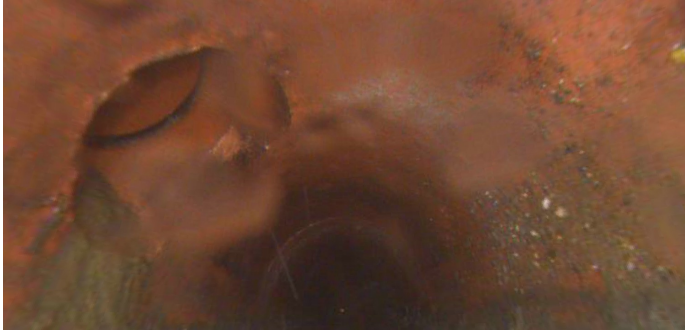
Code: **TF**
Description: **Tap Factory**

Distance (ft): **150.8**
Structural Grade: **0**
O&M Grade: **0**
Clock Start/From: **2**
Clock To:
1st Value: **4.000**
2nd Value:
Value Percent:
Continuous Index:
Within 8" of Joint:
Remarks:

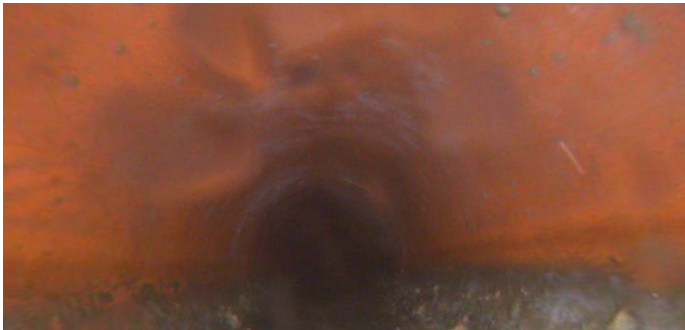
Code: **IW**
Description: **Infil Weeper**

Distance (ft): **158.2**
Structural Grade: **0**
O&M Grade: **2**
Clock Start/From: **8**
Clock To: **4**
1st Value:
2nd Value:
Value Percent:
Continuous Index: **F02**
Within 8" of Joint: **YES**
Remarks:

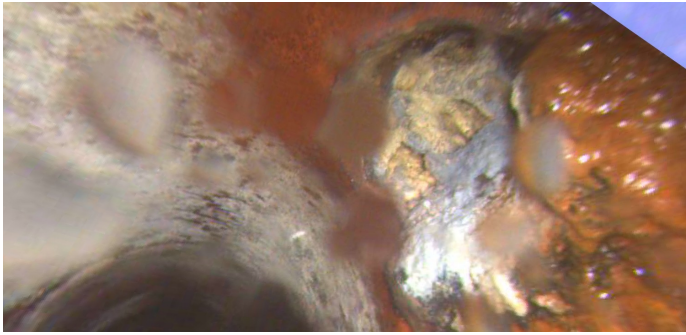
Code: **TFD**
Description: **Tap Factory Defective**

Distance (ft): **168.1**
Structural Grade: **0**
O&M Grade: **2**
Clock Start/From: **10**
Clock To:
1st Value: **4.000**
2nd Value:
Value Percent:
Continuous Index:
Within 8" of Joint:
Remarks: **dae**

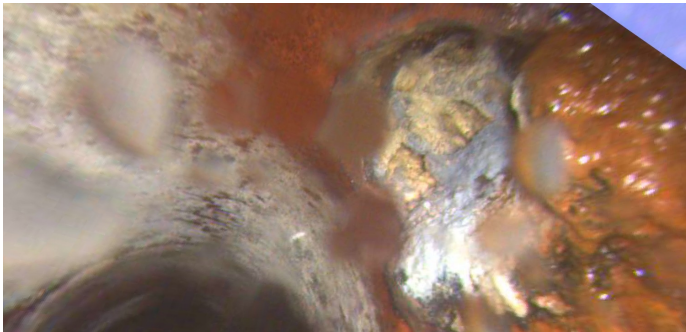
Code: **DAE**
Description: **Deposits Attached Encrustation**

Distance (ft): **168.1**
Structural Grade: **0**
O&M Grade: **2**
Clock Start/From: **9**
Clock To: **10**
1st Value:
2nd Value:
Value Percent: **10.000**
Continuous Index:
Within 8" of Joint: **NO**
Remarks:

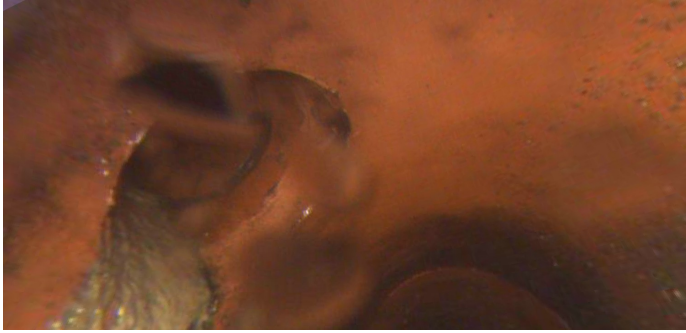
Code: **TFA**
Description: **Tap Factory Active**

Distance (ft): **191.2**
Structural Grade: **0**
O&M Grade: **0**
Clock Start/From: **2**
Clock To:
1st Value: **4.000**
2nd Value:
Value Percent:
Continuous Index:
Within 8" of Joint:
Remarks:

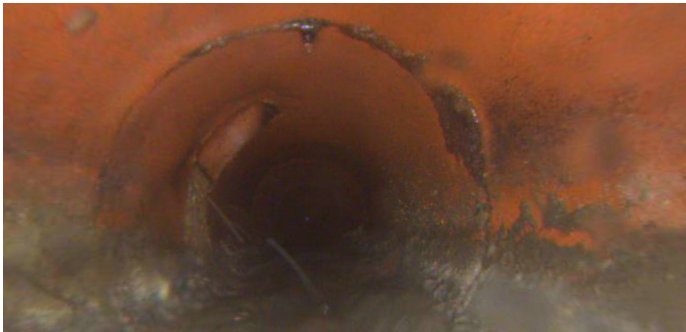
Code: **ID**
Description: **Infil Dripper**

Distance (ft): **192.4**
Structural Grade: **0**
O&M Grade: **3**
Clock Start/From: **12**
Clock To:
1st Value:
2nd Value:
Value Percent:
Continuous Index:
Within 8" of Joint: **YES**
Remarks:

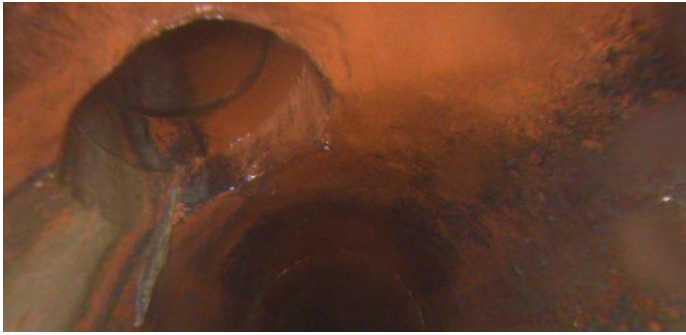
Code: **TF**
Description: **Tap Factory**

Distance (ft): **250.7**
Structural Grade: **0**
O&M Grade: **0**
Clock Start/From: **1**
Clock To:
1st Value: **4.000**
2nd Value:
Value Percent:
Continuous Index:
Within 8" of Joint:
Remarks:

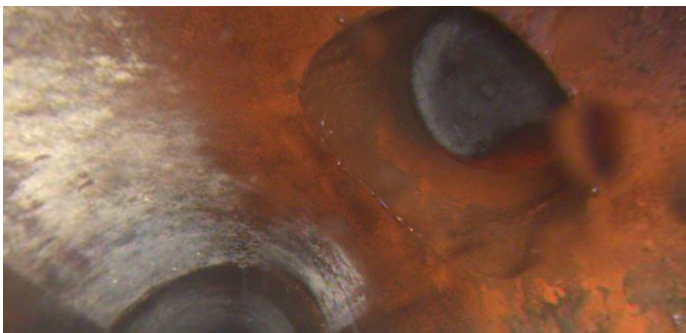
Code: **TFC**
Description: **Tap Factory Capped**

Distance (ft): **299.2**
Structural Grade: **0**
O&M Grade: **0**
Clock Start/From: **10**
Clock To:
1st Value: **4.000**
2nd Value:
Value Percent:
Continuous Index:
Within 8" of Joint:
Remarks:

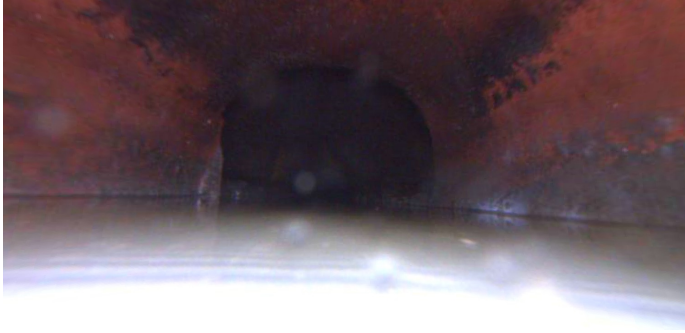
Code: **DAGS**
Description: **Deposits Attached Grease**

Distance (ft): **348.6**
Structural Grade: **0**
O&M Grade: **2**
Clock Start/From: **7**
Clock To: **5**
1st Value:
2nd Value:
Value Percent: **5.000**
Continuous Index: **F01**
Within 8" of Joint: **NO**
Remarks:
