Profile/Photo Observation Report

Date:	09/24/2018	Weather:		Coding:	PACP 6.0
Pipe Length (ft):	147.3	Owner:	NA	Pre Clean:	Not Known
P.O.#:		Surveyor:	Selasie Honu	PSR:	P-203-011-012
Customer:		Clean Date:	01/01/1900	Shape:	C

Street:	MAXWELL ST	Flow Control:	Not Controlled
City:	Hobart, IN	Year Renewed:	
Location:	Light Highway	Tape/Media #:	
Purpose:	Routine Assessment	Dia/Height:	8"
Use:	Sanitary	Material:	VCP
Drain Area:	NA	Lining:	
Category:	NA		
Comment:

Location Details:		Direction of Survey:	Upstream
US MH:	M-203-012	DS MH:	M-203-011
		Total Length Surveyed (ft):	108.1

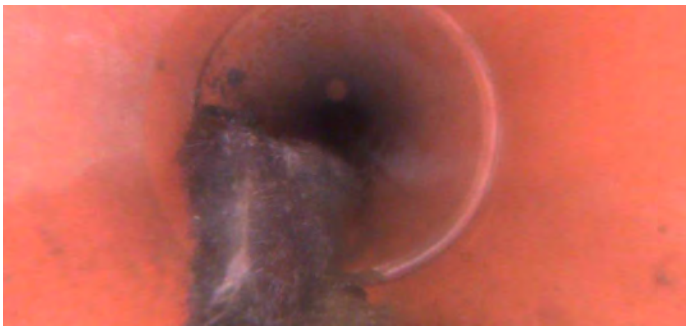
Code: **RMB**
Description: **Roots Medium Barrel**

Distance (ft): **15.6**
Structural Grade: **0**
O&M Grade: **4**
Clock Start/From: **5**
Clock To: **9**
1st Value:
2nd Value:
Value Percent: **40.000**
Continuous Index:
Within 8" of Joint: **NO**
Remarks:

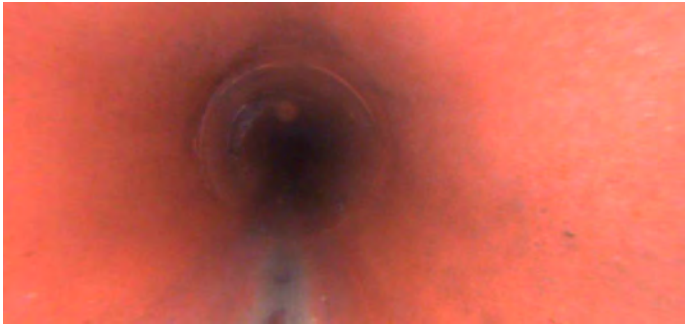
Code: **TF**
Description: **Tap Factory**

Distance (ft): **39.6**
Structural Grade: **0**
O&M Grade: **0**
Clock Start/From: **10**
Clock To:
1st Value: **4.000**
2nd Value:
Value Percent:
Continuous Index:
Within 8" of Joint:
Remarks:

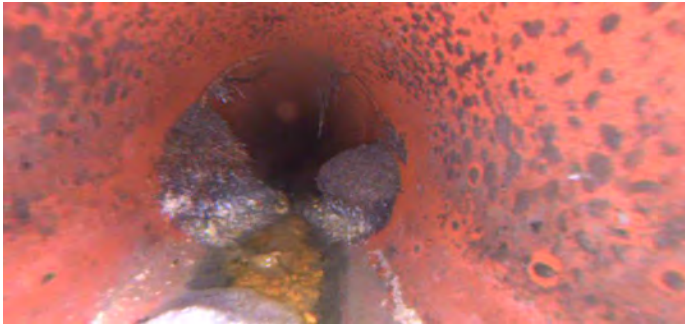
Code: **RMJ**
Description: **Roots Medium Joint**

Distance (ft): **78.1**
Structural Grade: **0**
O&M Grade: **3**
Clock Start/From: **6**
Clock To: **6**
1st Value:
2nd Value:
Value Percent: **40.000**
Continuous Index:
Within 8" of Joint: **YES**
Remarks:

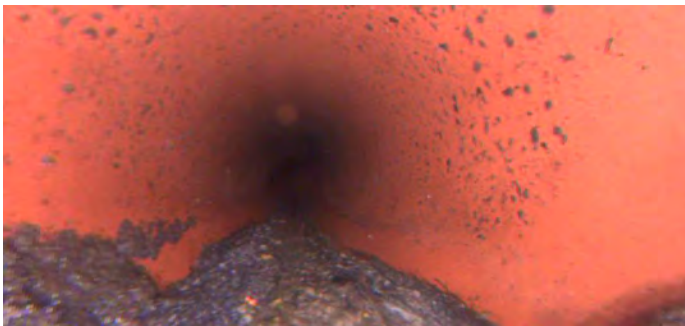
Code: **RMB**
Description: **Roots Medium Barrel**

Distance (ft): **79.3**
Structural Grade: **0**
O&M Grade: **4**
Clock Start/From: **5**
Clock To: **8**
1st Value:
2nd Value:
Value Percent: **30.000**
Continuous Index:
Within 8" of Joint: **NO**
Remarks:
