## Profile/Photo Observation Report

Date:	<b>09/24/2018</b>	Weather:		Coding:	<b>PACP 6.0</b>
Pipe Length (ft):	<b>147.3</b>	Owner:	<b>NA</b>	Pre Clean:	<b>Not Known</b>
P.O.#:		Surveyor:	<b>Selasie Honu</b>	PSR:	<b>P-203-011-012</b>
Customer:		Clean Date:	<b>01/01/1900</b>	Shape:	<b>C</b>

Street:	<b>Maxwell St</b>	Flow Control:	<b>Not Controlled</b>
City:	<b>Hobart, IN</b>	Year Renewed:	
Location:	<b>Light Highway</b>	Tape/Media #:	
Purpose:	<b>Routine Assessment</b>	Dia/Height:	<b>8"</b>
Use:	<b>Sanitary</b>	Material:	<b>VCP</b>
Drain Area:	<b>NA</b>	Lining:	
Category:	<b>NA</b>		
Comment:

Location Details:		Direction of Survey:	<b>Upstream</b>
US MH:	<b>M-203-012</b>	DS MH:	<b>M-203-011</b>
		Total Length Surveyed (ft):	<b>108.1</b>

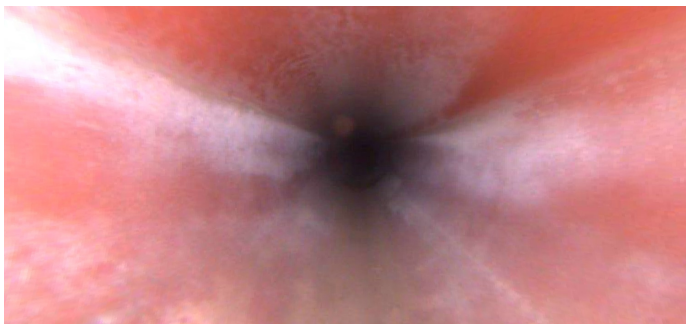
Code: **AMH**  
Description: **Manhole**

Distance (ft): **.0**  
Structural Grade: **0**  
O&M Grade: **0**  
Clock Start/From:  
Clock To:  
1st Value:  
2nd Value:  
Value Percent:  
Continuous Index:  
Within 8" of Joint: **NO**  
Remarks: **M-203-011**

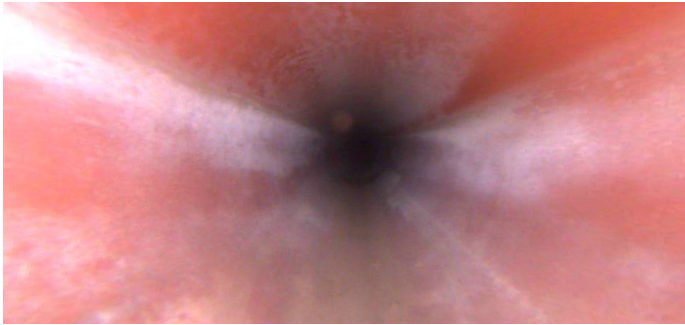
Code:	<b>MWL</b>
Description:	<b>Water Level</b>

Distance (ft):	<b>.0</b>
Structural Grade:	<b>0</b>
O&M Grade:	<b>0</b>
Clock Start/From:	
Clock To:	
1st Value:	
2nd Value:	
Value Percent:	<b>5.000</b>
Continuous Index:	
Within 8" of Joint:	<b>NO</b>
Remarks:

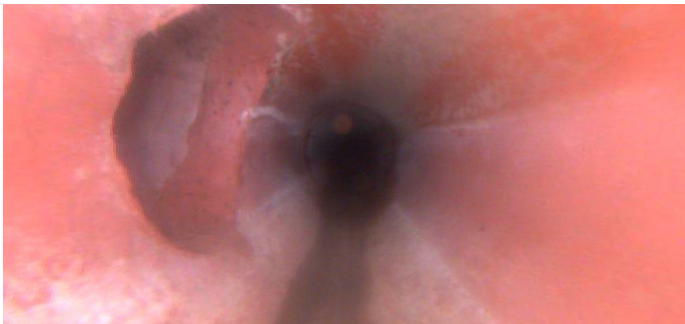
Code:	<b>TF</b>
Description:	<b>Tap Factory</b>

Distance (ft):	<b>4.5</b>
Structural Grade:	<b>0</b>
O&M Grade:	<b>0</b>
Clock Start/From:	<b>9</b>
Clock To:	
1st Value:	<b>4.000</b>
2nd Value:	
Value Percent:	
Continuous Index:	
Within 8" of Joint:	
Remarks:

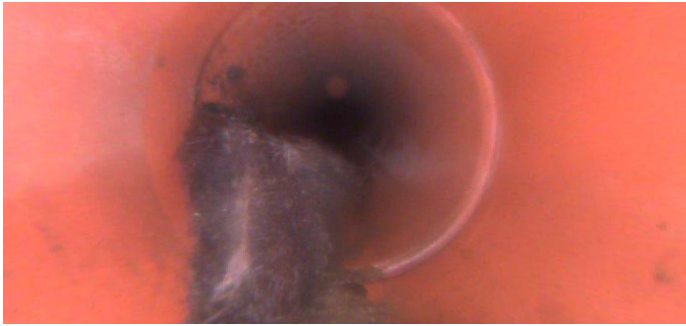
Code: **RMJ**  
Description: **Roots Medium Joint**

Distance (ft): **15.6**  
Structural Grade: **0**  
O&M Grade: **3**  
Clock Start/From: **5**  
Clock To: **9**  
1st Value:  
2nd Value:  
Value Percent: **30.000**  
Continuous Index:  
Within 8" of Joint: **YES**  
Remarks:

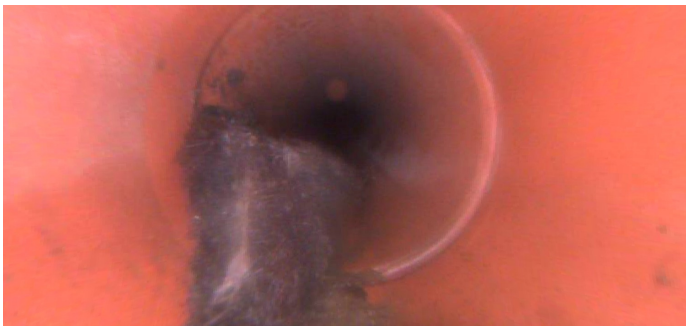
Code: **RMB**  
Description: **Roots Medium Barrel**

Distance (ft): **15.6**  
Structural Grade: **0**  
O&M Grade: **4**  
Clock Start/From: **5**  
Clock To: **9**  
1st Value:  
2nd Value:  
Value Percent: **40.000**  
Continuous Index:  
Within 8" of Joint: **NO**  
Remarks:

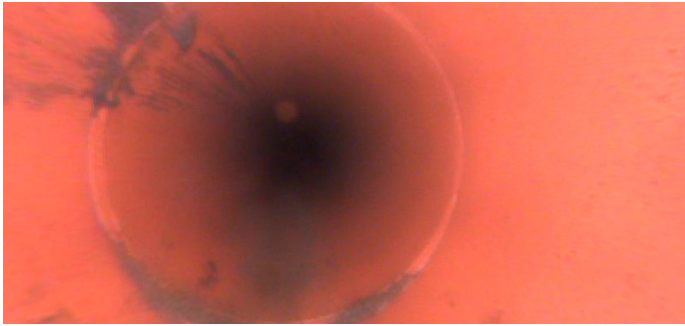
Code: **RFJ**  
Description: **Roots Fine Joint**

Distance (ft): **25.5**  
Structural Grade: **0**  
O&M Grade: **1**  
Clock Start/From: **5**  
Clock To: **11**  
1st Value:  
2nd Value:  
Value Percent:  
Continuous Index:  
Within 8" of Joint: **YES**  
Remarks:

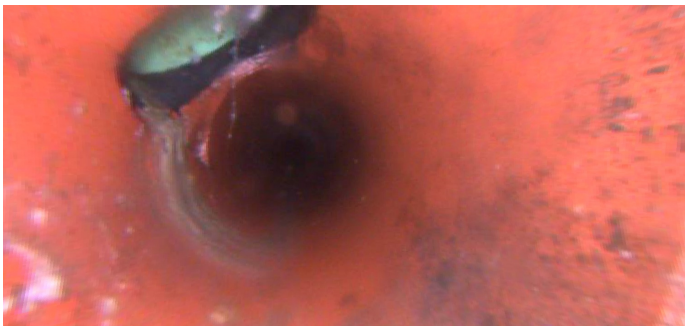
Code: **TF**  
Description: **Tap Factory**

Distance (ft): **30.8**  
Structural Grade: **0**  
O&M Grade: **0**  
Clock Start/From: **11**  
Clock To:  
1st Value: **4.000**  
2nd Value:  
Value Percent:  
Continuous Index:  
Within 8" of Joint:  
Remarks:

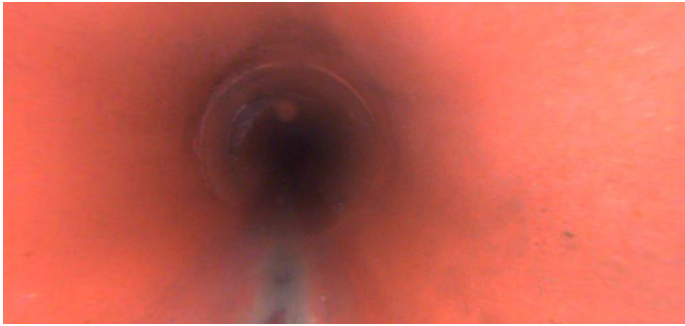
Code: **TF**  
Description: **Tap Factory**

Distance (ft): **39.6**  
Structural Grade: **0**  
O&M Grade: **0**  
Clock Start/From: **10**  
Clock To:  
1st Value: **4.000**  
2nd Value:  
Value Percent:  
Continuous Index:  
Within 8" of Joint:  
Remarks:

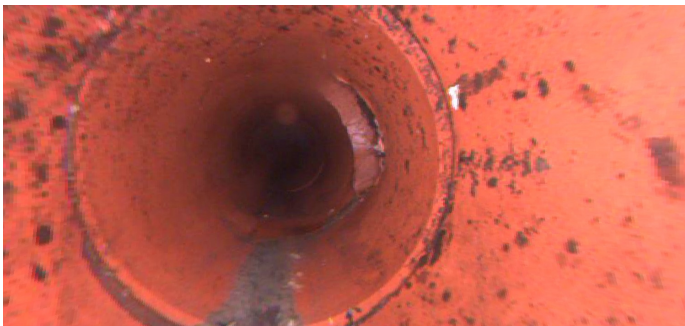
Code: **TF**  
Description: **Tap Factory**

Distance (ft): **61.8**  
Structural Grade: **0**  
O&M Grade: **0**  
Clock Start/From: **3**  
Clock To:  
1st Value: **4.000**  
2nd Value:  
Value Percent:  
Continuous Index:  
Within 8" of Joint:  
Remarks:

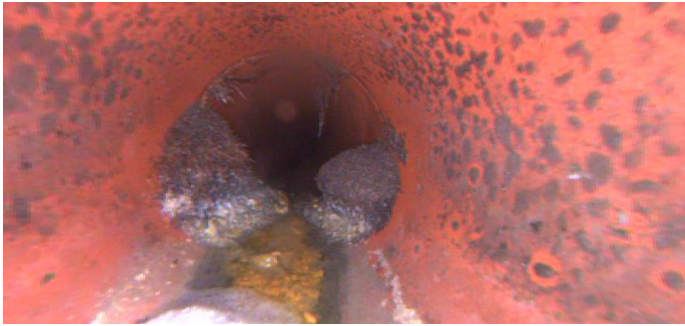
Code: **RMJ**  
Description: **Roots Medium Joint**

Distance (ft): **78.1**  
Structural Grade: **0**  
O&M Grade: **3**  
Clock Start/From: **6**  
Clock To: **6**  
1st Value:  
2nd Value:  
Value Percent: **40.000**  
Continuous Index:  
Within 8" of Joint: **YES**  
Remarks:

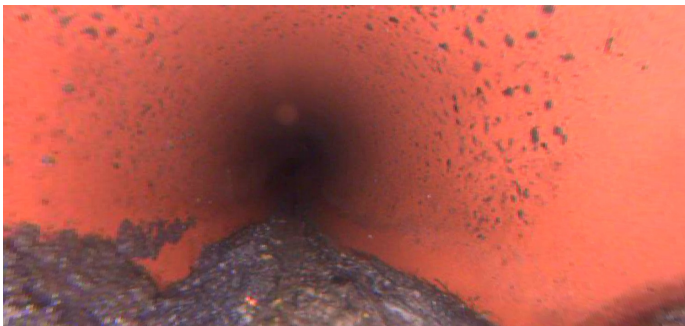
Code: **RMB**  
Description: **Roots Medium Barrel**

Distance (ft): **79.3**  
Structural Grade: **0**  
O&M Grade: **4**  
Clock Start/From: **5**  
Clock To: **8**  
1st Value:  
2nd Value:  
Value Percent: **30.000**  
Continuous Index:  
Within 8" of Joint: **NO**  
Remarks:

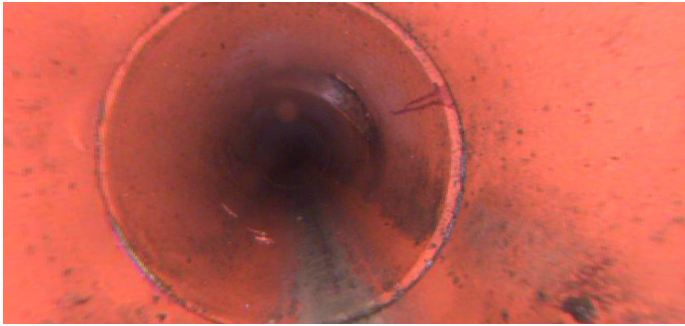
Code: **TF**  
Description: **Tap Factory**

Distance (ft): **83.4**  
Structural Grade: **0**  
O&M Grade: **0**  
Clock Start/From: **2**  
Clock To:  
1st Value: **4.000**  
2nd Value:  
Value Percent:  
Continuous Index:  
Within 8" of Joint:  
Remarks:

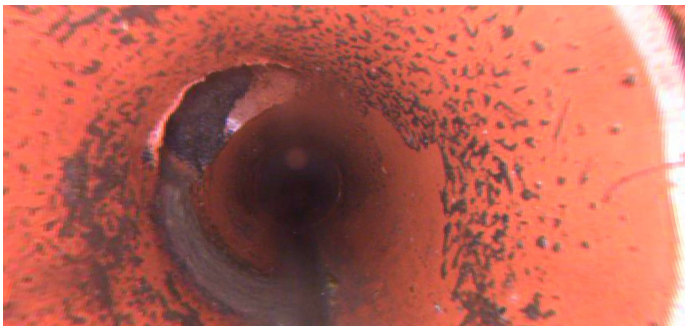
Code: **TF**  
Description: **Tap Factory**

Distance (ft): **100.4**  
Structural Grade: **0**  
O&M Grade: **0**  
Clock Start/From: **10**  
Clock To:  
1st Value: **4.000**  
2nd Value:  
Value Percent:  
Continuous Index:  
Within 8" of Joint:  
Remarks:

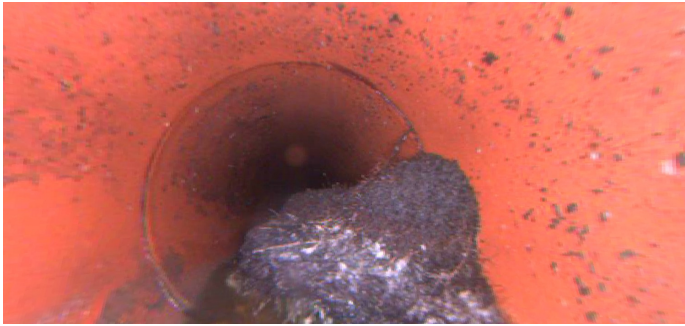
Code: **RBJ**  
Description: **Roots Ball Joint**

Distance (ft): **106.8**  
Structural Grade: **0**  
O&M Grade: **4**  
Clock Start/From: **2**  
Clock To: **7**  
1st Value:  
2nd Value:  
Value Percent: **55.000**  
Continuous Index:  
Within 8" of Joint: **YES**  
Remarks:

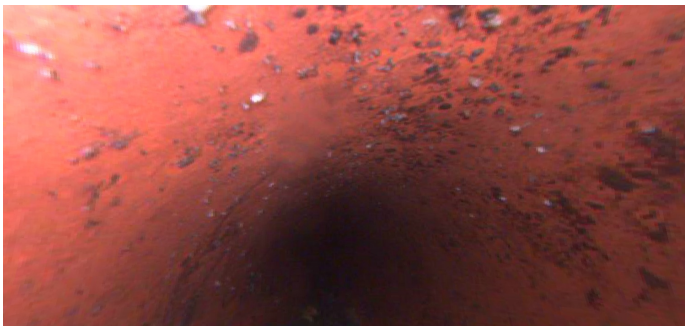
Code: **MSA**  
Description: **Abandoned Survey**

Distance (ft): **108.1**  
Structural Grade: **0**  
O&M Grade: **0**  
Clock Start/From:  
Clock To:  
1st Value:  
2nd Value:  
Value Percent:  
Continuous Index:  
Within 8" of Joint: **NO**  
Remarks: **root infiltration**
