Profile/Photo Observation Report

Location Details:		Direction of Survey:	Downstream
US MH:	M-203-014	DS MH:	M-203-013
		Total Length Surveyed (ft):	166.3

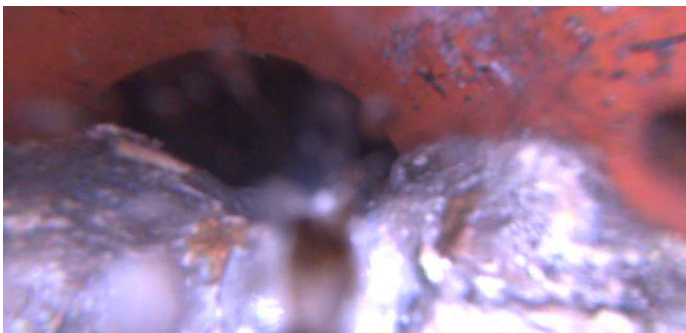
Code: **MSA**
Description: **Abandoned Survey**

Distance (ft): **166.3**
Structural Grade: **0**
O&M Grade: **0**
Clock Start/From:
Clock To:
1st Value:
2nd Value:
Value Percent:
Continuous Index:
Within 8" of Joint: **NO**
Remarks: **OBZ**
