Profile/Photo Observation Report

Date:	03/27/2018	Weather:		Coding:	PACP 6.0
Pipe Length (ft):	260.9	Owner:	NA	Pre Clean:	Not Known
P.O.#:		Surveyor:	Jen Costello	PSR:	P-203-014-016
Customer:		Clean Date:	01/01/1900	Shape:	C

Street:	W 38TH AVE	Flow Control:	Not Controlled
City:	Hobart, IN	Year Renewed:	
Location:	Other	Tape/Media #:	
Purpose:	Not Known	Dia/Height:	10"
Use:	Sanitary	Material:	VCP
Drain Area:	NA	Lining:	
Category:	NA		
Comment:	cnl

Location Details:		Direction of Survey:	Downstream
US MH:	M-203-014	DS MH:	M-203-016
		Total Length Surveyed (ft):	248.1

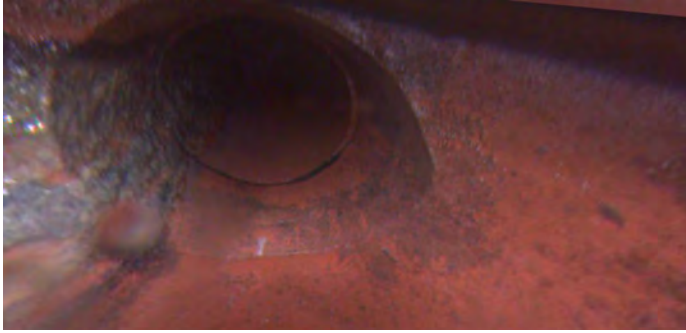
Code: **TF**
Description: **Tap Factory**

Distance (ft): **39.4**
Structural Grade: **0**
O&M Grade: **0**
Clock Start/From: **12**
Clock To:
1st Value: **4.000**
2nd Value:
Value Percent:
Continuous Index:
Within 8" of Joint:
Remarks:

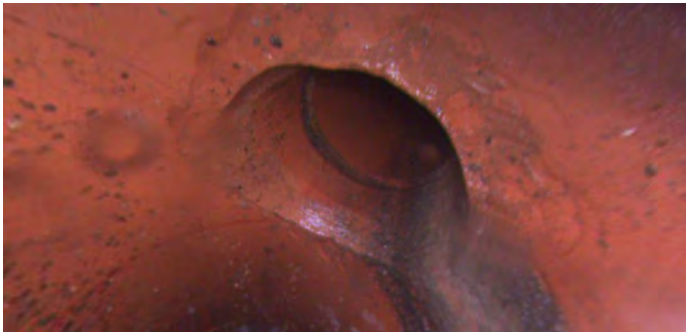
Code: **TF**
Description: **Tap Factory**

Distance (ft): **96.1**
Structural Grade: **0**
O&M Grade: **0**
Clock Start/From: **1**
Clock To:
1st Value: **4.000**
2nd Value:
Value Percent:
Continuous Index:
Within 8" of Joint:
Remarks:

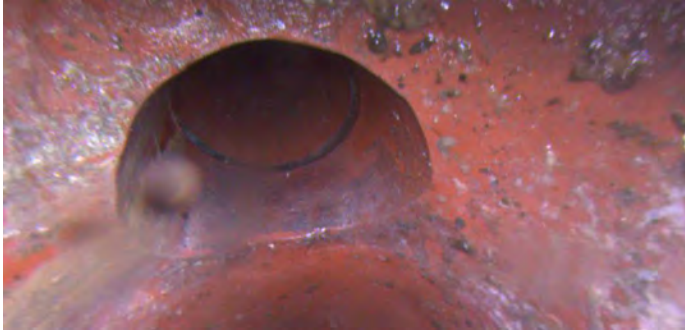
Code: **TF**
Description: **Tap Factory**

Distance (ft): **103.3**
Structural Grade: **0**
O&M Grade: **0**
Clock Start/From: **12**
Clock To:
1st Value: **4.000**
2nd Value:
Value Percent:
Continuous Index:
Within 8" of Joint:
Remarks:

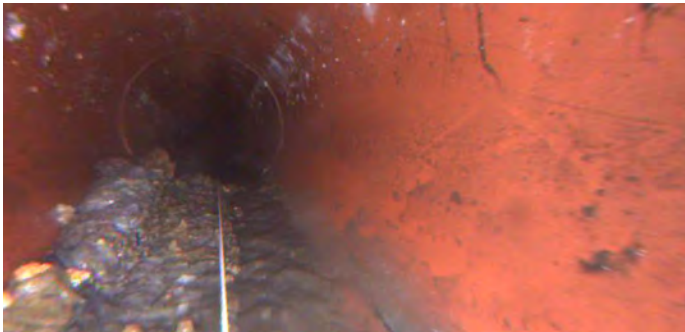
Code: **DSZ**
Description: **Deposits Settled Other**

Distance (ft): **121.8**
Structural Grade: **0**
O&M Grade: **2**
Clock Start/From: **4**
Clock To: **6**
1st Value:
2nd Value:
Value Percent: **10.000**
Continuous Index:
Within 8" of Joint: **NO**
Remarks: **misc**

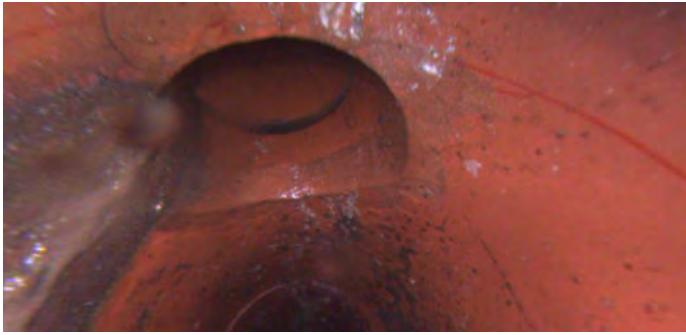
Code: **TF**
Description: **Tap Factory**

Distance (ft): **162.5**
Structural Grade: **0**
O&M Grade: **0**
Clock Start/From: **12**
Clock To:
1st Value: **4.000**
2nd Value:
Value Percent:
Continuous Index:
Within 8" of Joint:
Remarks:

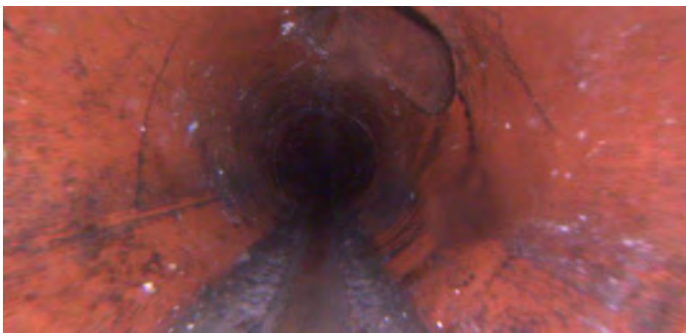
Code: **FM**
Description: **Fracture Multiple**

Distance (ft): **174.0**
Structural Grade: **4**
O&M Grade: **0**
Clock Start/From: **8**
Clock To: **4**
1st Value:
2nd Value:
Value Percent:
Continuous Index: **S02**
Within 8" of Joint:
Remarks:

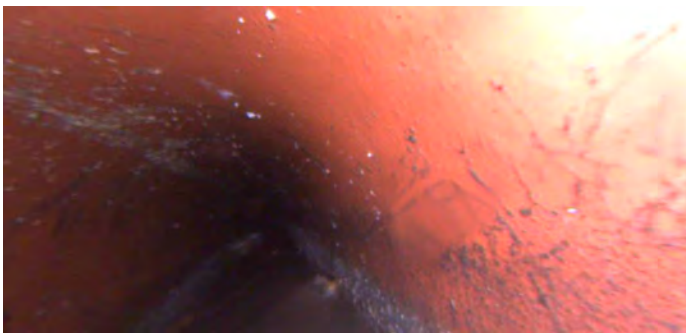
Code: **FM**
Description: **Fracture Multiple**

Distance (ft): **241.8**
Structural Grade: **4**
O&M Grade: **0**
Clock Start/From: **8**
Clock To: **4**
1st Value:
2nd Value:
Value Percent:
Continuous Index: **F02**
Within 8" of Joint:
Remarks:

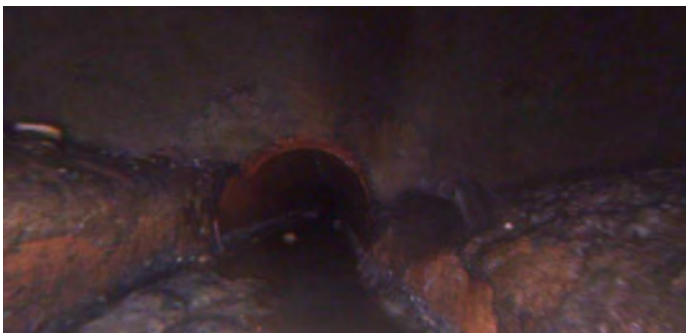
Code: **AMH**
Description: **Manhole**

Distance (ft): **248.1**
Structural Grade: **0**
O&M Grade: **0**
Clock Start/From:
Clock To:
1st Value:
2nd Value:
Value Percent:
Continuous Index:
Within 8" of Joint: **NO**
Remarks: **M-203-016**
