Profile/Photo Observation Report

Date:	03/27/2018	Weather:		Coding:	PACP 6.0
Pipe Length (ft):	260.9	Owner:	NA	Pre Clean:	Not Known
P.O.#:		Surveyor:	Jen Costello	PSR:	P-203-014-016
Customer:		Clean Date:	01/01/1900	Shape:	C

Street:	ALLEY WAY	Flow Control:	Not Controlled
City:	Hobart, IN	Year Renewed:	
Location:	Other	Tape/Media #:	
Purpose:	Not Known	Dia/Height:	10"
Use:	Sanitary	Material:	VCP
Drain Area:	NA	Lining:	
Category:	NA		
Comment:	cnl

Location Details:		Direction of Survey:	Downstream
US MH:	M-203-014	DS MH:	M-203-016
		Total Length Surveyed (ft):	248.1

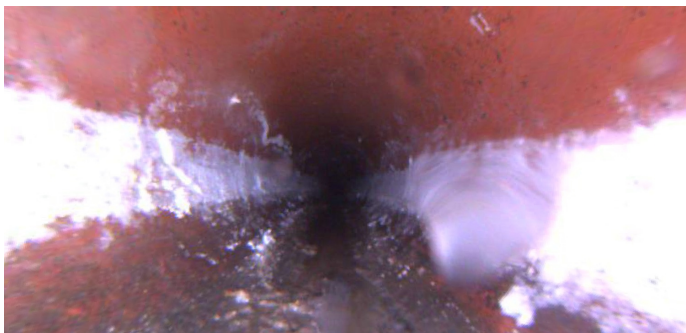
Code: **AMH**
Description: **Manhole**

Distance (ft): **.0**
Structural Grade: **0**
O&M Grade: **0**
Clock Start/From:
Clock To:
1st Value:
2nd Value:
Value Percent:
Continuous Index:
Within 8" of Joint: **NO**
Remarks: **M-203-014**

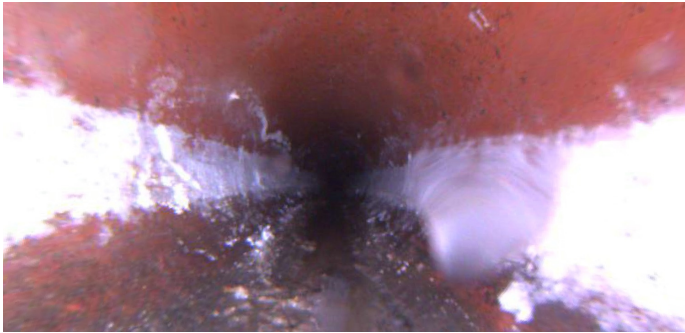
Code:	MWL
Description:	Water Level

Distance (ft):	.0
Structural Grade:	0
O&M Grade:	0
Clock Start/From:	
Clock To:	
1st Value:	
2nd Value:	
Value Percent:	5.000
Continuous Index:	
Within 8" of Joint:	NO
Remarks:

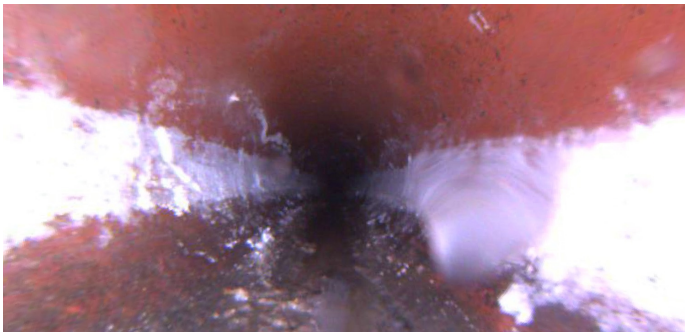
Code:	DAGS
Description:	Deposits Attached Grease

Distance (ft):	.0
Structural Grade:	0
O&M Grade:	2
Clock Start/From:	7
Clock To:	5
1st Value:	
2nd Value:	
Value Percent:	5.000
Continuous Index:	S01
Within 8" of Joint:	NO
Remarks:

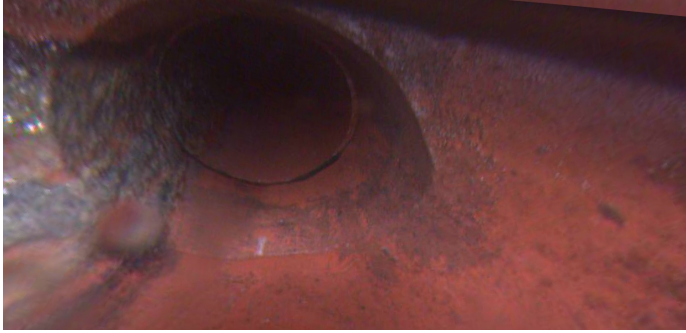
Code: **TF**
Description: **Tap Factory**

Distance (ft): **39.4**
Structural Grade: **0**
O&M Grade: **0**
Clock Start/From: **12**
Clock To:
1st Value: **4.000**
2nd Value:
Value Percent:
Continuous Index:
Within 8" of Joint:
Remarks:

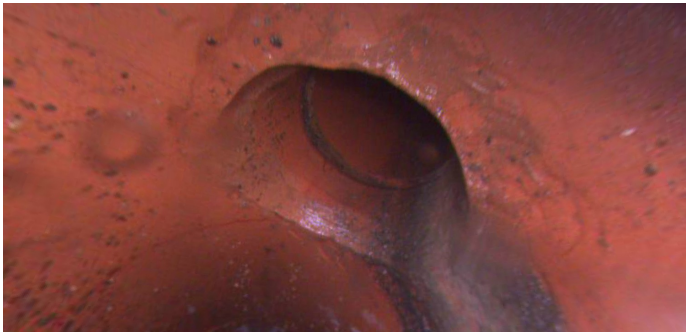
Code: **TF**
Description: **Tap Factory**

Distance (ft): **96.1**
Structural Grade: **0**
O&M Grade: **0**
Clock Start/From: **1**
Clock To:
1st Value: **4.000**
2nd Value:
Value Percent:
Continuous Index:
Within 8" of Joint:
Remarks:

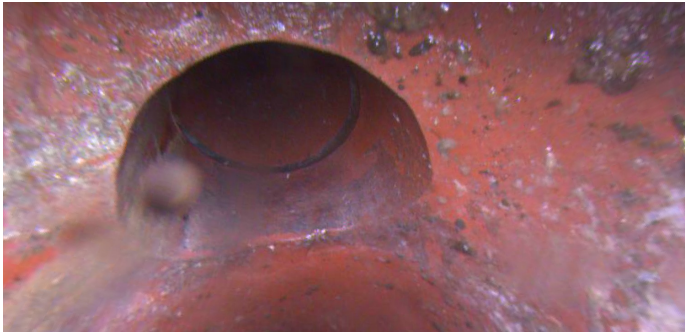
Code: **TF**
Description: **Tap Factory**

Distance (ft): **103.3**
Structural Grade: **0**
O&M Grade: **0**
Clock Start/From: **12**
Clock To:
1st Value: **4.000**
2nd Value:
Value Percent:
Continuous Index:
Within 8" of Joint:
Remarks:

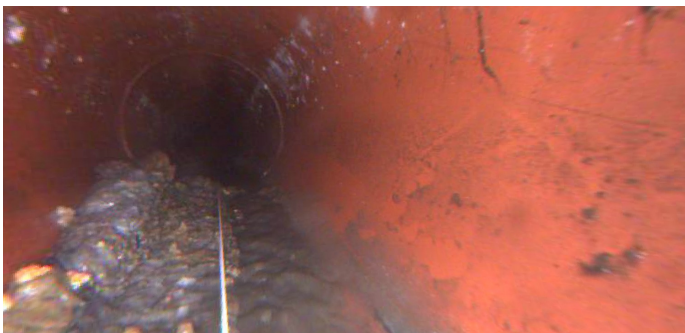
Code: **DSZ**
Description: **Deposits Settled Other**

Distance (ft): **121.8**
Structural Grade: **0**
O&M Grade: **2**
Clock Start/From: **4**
Clock To: **6**
1st Value:
2nd Value:
Value Percent: **10.000**
Continuous Index:
Within 8" of Joint: **NO**
Remarks: **misc**

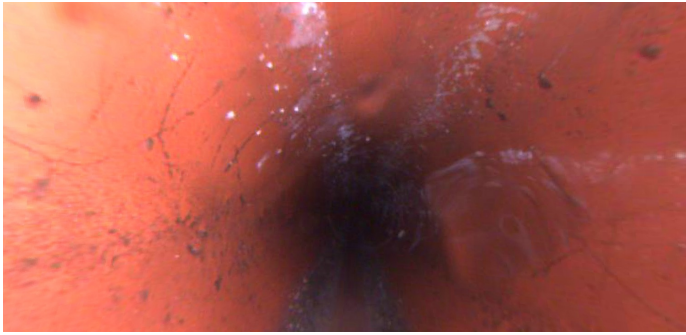
Code: **CM**
Description: **Crack Multiple**

Distance (ft): **121.8**
Structural Grade: **3**
O&M Grade: **0**
Clock Start/From: **8**
Clock To: **4**
1st Value:
2nd Value:
Value Percent:
Continuous Index:
Within 8" of Joint:
Remarks:

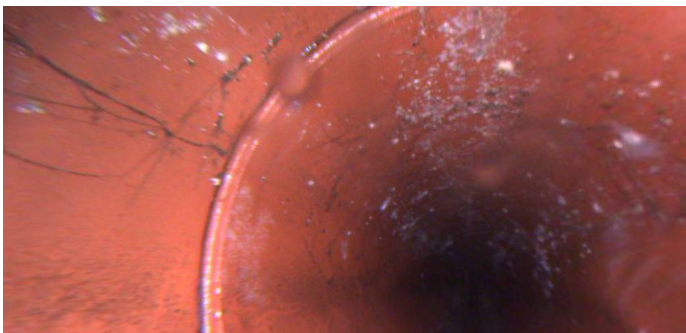
Code: **RFJ**
Description: **Roots Fine Joint**

Distance (ft): **124.6**
Structural Grade: **0**
O&M Grade: **1**
Clock Start/From: **10**
Clock To:
1st Value:
2nd Value:
Value Percent:
Continuous Index:
Within 8" of Joint: **YES**
Remarks:

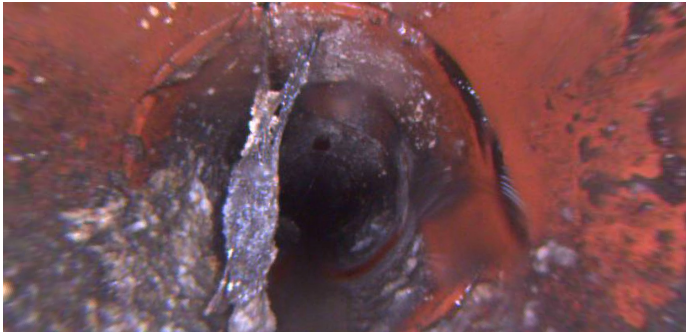
Code: **RMJ**
Description: **Roots Medium Joint**

Distance (ft): **134.4**
Structural Grade: **0**
O&M Grade: **3**
Clock Start/From: **12**
Clock To:
1st Value:
2nd Value:
Value Percent: **10.000**
Continuous Index:
Within 8" of Joint: **YES**
Remarks:

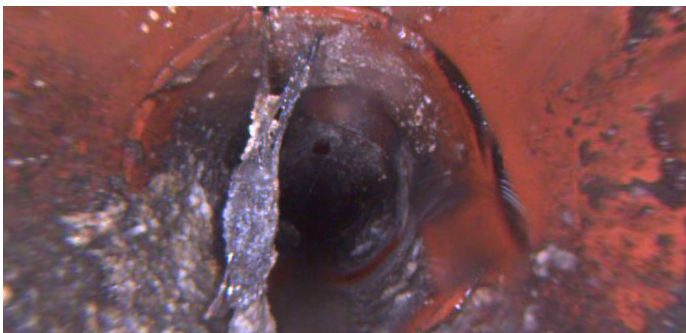
Code: **DAGS**
Description: **Deposits Attached Grease**

Distance (ft): **134.4**
Structural Grade: **0**
O&M Grade: **2**
Clock Start/From: **7**
Clock To: **9**
1st Value:
2nd Value:
Value Percent: **10.000**
Continuous Index:
Within 8" of Joint: **YES**
Remarks:

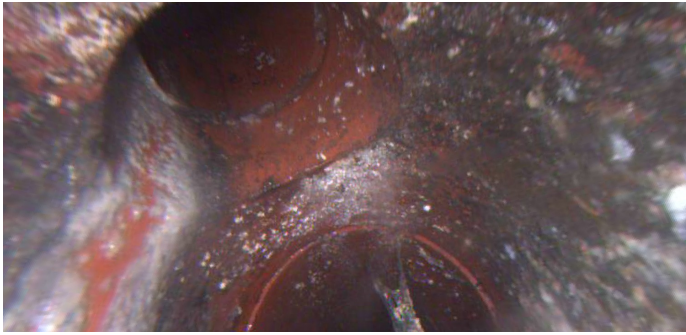
Code: **TFA**
Description: **Tap Factory Active**

Distance (ft): **136.1**
Structural Grade: **0**
O&M Grade: **0**
Clock Start/From: **1**
Clock To:
1st Value: **4.000**
2nd Value:
Value Percent:
Continuous Index:
Within 8" of Joint:
Remarks:

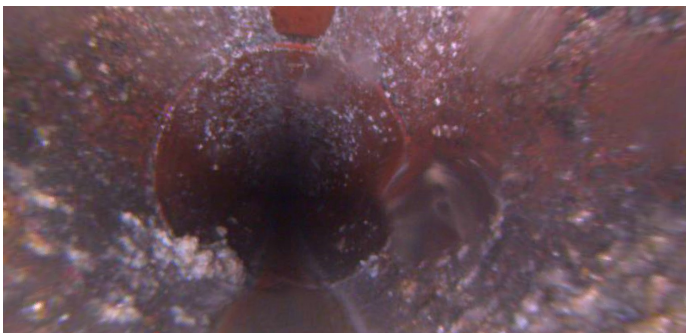
Code: **DAGS**
Description: **Deposits Attached Grease**

Distance (ft): **136.1**
Structural Grade: **0**
O&M Grade: **2**
Clock Start/From: **8**
Clock To: **4**
1st Value:
2nd Value:
Value Percent: **5.000**
Continuous Index:
Within 8" of Joint: **YES**
Remarks:

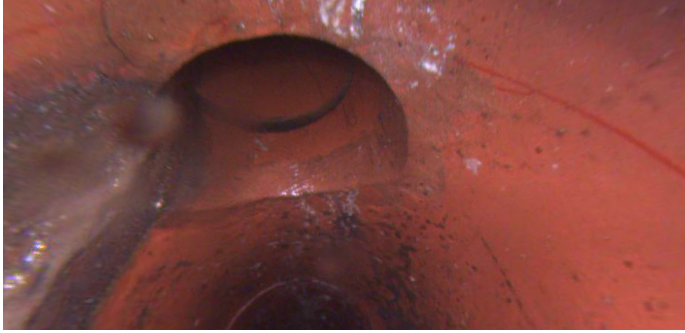
Code: **TF**
Description: **Tap Factory**

Distance (ft): **162.5**
Structural Grade: **0**
O&M Grade: **0**
Clock Start/From: **12**
Clock To:
1st Value: **4.000**
2nd Value:
Value Percent:
Continuous Index:
Within 8" of Joint:
Remarks:

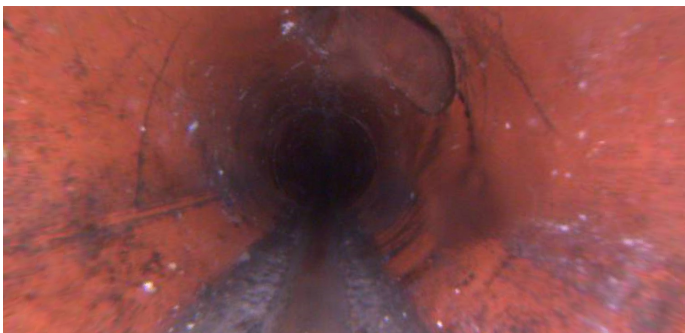
Code: **FM**
Description: **Fracture Multiple**

Distance (ft): **174.0**
Structural Grade: **4**
O&M Grade: **0**
Clock Start/From: **8**
Clock To: **4**
1st Value:
2nd Value:
Value Percent:
Continuous Index: **S02**
Within 8" of Joint:
Remarks:

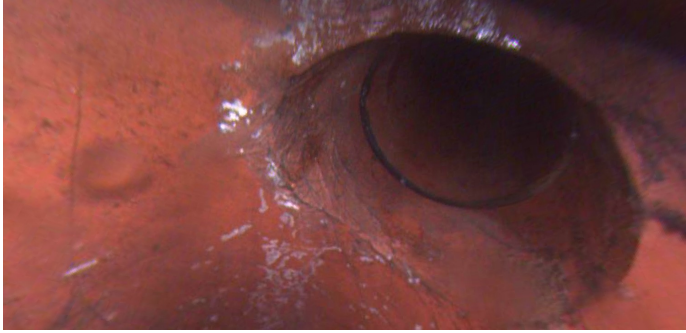
Code: **TF**
Description: **Tap Factory**

Distance (ft): **174.6**
Structural Grade: **0**
O&M Grade: **0**
Clock Start/From: **1**
Clock To:
1st Value: **4.000**
2nd Value:
Value Percent:
Continuous Index:
Within 8" of Joint:
Remarks:

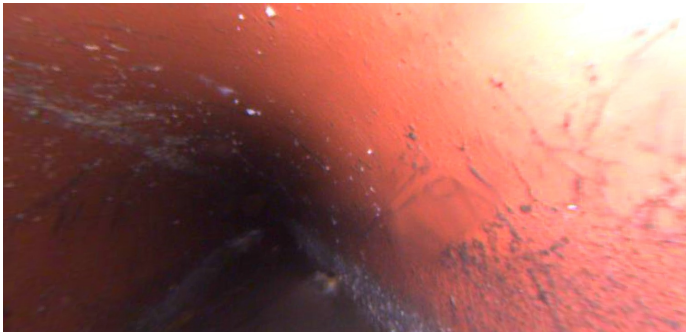
Code: **FM**
Description: **Fracture Multiple**

Distance (ft): **241.8**
Structural Grade: **4**
O&M Grade: **0**
Clock Start/From: **8**
Clock To: **4**
1st Value:
2nd Value:
Value Percent:
Continuous Index: **F02**
Within 8" of Joint:
Remarks:

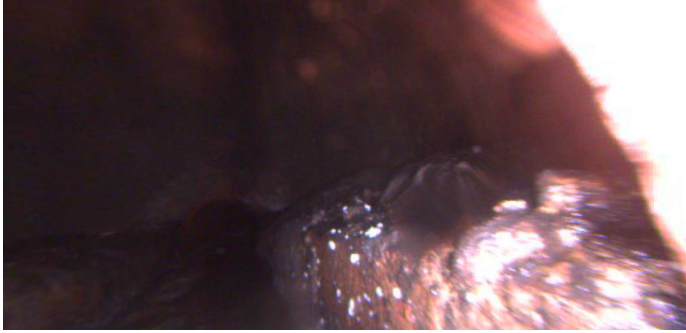
Code: **DAGS**
Description: **Deposits Attached Grease**

Distance (ft): **246.2**
Structural Grade: **0**
O&M Grade: **2**
Clock Start/From: **7**
Clock To: **5**
1st Value:
2nd Value:
Value Percent: **5.000**
Continuous Index: **F01**
Within 8" of Joint: **NO**
Remarks:

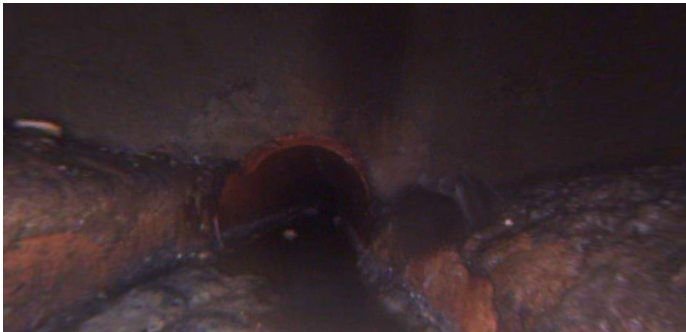
Code: **AMH**
Description: **Manhole**

Distance (ft): **248.1**
Structural Grade: **0**
O&M Grade: **0**
Clock Start/From:
Clock To:
1st Value:
2nd Value:
Value Percent:
Continuous Index:
Within 8" of Joint: **NO**
Remarks: **M-203-016**
